**NYC Department of Education**  
**Building Condition Assessment Survey 2023 - 2024**

Architectural Inspection

**Asset: P.S. 95 TRANSPORTABLE - K, 345 VAN SICKLEN STREET, New York, 11223**

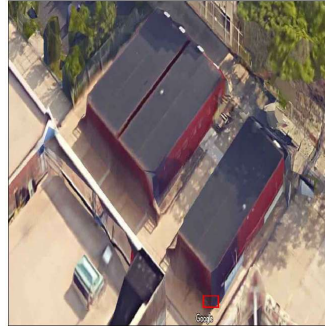
Question	Response
<b>Architectural</b>	
<b>EXTERIOR</b>	Inspected
<b>AWNINGS AND CANOPIES</b>	Does not Exist
<b>DOORS</b>	Inspected
<b>DOORS AND FRAMES</b>	Inspected
Condition	2 - Between Good and Fair
Deficiency	No deficiencies recorded
<b>DOOR HARDWARE</b>	Inspected
Condition	3 - Fair
Deficiency	No deficiencies recorded
<b>EXTERIOR WALLS</b>	Inspected
Material Type(s)	Steel
Replacement Quantity	4,300
Replacement Uom	S.F.
Instance on All Facades	Inspected
Instance Condition	5 - Poor
Instance Quantity	4,300
Instance Quantity Uom	S.F.
Deficiency	METAL PANEL: DAMAGED TRIM
Roof Plan reference	K951

Deficiency Quantity

15

Quantity Uom

L.F.

Potential Action

REPLACE

Urgency of Action

PRIORITY 4

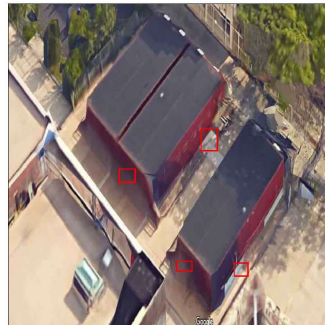
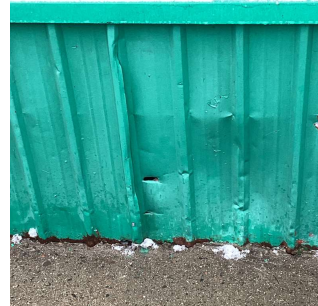
Facade E - Unit T3

METAL PANEL: SEVERE DENTS

Deficiency Quantity

150

Quantity Uom

S.F.

Potential Action

REPLACE

PRIORITY 4  
LEVEL 2

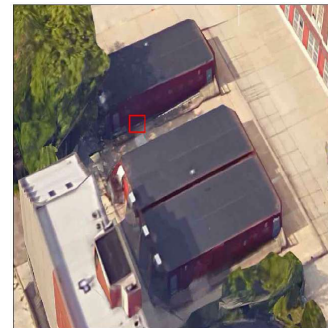
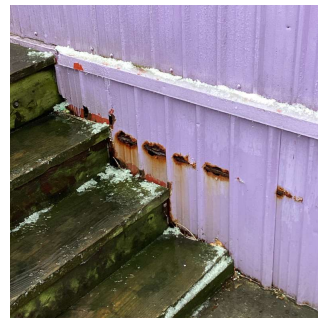
Facade A - Unit T2

METAL PANEL: MAJOR RUSTING

Deficiency Quantity

20

Quantity Uom

S.F.

Potential Action

REPLACE

Urgency of Action

PRIORITY 4

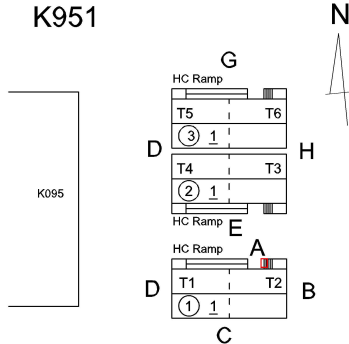
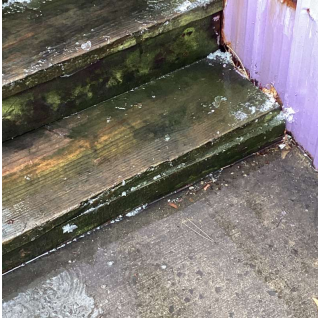
<b>STAIRS/RAMPS: EXTERIOR</b>	Inspected
<b>RAILINGS</b>	Inspected
Condition	2 - Between Good and Fair
Deficiency	No deficiencies recorded
<b>STAIRS/RAMPS</b>	Inspected
Condition	4 - Between Fair and Poor
Deficiency	WOOD: DETERIORATED
Roof Plan reference	<p><b>K951</b></p>

Deficiency Quantity	20

Question	Response
<b>EXTERIOR</b>	
<b>STAIRS/RAMPS: EXTERIOR</b>	
<b>STAIRS/RAMPS</b>	
Quantity Uom	S.F.
Potential Action	REPLACE
Urgency of Action	PRIORITY 4
Purpose of Action	LEVEL 2
Deficiency Photo1

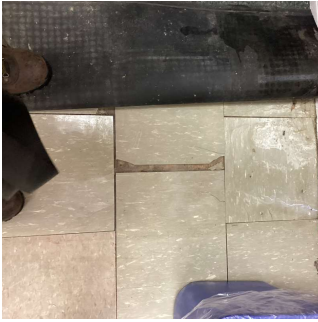
Question	Response
<b>INTERIOR</b>	
<b>CLASSROOMS/CORRIDORS/ADMIN SPACES</b>	
<b>Door(s)</b>	Inspected
Condition	2 - Between Good and Fair
Deficiency	No deficiencies recorded
<b>Floor Finish</b>	Inspected
Condition	5 - Poor
Deficiency	VINYL TILES: BROKEN/DETERIORATED/MISSING TILES
Deficiency Location/Instance	Room T6
Deficiency Quantity	15
Quantity Uom	S.F.
Potential Action	REPLACE
Urgency of Action	PRIORITY 3
Purpose of Action	LEVEL 2
Deficiency Photo1

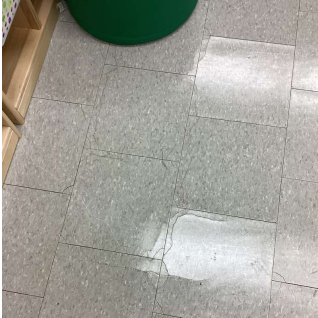
Room T1
Violations	No violations recorded.
<b>Walls</b>	Inspected
Condition	2 - Between Good and Fair
Deficiency	No deficiencies recorded
<b>INTERIOR DOOR HARDWARE</b>	
Condition	3 - Fair
Deficiency	No deficiencies recorded

Room T6
Violations	No violations recorded.
Deficiency	VINYL TILES: DETERIORATED SUBSTRATE
Deficiency Location/Instance	Rooms T1-T6
Deficiency Quantity	600
Quantity Uom	S.F.
Potential Action	REPLACE
Urgency of Action	PRIORITY 3
Purpose of Action	LEVEL 2
Deficiency Photo1

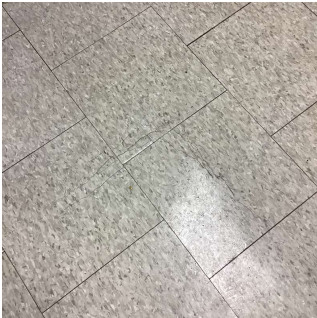
Inside room T2
Violations	No violations recorded.
<b>Walls</b>	Inspected
Condition	2 - Between Good and Fair
Deficiency	No deficiencies recorded
<b>SITE</b>	Not Required
<b>ARTWORK</b>	Does not Exist

<b>Question</b>	<b>Response</b>
<b>INTERIOR</b>	
<b>TOILET ROOMS - STUDENTS</b>	Inspected
<b>Ceiling</b>	Inspected
Condition	2 - Between Good and Fair
Deficiency	No deficiencies recorded
<b>Door(s)</b>	Inspected
Condition	2 - Between Good and Fair
Deficiency	No deficiencies recorded
<b>Floor Finish</b>	Inspected
Condition	2 - Between Good and Fair
Deficiency	VINYL TILES: DETERIORATED SUBSTRATE
Deficiency Location/Instance	Inside rooms T2, T5
Deficiency Quantity	15
Quantity Uom	S.F.
Potential Action	REPLACE
Urgency of Action	PRIORITY 3
Purpose of Action	LEVEL 2
Deficiency Photo1
