**NYC Department of Education**  
**Building Condition Assessment Survey 2023 - 2024**

Architectural Inspection

**Asset: P.S. 971 - BROOKLYN, 6214 4TH AVE, New York, 11220**

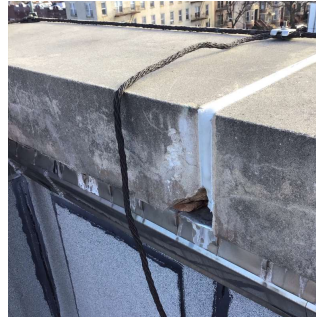
Roof 1

CAST STONE: CRACKED/BROKEN PIECES

REPLACE-IN-KIND

PRIORITY 4

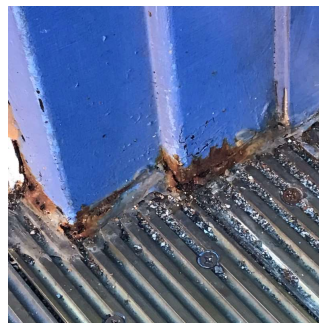
METAL: DETERIORATED DOOR AND FRAME - MINOR DETERIORATION

Deficiency Quantity	2
Quantity Uom	EACH
Potential Action	MAINTENANCE
Urgency of Action	PRIORITY 3
Purpose of Action	LEVEL 2
Deficiency Photo1

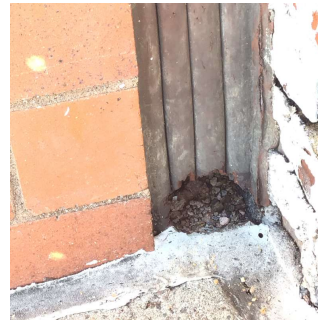
Facade A

Violations	Facade C No violations recorded.
<b>DOOR HARDWARE</b>	Inspected
Condition	3 - Fair
Deficiency	No deficiencies recorded
<b>LINTELS</b>	Inspected
Condition	2 - Between Good and Fair
Deficiency	No deficiencies recorded
<b>TRANSOM/SIDE LIGHT</b>	Inspected
Condition	2 - Between Good and Fair
Deficiency	No deficiencies recorded
<b>EXTERIOR WALLS</b>	Inspected
Material Type(s)	Masonry
Replacement Quantity	14,500
Replacement Uom	S.F.
Instance on All Facades	Inspected
Instance Condition	2 - Between Good and Fair
Instance Quantity	14,500
Instance Quantity Uom	S.F.
Deficiency	BRICK: DETERIORATED CONTROL/EXPANSION JOINTS

MAINTENANCE

PRIORITY 3

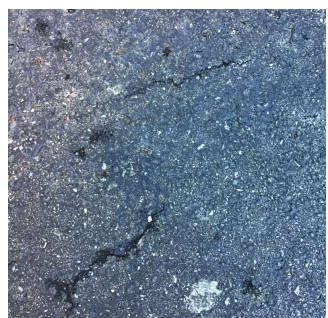
Question	Response
<b>EXTERIOR</b>	
<b>PLAZA DECK</b>	
Instance Quantity Uom	S.F.
Installation Year	2010
Source of Installation	Custodial Staff
Deficiency	ASPHALT: MINOR CRACKS
Roof Plan reference

Deficiency Quantity	20
Quantity Uom	S.F.
Potential Action	REPAIR
Urgency of Action	PRIORITY 3
Purpose of Action	LEVEL 2
Deficiency Photo1

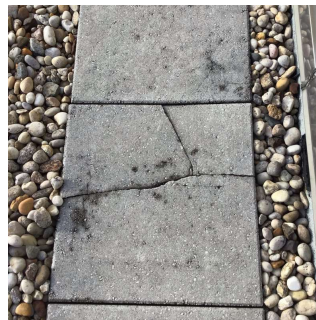
Roof 1

IRMA: ROOFING: DETERIORATED PAVERS WITH INTEGRAL INSULATION

REPLACE

PRIORITY 4

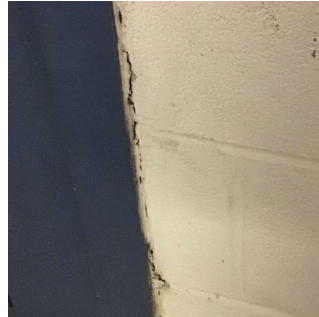
Question	Response
<b>EXTERIOR</b>	
<b>ROOF</b>	
<b>Specialties</b>	Inspected
<b>BULKHEAD/PENTHOUSE</b>	Inspected
Condition	4 - Between Fair and Poor
Deficiency	BULKHEAD/PENTHOUSE WALLS/INTERIOR: CMU CRACKS/SPALLING
Roof Plan reference	K971

Deficiency Quantity	10
Quantity Uom	S.F.
Potential Action	REPLACE
Urgency of Action	PRIORITY 3
Purpose of Action	LEVEL 2
Deficiency Photo1

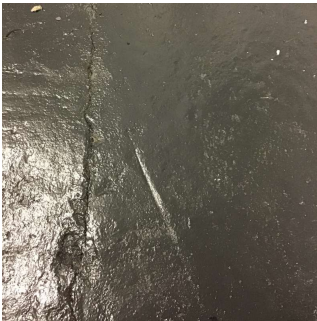
Question	Response
<b>INTERIOR</b>	
<b>STRUCTURAL</b>	
<b>FLOOR STRUCTURE</b>	
Deficiency Photo1

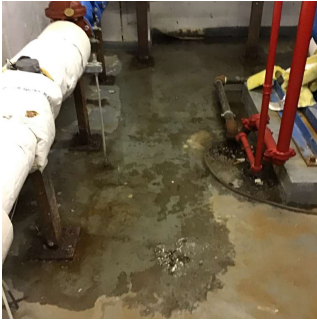
Violations	Basement - Room C01B No violations recorded.
Deficiency	CONCRETE SLAB ON GRADE: WATER INFILTRATION IN NON- INSTRUCTIONAL SPACE
Deficiency Location/Instance	Basement - Room C01A
Deficiency Quantity	100
Quantity Uom	S.F.
Potential Action	INSTALL WATERPROOFING
Urgency of Action	PRIORITY 5
Purpose of Action	LEVEL 5
Deficiency Photo1

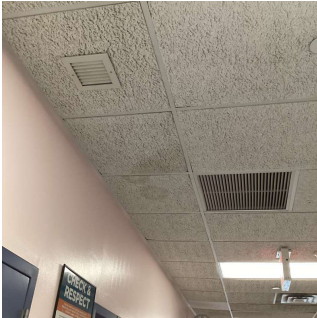
Near Room C04A
Violations	No violations recorded.
<b>Window Curtains/Shades/Blinds</b>	
Instance on Basement	Does not Exist
<b>CLASSROOMS/CORRIDORS/ADMIN SPACES</b>	
<b>Ceiling</b>	
Condition	2 - Between Good and Fair
Deficiency	ACOUSTIC TILES: DAMAGED/MISSING
Deficiency Location/Instance	Room 408, Corridor near Rooms 409, 405
Deficiency Quantity	50
Quantity Uom	S.F.
Potential Action	REPLACE
Urgency of Action	PRIORITY 3
Purpose of Action	LEVEL 2
Deficiency Photo1

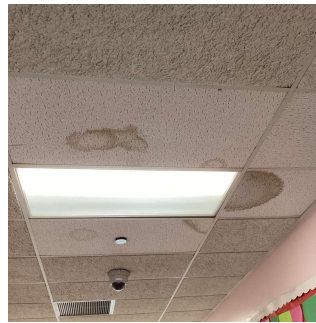
Corridor near Room 409
Violations	No violations recorded.
Deficiency	ACOUSTIC TILES: DAMAGED/MISSING - ACTIVE LEAK
Deficiency Location/Instance	Corridor near Room 404
Deficiency Quantity	30
Quantity Uom	S.F.
Potential Action	REPLACE
Urgency of Action	PRIORITY 5

Purpose of Action	LEVEL 2

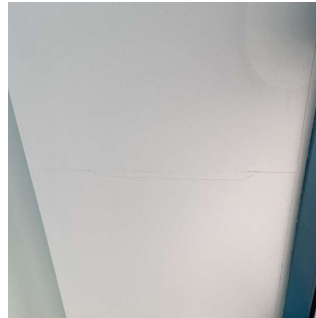
Main Entrance - Vestibule

GYPSUM BOARD: DAMAGED/DETERIORATED

REPLACE

PRIORITY 3

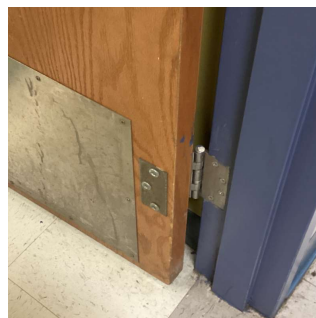
WOOD: DETERIORATED DOOR

Room 107

MAINTENANCE

PRIORITY 3

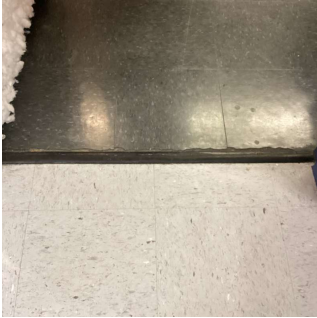
Question	Response
<b>INTERIOR</b>	
<b>CLASSROOMS/CORRIDORS/ADMIN SPACES</b>	
<b>Door(s)</b>	Inspected
	Room 107
Violations	No violations recorded.
<b>Floor Finish</b>	Inspected
Condition	2 - Between Good and Fair
Deficiency	VINYL TILES: BROKEN/DETERIORATED/MISSING TILES
Deficiency Location/Instance	Room 413, Corridor near Room 301
Deficiency Quantity	20
Quantity Uom	S.F.
Potential Action	REPLACE
Urgency of Action	PRIORITY 3
Purpose of Action	LEVEL 2
Deficiency Photo1

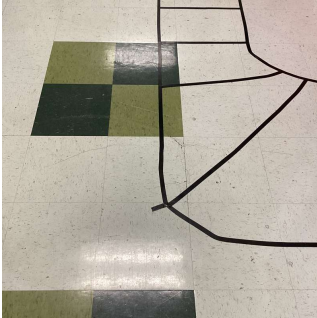
Room 413
Violations	No violations recorded.
Deficiency	VINYL TILES: DETERIORATED SUBSTRATE
Deficiency Location/Instance	Corridor near Room C09
Deficiency Quantity	20
Quantity Uom	S.F.
Potential Action	REPLACE
Urgency of Action	PRIORITY 3
Purpose of Action	LEVEL 2
Deficiency Photo1

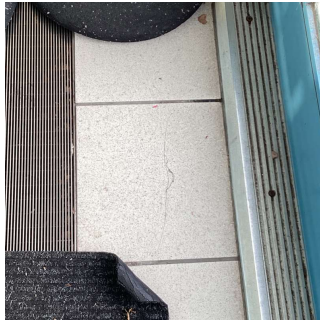
Corridor near Room C09
Violations	No violations recorded.
Deficiency	CERAMIC TILE: BROKEN/MISSING TILES
Deficiency Location/Instance	Main Entrance - Vestibule
Deficiency Quantity	10

Quantity Uom	S.F.
Potential Action	REPLACE
Urgency of Action	PRIORITY 3
Purpose of Action	LEVEL 2

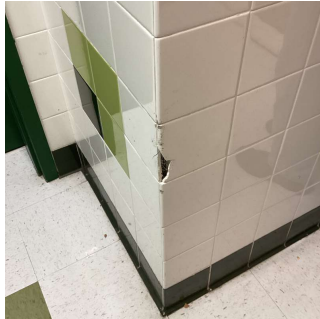
Main Entrance - Vestibule
Violations	No violations recorded.
<b>Walls</b>	Inspected
Condition	2 - Between Good and Fair
Deficiency	CERAMIC TILE: BROKEN/ MISSING
Deficiency Location/Instance	Corridor near Stair A/Basement, By Room C17
Deficiency Quantity	20
Quantity Uom	S.F.
Potential Action	REPLACE
Urgency of Action	PRIORITY 3
Purpose of Action	LEVEL 2
Deficiency Photo1

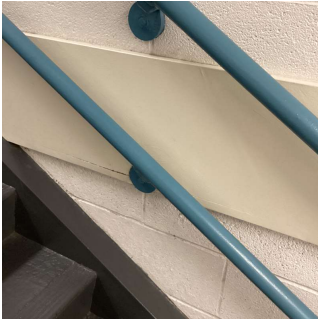
Question	Response
<b>INTERIOR</b>	
<b>STAIRS/RAMPS: INTERIOR</b>	
<b>Stairs and Landings</b>	Inspected
Condition	2 - Between Good and Fair
Deficiency	No deficiencies recorded
<b>Walls</b>	Inspected
Condition	2 - Between Good and Fair
Deficiency	GYPSON BOARD: DETERIORATED
Deficiency Location/Instance	Stairs B/4, 3
Deficiency Quantity	20
Quantity Uom	S.F.
Potential Action	REPLACE
Urgency of Action	PRIORITY 3
Purpose of Action	LEVEL 2
Deficiency Photo1

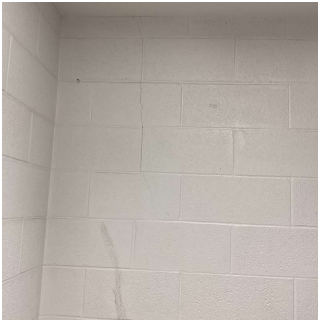
Stair B/4	
Violations	No violations recorded.
Deficiency	MASONRY: CRACKS/SPALLING
Deficiency Location/Instance	Stairs A/4, B/1, 2, 4
Deficiency Quantity	60
Quantity Uom	S.F.
Potential Action	REPLACE
Urgency of Action	PRIORITY 3
Purpose of Action	LEVEL 2
Deficiency Photo1

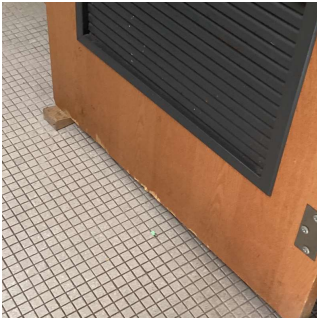
Question	Response
<b>INTERIOR</b>	
<b>TOILET ROOMS - STAFF</b>	
<b>Floor Finish</b>	Inspected
Condition	2 - Between Good and Fair
Deficiency	No deficiencies recorded
<b>Stalls</b>	Inspected
Condition	2 - Between Good and Fair
Deficiency	No deficiencies recorded
<b>Walls</b>	Inspected
Condition	2 - Between Good and Fair
Deficiency	No deficiencies recorded
<b>TOILET ROOMS - STUDENTS</b>	
<b>Ceiling</b>	Inspected
Condition	2 - Between Good and Fair
Deficiency	No deficiencies recorded
<b>Door(s)</b>	Inspected
Condition	3 - Fair
Deficiency	WOOD: DETERIORATED DOOR
Deficiency Location/Instance	In Rooms 201
Deficiency Quantity	1
Quantity Uom	EACH
Potential Action	MAINTENANCE
Urgency of Action	PRIORITY 3
Purpose of Action	LEVEL 2
Deficiency Photo1
