NYC Department of Education
Building Condition Assessment Survey 2023 - 2024

Architectural Inspection

Asset: P.S. 261 TRANSPORTABLE - K, 314 PACIFIC STREET, New York, 11210

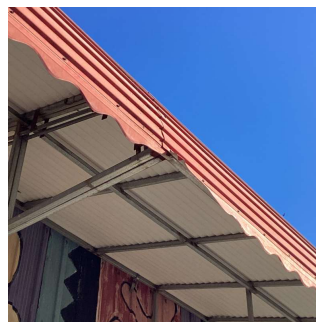
Facade A - T2

Question	Response
Architectural	
EXTERIOR	Inspected
AWNINGS AND CANOPIES	Inspected
Condition	2 - Between Good and Fair
Deficiency	METAL: DETERIORATION/DAMAGED/MISSING PIECES
Roof Plan reference

10
 S.F.
 REPAIR
 PRIORITY 3
 LEVEL 2

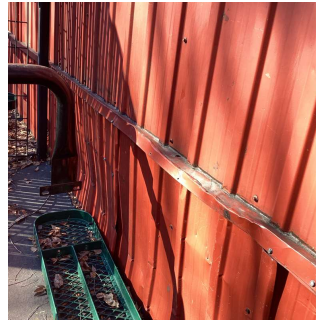
Facade D

Question	Response
EXTERIOR	
AWNINGS AND CANOPIES	
Violations	No violations recorded.
DOORS	
DOORS AND FRAMES	
Condition	2 - Between Good and Fair
Deficiency	No deficiencies recorded
DOOR HARDWARE	
Condition	2 - Between Good and Fair
Deficiency	No deficiencies recorded
EXTERIOR WALLS	
Material Type(s)	Steel
Replacement Quantity	1,500
Replacement Uom	S.F.
Instance on All Facades	Inspected
Instance Condition	5 - Poor
Instance Quantity	1,500
Instance Quantity Uom	S.F.
Deficiency	METAL PANEL: DAMAGED TRIM
Roof Plan reference

20
 L.F.
 REPLACE
 PRIORITY 4
 LEVEL 2

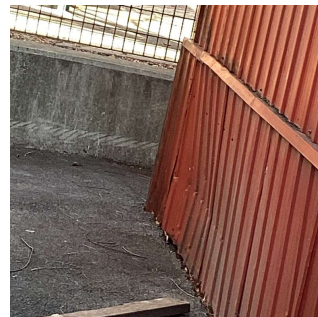
Facade B

METAL PANEL: SEVERE DENTS

120

REPLACE

PRIORITY 4

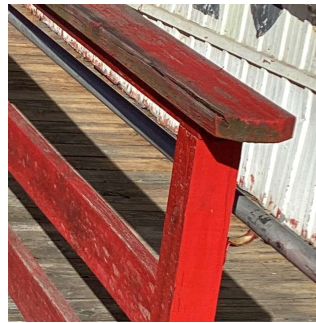
Facade A - T2

Roof 1
Instance Quantity	1,300
Instance Quantity Uom	S.F.
Does the roof have major mechanical equipment sitting on Dunnage Steel less than 18" above the Roofing?	No
Does this roof instance have a Sustainable Roof System?	No
Do solar panels exist on these roofs?	No
Is/Are the roof(s) suitable for Solar Panel installation?	No
Installation Year	1999
Source of Installation	Custodial Staff
Deficiency	No deficiencies recorded
STAIRS/RAMPS: EXTERIOR	Inspected
RAILINGS	Inspected
Condition	4 - Between Fair and Poor
Deficiency	DAMAGED
Roof Plan reference

</div> </div> <div style="margin-top: 20px; border-left: 1px solid black; padding-left: 10px;"> <p>P.S. 261</p> </div>
Deficiency Quantity	16
Quantity Uom	L.F.
Potential Action	REPLACE
Urgency of Action	PRIORITY 4
Purpose of Action	LEVEL 2

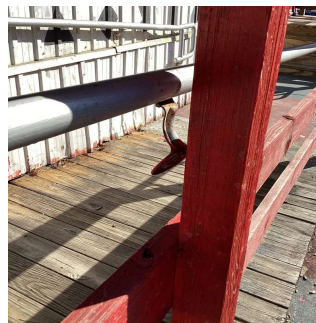
Facade A - T2

BROKEN BRACKET

REPLACE

PRIORITY 4

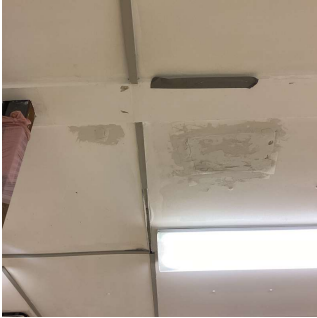
Question	Response
INTERIOR	
STRUCTURAL	
FLOOR STRUCTURE	Inspected
Condition	2 - Between Good and Fair
Deficiency	No deficiencies recorded
ROOF STRUCTURE	Inspected
Condition	2 - Between Good and Fair
Deficiency	No deficiencies recorded
CLASSROOMS/CORRIDORS/ADMIN SPACES	Inspected
Ceiling	Inspected
Condition	2 - Between Good and Fair
Deficiency	ACOUSTIC TILES: DAMAGED/MISSING
Deficiency Location/Instance	Near Entrance, center, Corridor near Rooms 015, 016
Deficiency Quantity	50
Quantity Uom	S.F.
Potential Action	REPLACE
Urgency of Action	PRIORITY 3
Purpose of Action	LEVEL 2
Deficiency Photo1

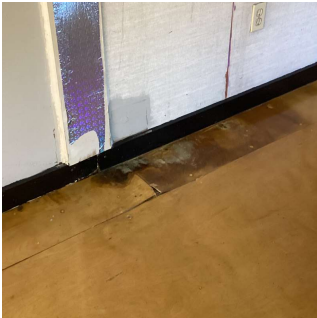
Violations	Near Entrance No violations recorded.
Door(s)	Does not Exist
Floor Finish	Inspected
Condition	2 - Between Good and Fair
Deficiency	WOOD: DETERIORATED SUBSTRATE
Deficiency Location/Instance	Near center
Deficiency Quantity	25
Quantity Uom	S.F.
Potential Action	REPLACE
Urgency of Action	PRIORITY 3
Purpose of Action	LEVEL 2

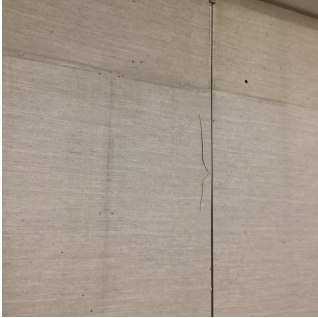
Question	Response
INTERIOR	
CLASSROOMS/CORRIDORS/ADMIN SPACES	
Walls	Inspected
Condition	2 - Between Good and Fair
Deficiency	GYPSUM BOARD: DETERIORATED
Deficiency Location/Instance	Near Entrance
Deficiency Quantity	25
Quantity Uom	S.F.
Potential Action	REPLACE
Urgency of Action	PRIORITY 3
Purpose of Action	LEVEL 2
Deficiency Photo1

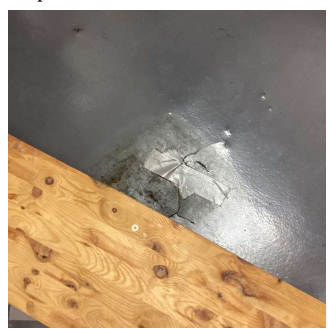
Violations	Student Restroom #2 No violations recorded.
Walls	
Condition	Inspected
Deficiency	2 - Between Good and Fair
Deficiency	No deficiencies recorded
SITE	Not Required
ARTWORK	Does not Exist

Priority Condition Exist Last Year?	Priority Category	Condition Description	Component Affected	Location Description	Person(s) Notified	Person(s) Title	PhotoImage
No	Tripping Hazard	Severely damaged floor is a potential safety hazard.	INTERIOR TOILET ROOMS - STUDENTS Floor Finish	Student Restroom #2	Reinaldo Hernandez	Handyman

Question	Response
INTERIOR	
TOILET ROOMS - STUDENTS	
Floor Finish	Inspected
Deficiency Photo1

Violations	Near Entrance No violations recorded.
INTERIOR DOOR HARDWARE	Inspected
Condition	3 - Fair
Deficiency	No deficiencies recorded
TOILET ROOMS - STAFF	Does not Exist
TOILET ROOMS - STUDENTS	Inspected
Ceiling	Inspected
Condition	2 - Between Good and Fair
Deficiency	No deficiencies recorded
Door(s)	Inspected
Condition	2 - Between Good and Fair
Deficiency	No deficiencies recorded
Floor Finish	Inspected
Condition	5 - Poor
Deficiency	VINYL TILES: DETERIORATED SUBSTRATE
Deficiency Location/Instance	Student Restroom #2
Deficiency Quantity	80
Quantity Uom	S.F.
Potential Action	REPLACE
Urgency of Action	PRIORITY 5
