**NYC Department of Education
Building Condition Assessment Survey 2023 - 2024**

Architectural Inspection

K986

Asset: DIV. OF INSTR. & INFO. TECH.-K, 335 ADAMS STREET, New York, 11201

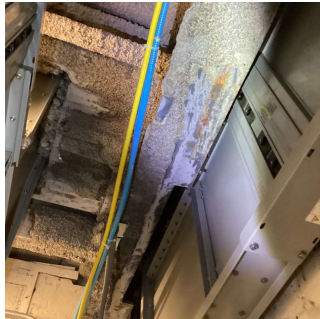
Question	Response
EXTERIOR	Inspected
WINDOWS	Inspected
WINDOWS	
Source of Installation	Custodial Staff
Deficiency	No deficiencies recorded
INTERIOR	Inspected
POOLS	Does not Exist
STRUCTURAL	Inspected
COLUMNS/BEAMS/BEARING WALLS	Inspected
Condition	2 - Between Good and Fair
Deficiency	STEEL COLUMNS/BEAMS: DETERIORATED/MISSING SPRAY-ON FIREPROOFING
Deficiency Location/Instance	6th Floor - Room E6-S
Deficiency Quantity	10
Quantity Uom	S.F.
Potential Action	REPLACE
Urgency of Action	PRIORITY 3
Purpose of Action	LEVEL 5
Deficiency Photo1

Violations	6th Floor - Room E6-S No violations recorded.
FLOOR STRUCTURE	Inspected
Condition	3 - Fair
Deficiency	METAL DECK AND CONCRETE: DETERIORATED
Deficiency Location/Instance	5th Floor - Room F5-S, 28th, 29th Floor - Fan Rooms
Deficiency Quantity	40
Quantity Uom	S.F.
Potential Action	REPAIR
Urgency of Action	PRIORITY 3
Purpose of Action	LEVEL 5
Deficiency Photo1

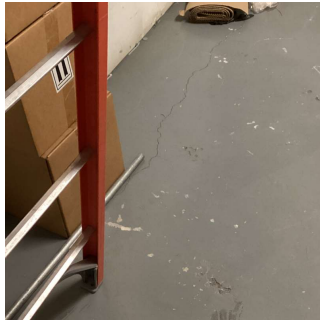
Violations	28th Floor - Fan Room No violations recorded.

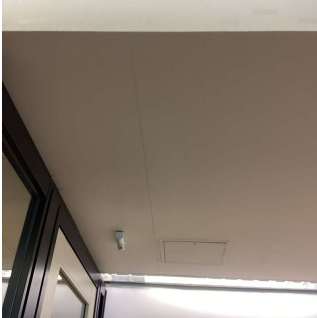
Question	Response
INTERIOR	Inspected
STRUCTURAL	Inspected
ROOF STRUCTURE	Not Required
VAULTS-BUNKERS	Does not Exist
AUDITORIUM	Does not Exist
CAFETERIA	Does not Exist
CLASSROOMS/CORRIDORS/ADMIN SPACES	Inspected
Ceiling	Inspected
Condition	2 - Between Good and Fair
Deficiency	GYPSUM BOARD: DAMAGED/DETERIORATED
Deficiency Location/Instance	Main Entrance - 28th Floor, Corridor near Pantry, by Room M203 - 28th Floor, by Men Toilet Room - 28th Floor
Deficiency Quantity	90
Quantity Uom	S.F.
Potential Action	REPLACE
Urgency of Action	PRIORITY 3
Purpose of Action	LEVEL 2
Deficiency Photo1

Main Entrance - 28th Floor
Violations	No violations recorded.
Deficiency	ACOUSTIC TILES: DAMAGED/MISSING
Deficiency Location/Instance	Corridor near Rooms 517, 516, Pantry Room - 28th Floor, Room 2922, Lounge Room - 6th Floor and others
Deficiency Quantity	80
Quantity Uom	S.F.
Potential Action	REPLACE
Urgency of Action	PRIORITY 3
Purpose of Action	LEVEL 2

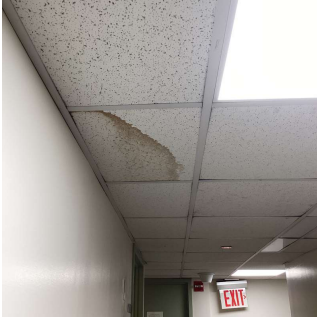
Corridor near Room 517
Violations	No violations recorded.
Door(s)	Inspected
Condition	2 - Between Good and Fair
Deficiency	No deficiencies recorded

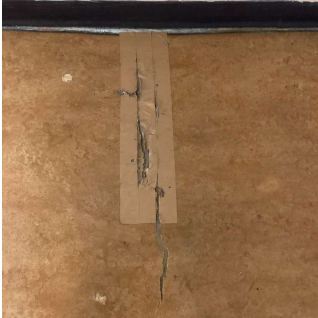
Question	Response
INTERIOR	
CLASSROOMS/CORRIDORS/ADMIN SPACES	
Floor Finish	Inspected
Condition	2 - Between Good and Fair
Deficiency	SHEET VINYL: BROKEN/DETERIORATED
Deficiency Location/Instance	Room M200 - 28th Floor, Corridor near Fan Room - 28th Floor, by Women Toilet Room - 28th Floor
Deficiency Quantity	30
Quantity Uom	S.F.
Potential Action	REPLACE
Urgency of Action	PRIORITY 3
Purpose of Action	LEVEL 2
Deficiency Photo1

Violations	Corridor near Fan Room - 28th Floor No violations recorded.
Deficiency	VINYL TILES: DETERIORATED SUBSTRATE
Deficiency Location/Instance	Room near Waiting Room - 6th Floor
Deficiency Quantity	50
Quantity Uom	S.F.
Potential Action	REPLACE
Urgency of Action	PRIORITY 3
Purpose of Action	LEVEL 2
Deficiency Photo1	 
Violations	Room near Waiting Room - 6th Floor No violations recorded.
Walls	Inspected
Condition	2 - Between Good and Fair
Deficiency	GYPSUM BOARD: DETERIORATED
Deficiency Location/Instance	Room 517, Corridor near Rooms 506, 517, 518, by Windows - 6th Floor and others

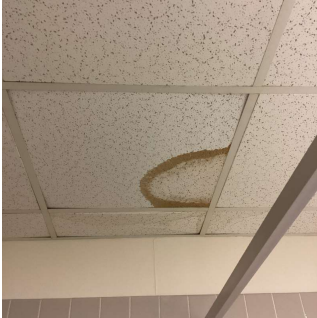
Walls	Not Required
TOILET ROOMS - STAFF	Inspected
Ceiling	Inspected
Condition	5 - Poor
Deficiency	ACOUSTIC TILES: DAMAGED/MISSING
Deficiency Location/Instance	Women Toilet Room - 5th, 6th Floor, Men Toilet Room - 5th, 6th, 28th Floor and others
Deficiency Quantity	140

Question	Response
INTERIOR	
TOILET ROOMS - STAFF	
Ceiling	
Quantity Uom	S.F.
Potential Action	REPLACE
Urgency of Action	PRIORITY 3
Purpose of Action	LEVEL 2
Deficiency Photo1

Violations	Women Toilet Room - 5th Floor No violations recorded.
Door(s)	Inspected
Condition	2 - Between Good and Fair
Deficiency	No deficiencies recorded
Floor Finish	Inspected
Condition	2 - Between Good and Fair
Deficiency	No deficiencies recorded
Stalls	Inspected
Condition	5 - Poor
Deficiency	RUST - MAJOR
Deficiency Location/Instance	Men Toilet Room - 5th Floor, Women Toilet Room - 6th Floor
Deficiency Quantity	2
Quantity Uom	EACH
Potential Action	REPLACE
Urgency of Action	PRIORITY 3
Purpose of Action	LEVEL 2
Deficiency Photo1

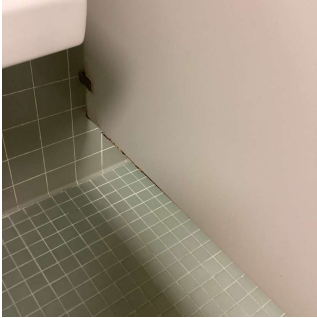
Violations	Men Toilet Room - 5th Floor No violations recorded.
Walls	Inspected
Condition	2 - Between Good and Fair
Deficiency	GYPSUM BOARD: DETERIORATED
Deficiency Location/Instance	Women Toilet Room - 5th Floor
Deficiency Quantity	10
