**NYC Department of Education**  
**Building Condition Assessment Survey 2023 - 2024**

Architectural Inspection

**K987**

**Asset: ACORN SCHOOL FOR SOCIAL JUSTICE-K, 1396 BROADWAY, New York, 11221**

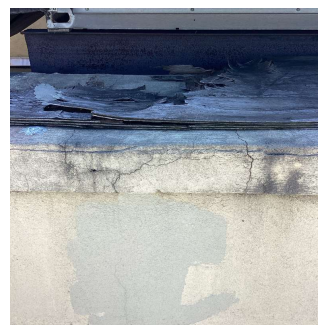
Roof 2  
No violations recorded.

CAST STONE: CRACKED/BROKEN PIECES

40  
L.F.  
REPLACE-IN-KIND  
PRIORITY 4  
LEVEL 2

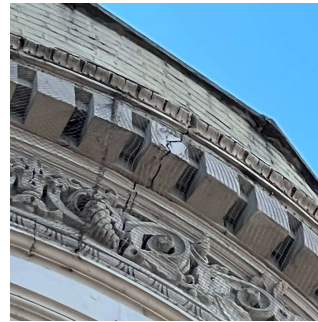
Facade A  
No violations recorded.

TERRA COTTA: MAJOR CRACKS, SPALLING

20  
S.F.  
REPLACE  
PRIORITY 4  
LEVEL 2

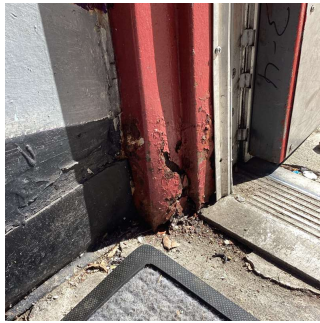
METAL: DETERIORATED DOOR AND FRAME - MAJOR DETERIORATION

4  
EACH  
REPLACE  
PRIORITY 4  
LEVEL 2

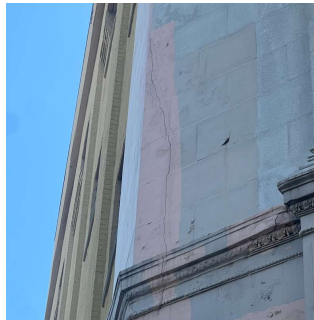
Facade A

Deficiency Quantity	2
Quantity Uom	EACH
Potential Action	MAINTENANCE
Urgency of Action	PRIORITY 3
Purpose of Action	LEVEL 2
Deficiency Photo1	No photo recorded
Violations	No violations recorded.
<b>DOOR HARDWARE</b>	Inspected
Condition	3 - Fair
Deficiency	No deficiencies recorded
<b>LINTELS</b>	Inspected
Condition	2 - Between Good and Fair
Deficiency	No deficiencies recorded
<b>TRANSOM/SIDE LIGHT</b>	Does not Exist
<b>EXTERIOR WALLS</b>	Inspected
Material Type(s)	Masonry
Replacement Quantity	29,000
Replacement Uom	S.F.
Instance on All Facades	Inspected
Instance Condition	4 - Between Fair and Poor
Instance Quantity	29,000
Instance Quantity Uom	S.F.
Deficiency	STONE: CRACKS AT BUILDING CORNERS

REPLACE

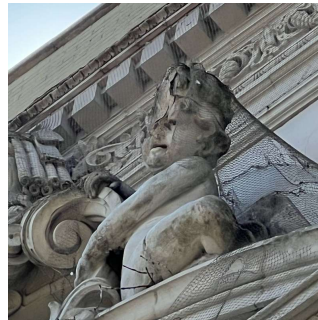
Facade A

TERRA COTTA: CHIPPED/SPALLED/BROKEN PIECES - MAJOR

REPLACE

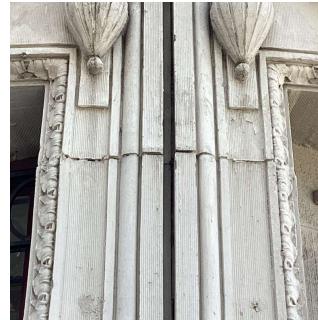
Facade A

STONE: DETERIORATED JOINTS

PRIORITY 4  
LEVEL 2

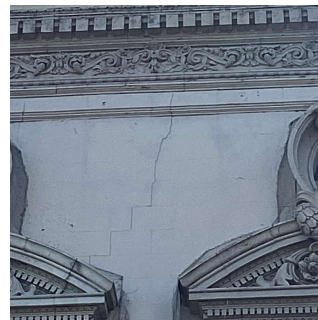
Facade D

STONE: CHIPPED/SPALLED/BROKEN PIECES - MAJOR

REPLACE

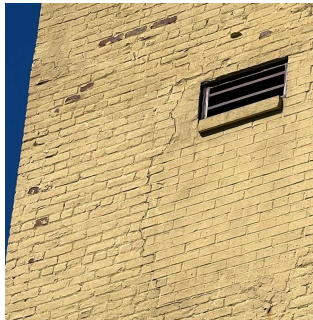
Facade B

**BRICK: MAJOR / THRU CRACKS**

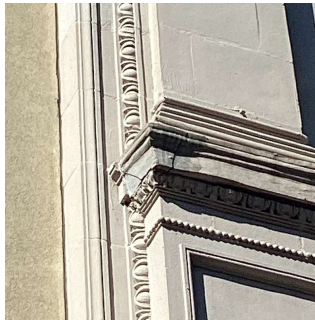
Facade A

**STONE: CHIPPED/SPALLED/BROKEN PIECES - MAJOR**

REPLACE

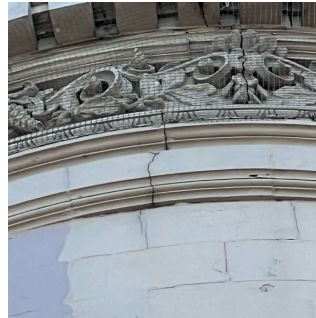
Facade D

STONE: CHIPPED/SPALLED/BROKEN PIECES - MINOR

REPAIR

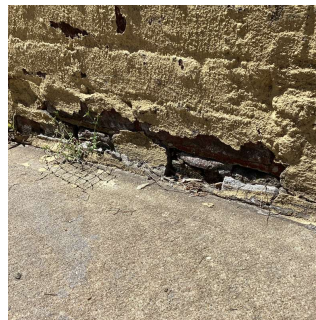
Facade B

**BRICK: MINOR CRACKS AND SPALLING**

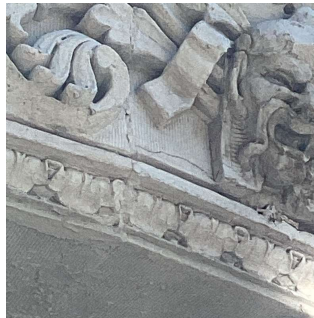
Facade A

TERRA COTTA: CHIPPED/SPALLED/BROKEN PIECES - MINOR

REPAIR

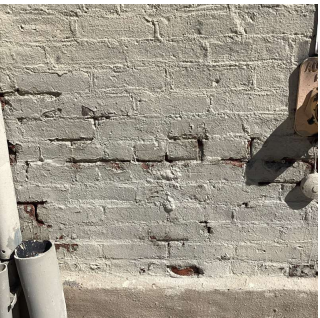
BRICK: DETERIORATED JOINTS

Question	Response
<b>EXTERIOR</b>	
<b>EXTERIOR WALLS</b>	
Elevation	 
Deficiency Quantity	100
Quantity Uom	S.F.
Potential Action	REPOINT
Urgency of Action	PRIORITY 4
Purpose of Action	LEVEL 2
Deficiency Photo1

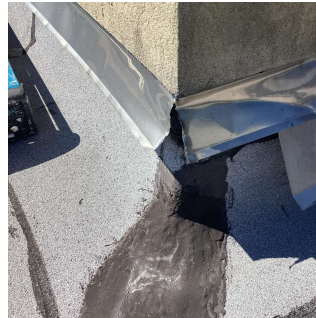
Roof 1 - BH

**MODIFIED BITUMEN: FLASHING: CAP FLASHING DAMAGED**

**REPLACE**

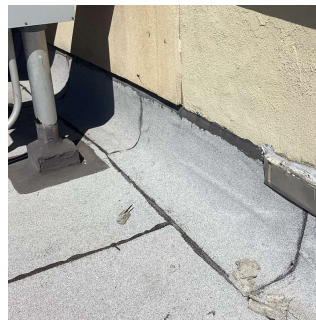
Roof 2

MODIFIED BITUMEN: FLASHING: CAP FLASHING MISSING

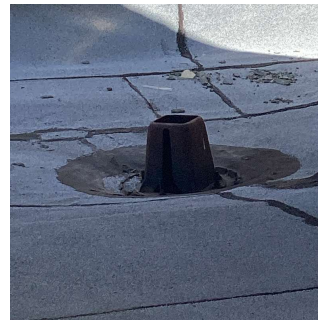
DETERIORATED

1  
EACH  
REPLACE  
PRIORITY 4  
LEVEL 2

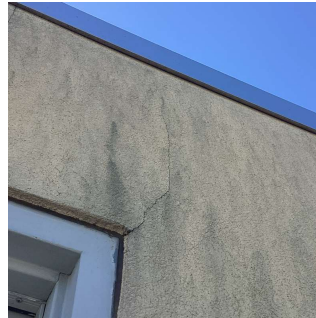
Roof 1 - BH

**BULKHEAD/PENTHOUSE WALLS/EXTERIOR:  
CRACKS/SPALLING - MINOR**

10  
S.F.  
REPAIR  
PRIORITY 3  
LEVEL 2

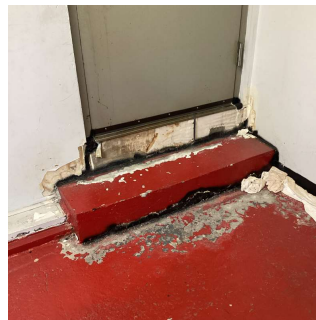
BH

**BULKHEAD/PENTHOUSE WALLS/EXTERIOR: WATER INFILTRATION**

REPAIR

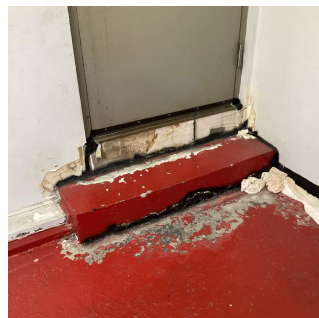
**BULKHEAD/PENTHOUSE WALLS/INTERIOR: PLASTER CRACKS/SPALLING**

Deficiency Quantity	20
Quantity Uom	S.F.
Potential Action	REPLACE
Urgency of Action	PRIORITY 3
Purpose of Action	LEVEL 2
Deficiency Photo1

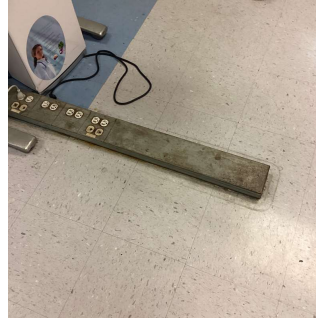
Room 514

VINYL TILES: TRIPPING HAZARD - ELECTRICAL OUTLET

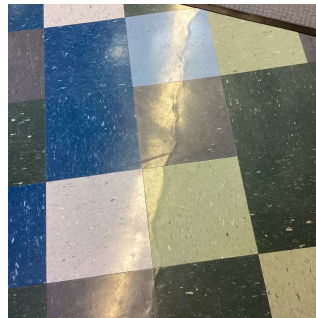
Main Entrance Lobby

VINYL TILES: DETERIORATED SUBSTRATE

REPLACE
