NYC Department of Education
Building Condition Assessment Survey 2023 - 2024

Architectural Inspection

Asset: P.S. 104/P.S. 185 ANNEX-K, 415 89TH STREET, New York, 11209

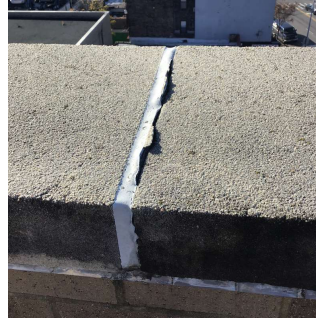
Roof 1 - Facade A

Question	Response
Architectural	
EXTERIOR	Inspected
AREAWAY	Does not Exist
AWNINGS AND CANOPIES	Does not Exist
CHIMNEY	Inspected
Material Type(s)	Metal
Condition	2 - Between Good and Fair
Deficiency	No deficiencies recorded
COPING	Inspected
Condition	3 - Fair
Deficiency	CAST STONE: DETERIORATED TRANSVERSE JOINTS
Roof Plan reference

L.F.
MAINTENANCE
PRIORITY 3
LEVEL 2

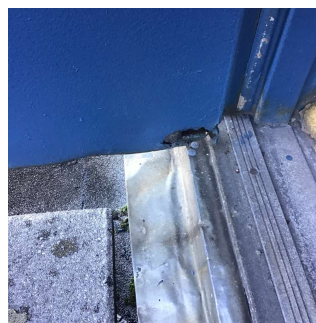
Facade C - Exit to Roof 3

METAL: DETERIORATED DOOR - MAJOR DETERIORATION

1
EACH
REPLACE
PRIORITY 4
LEVEL 2

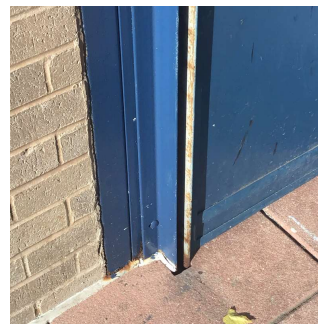
Facade A - Main Entrance
No violations recorded.

ROLL-UP DOOR: DETERIORATED DOOR AND FRAME - MINOR DETERIORATION

240
S.F.
MAINTENANCE
PRIORITY 3
LEVEL 2

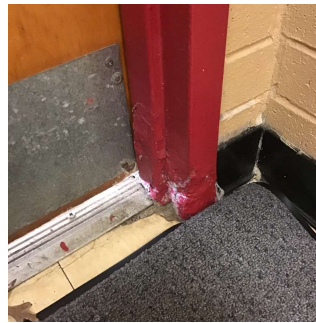
Facade A - Exit 3

METAL CLAD: DETERIORATED DOOR AND FRAME - MAJOR DETERIORATION

2
EACH
REPLACE
PRIORITY 4
LEVEL 2

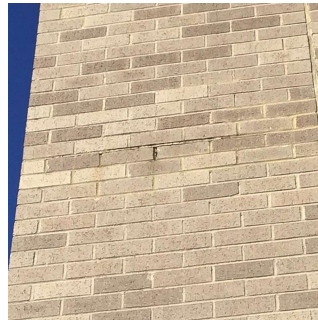
Facade D1

BRICK: DETERIORATED JOINTS

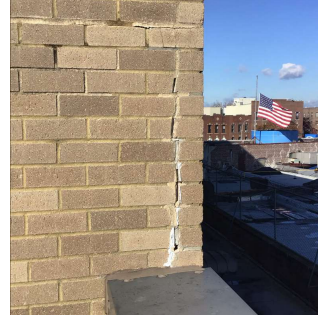
Corner of Facades C1 and D1
No violations recorded.

BRICK: CRACKS/DISPLACED/SPALLED BRICK AT BUILDING CORNERS

REMOVE AND REBUILD
PRIORITY 4
LEVEL 2

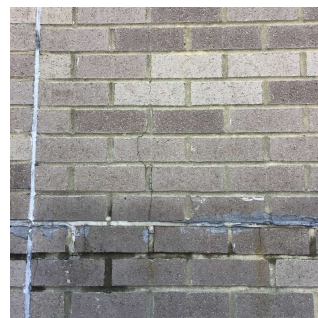
BRICK: MINOR CRACKS AND SPALLING

20
S.F.
RESTITCH
PRIORITY 3
LEVEL 2

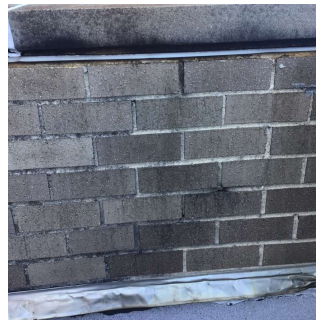
Roof 3 - Facade B

Deficiency	BRICK: DETERIORATED JOINTS
Roof Plan reference

Deficiency Quantity	20
Quantity Uom	S.F.
Potential Action	REPOINT
Urgency of Action	PRIORITY 3
Purpose of Action	LEVEL 2
Deficiency Photo1

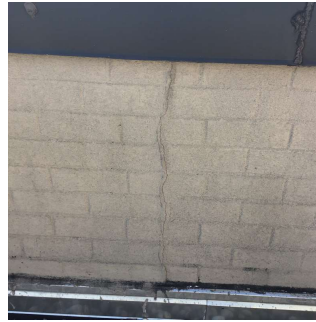
Roof 2 - Facade A

Deficiency	BRICK: MINOR CRACKS, SPALLING
Roof Plan reference

Deficiency Quantity	80
Quantity Uom	S.F.
Potential Action	REPAIR
Urgency of Action	PRIORITY 3
Purpose of Action	LEVEL 2

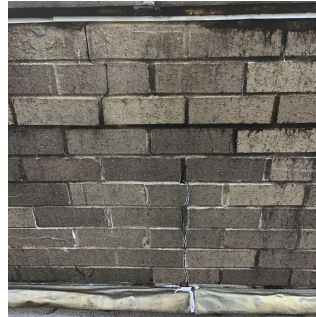
Roof 3 - Facade C

BRICK: MAJOR DETERIORATION/CRACKS

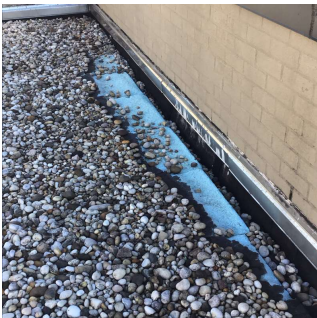
Roof 2
Instance Quantity	15,000
Instance Quantity Uom	S.F.
Does the roof have major mechanical equipment sitting on Dunnage Steel less than 18" above the Roofing?	No
Does this roof instance have a Sustainable Roof System?	No
Do solar panels exist on these roofs?	No
Is/Are the roof(s) suitable for Solar Panel installation?	No
Installation Year	2001
Source of Installation	Custodial Staff
Deficiency	IRMA: ROOFING: DAMAGED INSULATION
Roof Plan reference

Deficiency Quantity	100
Quantity Uom	S.F.
Potential Action	REPLACE
Urgency of Action	PRIORITY 4
Purpose of Action	LEVEL 2
Deficiency Photo1

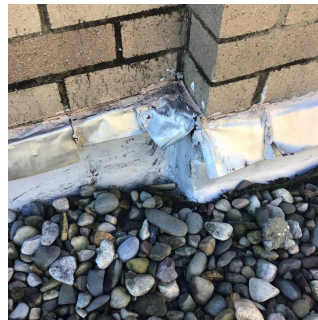
Roof 1 - Facade A

Roof 2
Violations	No violations recorded.
Deficiency	IRMA: FLASHING: CAP FLASHING DAMAGED

100
L.F.
REPLACE
PRIORITY 4
LEVEL 2

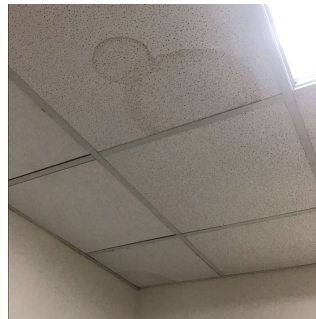
Roof 3 - Room 116
No violations recorded.

MODIFIED BITUMEN: ROOFING: MAJOR ACTIVE ROOF LEAKS IN INSTRUCTIONAL SPACE

100
S.F.
REPLACE ROOFING WITHOUT MAJOR EQUIPMENT
REMOVAL
PRIORITY 5
LEVEL 2

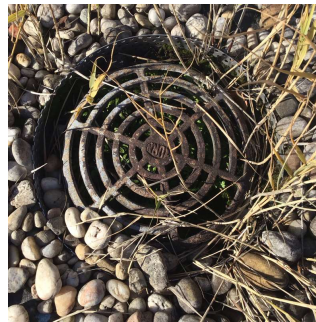
Roof 2
No violations recorded.

DETERIORATED

1
EACH
REPLACE
PRIORITY 4
LEVEL 2

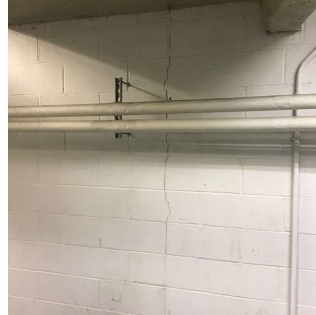
PH/Elevator Machine Room

BULKHEAD/PENTHOUSE WALLS/INTERIOR: CMU
CRACKS/SPALLING

30
S.F.
REPLACE
PRIORITY 3

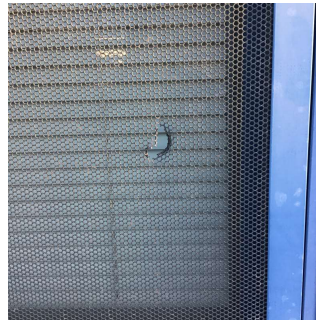
Facade A

DETERIORATED/TORN-OUT/MISSING

Deficiency Quantity	30
Quantity Uom	S.F.
Potential Action	REPLACE
Urgency of Action	PRIORITY 4
Purpose of Action	LEVEL 2
Deficiency Photo1

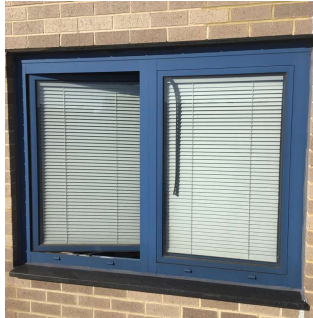
Facade D

Material Type(s)	Inspected
	Aluminum
Instance on Aluminum - Other: Facades A, C, D	Inspected
Instance Condition	3 - Fair
Instance Quantity	2,200
Instance Quantity Uom	S.F.
Are these windows insulated	Yes
Installation Year	1999
Source of Installation	Custodial Staff
Deficiency	ALUMINUM - OTHER: DETERIORATED
Roof Plan reference

REPLACE WINDOW

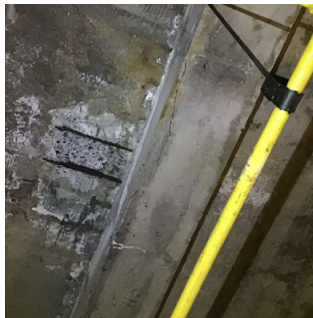
STEEL COLUMNS/BEAMS: DETERIORATED CONCRETE FIREPROOFING

REPLACE

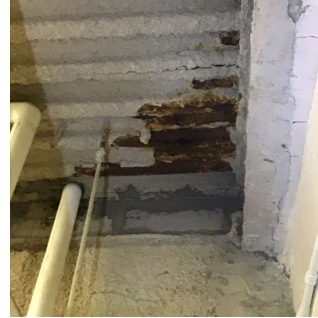
Basement - Garage near Oil Tank Room

Violations	Oil Tank Room No violations recorded.
Deficiency	METAL DECK AND CONCRETE: DETERIORATED
Deficiency Location/Instance	Basement - Water Meter Room, Garage

Deficiency Quantity	50
Quantity Uom	S.F.
Potential Action	REPAIR

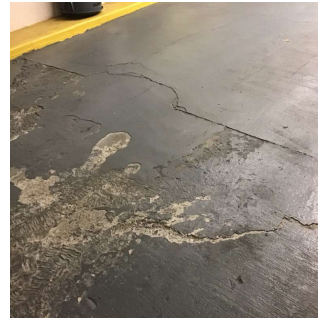
Basement - Garage

CONCRETE SLAB ON GRADE: THRU CRACKS

REPAIR

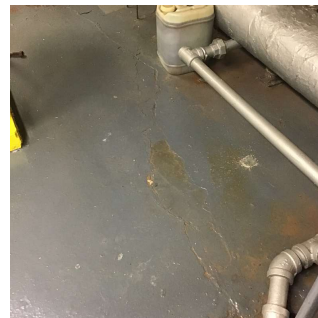
CONCRETE: CRACKS/SPALLED/REINFORCEMENT EXPOSED

REPAIR

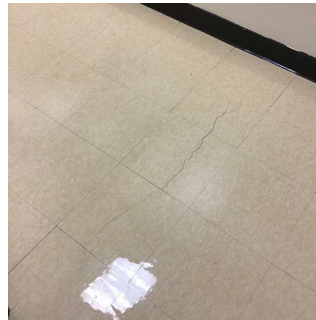
Corridor near Room 118

VINYL TILES: DETERIORATED SUBSTRATE

REPLACE

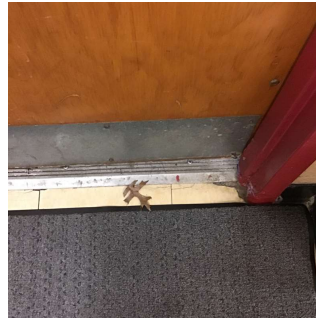
Near Exit 3

VINYL TILES: BROKEN/DETERIORATED/MISSING TILES

REPLACE

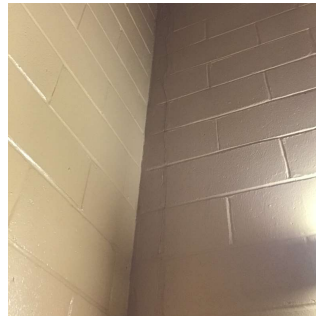
MASONRY: CRACKS/SPALLING

REPLACE
