NYC Department of Education
Building Condition Assessment Survey 2023 - 2024

Architectural Inspection

K990

Asset: PAVE ACADEMY CHARTER SCHOOL - BROOKLYN, 732 HENRY STREET, New York, 11231

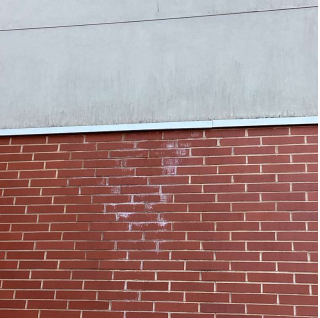
Question	Response
EXTERIOR	
EXTERIOR WALLS	
Instance Condition	3 - Fair
Instance Quantity	22,500
Instance Quantity Uom	S.F.
Deficiency	BRICK: EFFLORESCENCE
Roof Plan reference

Deficiency Quantity	20
Quantity Uom	S.F.
Potential Action	MAINTENANCE
Urgency of Action	PRIORITY 1
Purpose of Action	LEVEL 1
Deficiency Photo1

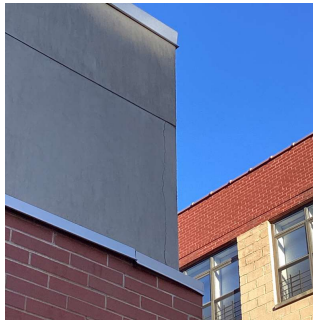
Facade D - 1 Story Building

Violations	Facade D No violations recorded.
Deficiency	STUCCO CEMENT SURFACE: CRACKS, SPALLING

Deficiency Quantity

30

REPLACE

PRIORITY 4

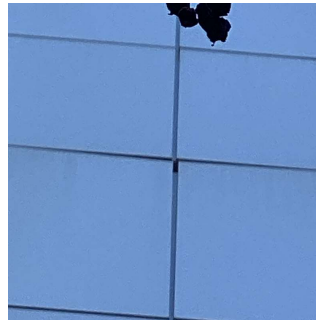
Facade G

METAL PANEL: DETERIORATED JOINTS

20

REPAIR

PRIORITY 3

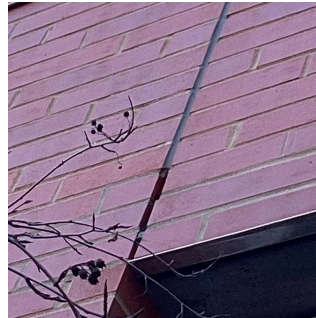
Facade H

BRICK: DETERIORATED CONTROL/EXPANSION JOINTS

10

MAINTENANCE

PRIORITY 3
LEVEL 2

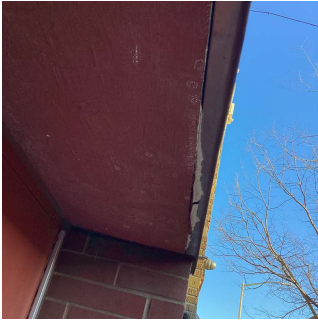
CONCRETE: MINOR CRACKS/SPALLING

10
S.F.
REPAIR
PRIORITY 3
LEVEL 2

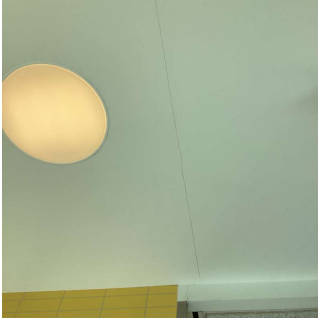
Question	Response
INTERIOR	
STRUCTURAL	
COLUMNS/BEAMS/BEARING WALLS	Inspected
Violations	No violations recorded.
FLOOR STRUCTURE	Inspected
Condition	2 - Between Good and Fair
Deficiency	No deficiencies recorded
FOUNDATION WALLS	Inspected
Material Type(s)	Concrete
Condition	2 - Between Good and Fair
Deficiency	No deficiencies recorded
ROOF STRUCTURE	Inspected
Condition	2 - Between Good and Fair
Deficiency	No deficiencies recorded
VAULTS-BUNKERS	Does not Exist
AUDITORIUM	Does not Exist
CAFETERIA	Inspected
Instance on 1st Floor	Inspected
Ceiling	
Instance on 1st Floor	Inspected
Condition	2 - Between Good and Fair
Deficiency	GYPSUM BOARD: DAMAGED/DETERIORATED
Deficiency Location/Instance	Near Windows
Deficiency Quantity	20
Quantity Uom	S.F.
Potential Action	REPLACE
Urgency of Action	PRIORITY 3
Purpose of Action	LEVEL 2
Deficiency Photo1

Violations	Near Windows No violations recorded.
Door(s)	
Instance on 1st Floor	Inspected

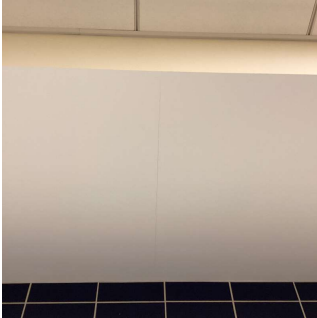
Question	Response
INTERIOR	
CAFETERIA	
Floor Finish	
Deficiency Quantity	10
Quantity Uom	S.F.
Potential Action	REPLACE
Urgency of Action	PRIORITY 3
Purpose of Action	LEVEL 2
Deficiency Photo1	 
Violations	Near center No violations recorded.
Sliding-folding Partition	
Instance on 1st Floor	Does not Exist
Stage	
Instance on 1st Floor	Does not Exist
Walls	
Instance on 1st Floor	Inspected
Condition	2 - Between Good and Fair
Deficiency	CERAMIC TILE: BROKEN/ MISSING
Deficiency Location/Instance	Near Stair C/1
Deficiency Quantity	10
Quantity Uom	S.F.
Potential Action	REPLACE
Urgency of Action	PRIORITY 3
Purpose of Action	LEVEL 2
Deficiency Photo1	 
Violations	Near Stair C/1 No violations recorded.
Window Curtains/Shades/Blinds	
Instance on 1st Floor	Does not Exist
CLASSROOMS/CORRIDORS/ADMIN SPACES	
Ceiling	
Condition	Inspected
Condition	2 - Between Good and Fair
Deficiency	GYPSUM BOARD: DAMAGED/DETERIORATED

Question	Response
INTERIOR	
CLASSROOMS/CORRIDORS/ADMIN SPACES	
Ceiling	
Deficiency Location/Instance	Main Entrance Vestibule, Room 118, Corridor near Room 204
Deficiency Quantity	50
Quantity Uom	S.F.
Potential Action	REPLACE
Urgency of Action	PRIORITY 3
Purpose of Action	LEVEL 2
Deficiency Photo1

Violations	Corridor near Room 204 No violations recorded.
Deficiency	ACOUSTIC TILES: DAMAGED/MISSING
Deficiency Location/Instance	Main Entrance Lobby, Room 118, 115, 113A, Corridor near Room 301
Deficiency Quantity	50
Quantity Uom	S.F.
Potential Action	REPLACE
Urgency of Action	PRIORITY 3
Purpose of Action	LEVEL 2
Deficiency Photo1

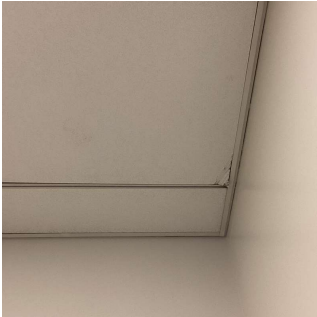
Violations	Corridor near Room 301 No violations recorded.
Door(s)	Inspected
Condition	2 - Between Good and Fair
Deficiency	No deficiencies recorded
Floor Finish	Inspected
Condition	2 - Between Good and Fair
Deficiency	CERAMIC TILE: BROKEN/MISSING TILES
Deficiency Location/Instance	Main Entrance Lobby, Main Entrance Vestibule

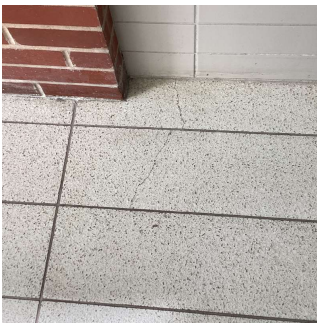
Deficiency Quantity	15
Quantity Uom	S.F.
Potential Action	REPLACE
Urgency of Action	PRIORITY 3
Purpose of Action	LEVEL 2

Violations	Main Entrance Lobby No violations recorded.
Walls	
Condition	Inspected 2 - Between Good and Fair
Deficiency	GYPSON BOARD: DETERIORATED
Deficiency Location/Instance	Room 307, Corridor near Room 303
Deficiency Quantity	20
Quantity Uom	S.F.
Potential Action	REPLACE
Urgency of Action	PRIORITY 3
Purpose of Action	LEVEL 2
Deficiency Photo1

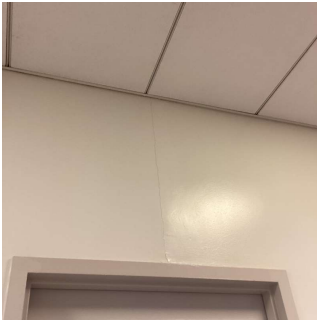
Violations	Corridor near Room 303 No violations recorded.
Specialties	Does not Exist
GYMNASIUM	
Instance on 1st Floor	Inspected
Ceiling	Inspected
Instance on 1st Floor	Does not Exist
Door(s)	Inspected
Instance on 1st Floor	Inspected
Condition	2 - Between Good and Fair
Deficiency	No deficiencies recorded
Fixed Equipment	Inspected
Instance on 1st Floor	Inspected
Condition	2 - Between Good and Fair
Deficiency	No deficiencies recorded
Floor Finish	Inspected
Instance on 1st Floor	Inspected

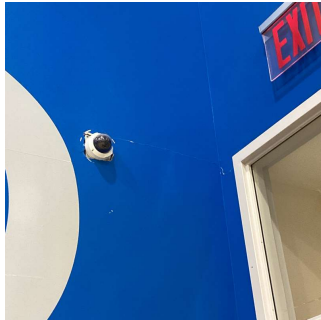
Instance on 1st Floor	Inspected
Condition	2 - Between Good and Fair
Deficiency	GYPSUM BOARD: DETERIORATED
Deficiency Location/Instance	Near Entrance
Deficiency Quantity	20
Quantity Uom	S.F.
Potential Action	REPLACE
Urgency of Action	PRIORITY 3
Purpose of Action	LEVEL 2
Deficiency Photo1

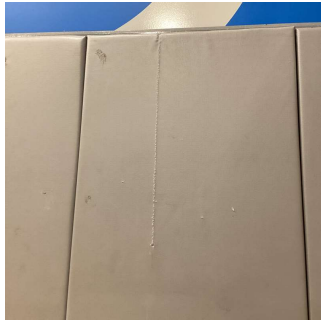
Deficiency	WALL PADDING: DETERIORATED
Deficiency Location/Instance	Near Entrance
Deficiency Quantity	160
Quantity Uom	S.F.
Potential Action	REPLACE
Urgency of Action	PRIORITY 3
Purpose of Action	LEVEL 2
Deficiency Photo1

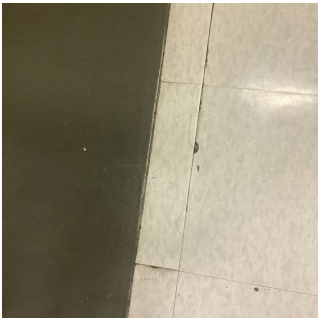
Question	Response
INTERIOR	
STAIRS/RAMPS: INTERIOR	
Door(s)	Inspected
Deficiency	No deficiencies recorded
Partition	Does not Exist
Railings	Inspected
Condition	2 - Between Good and Fair
Deficiency	No deficiencies recorded
Stairs and Landings	Inspected
Condition	2 - Between Good and Fair
Deficiency	VINYL TILES: BROKEN/DETERIORATED/MISSING TILES
Deficiency Location/Instance	Stair B/1
Deficiency Quantity	10
Quantity Uom	S.F.
Potential Action	REPLACE
Urgency of Action	PRIORITY 3
Purpose of Action	LEVEL 2
Deficiency Photo1

Violations	Stair B/1 No violations recorded.
Deficiency	CONCRETE: CRACKS/SPALLING - MAJOR
Deficiency Location/Instance	Stair A/Bulkhead, 3, 2, B/3, 2, and others
Deficiency Quantity	50
Quantity Uom	S.F.
Potential Action	REPLACE
Urgency of Action	PRIORITY 3
Purpose of Action	LEVEL 2
Deficiency Photo1

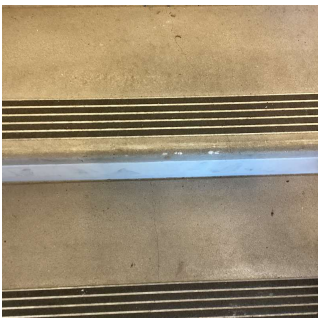
Violations	Stair A/Bulkhead No violations recorded.
Walls	Inspected
Condition	2 - Between Good and Fair

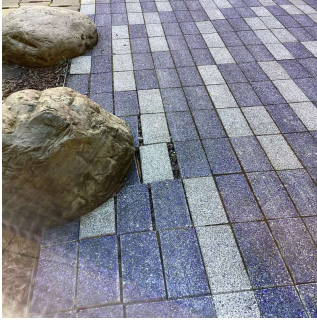
Question	Response
SITE	
PAVING	
Student Use	
Pavers	
Deficiency	DAMAGED/MISSING
Deficiency Location/Instance	Schoolyard
Deficiency Quantity	20
Quantity Uom	S.F.
Potential Action	REPLACE
Urgency of Action	PRIORITY 5
Purpose of Action	LEVEL 6
Deficiency Photo1	 
Violations	Schoolyard No violations recorded.
Deficiency	DAMAGED/MISSING
Deficiency Location/Instance	Schoolyard
Deficiency Quantity	10
Quantity Uom	S.F.
Potential Action	REPLACE
Urgency of Action	PRIORITY 3
Purpose of Action	LEVEL 2
Deficiency Photo1

Violations	Schoolyard No violations recorded.
Site Sidewalks & Walkways	Inspected
Asphalt	Does not Exist
Concrete	Inspected
Condition	3 - Fair
Deficiency	DAMAGED/DETERIORATED/MISSING SECTIONS
Deficiency Location/Instance	Along Mill Street, Henry Street
Deficiency Quantity	50
Quantity Uom	S.F.
Potential Action	REPLACE
Urgency of Action	PRIORITY 3

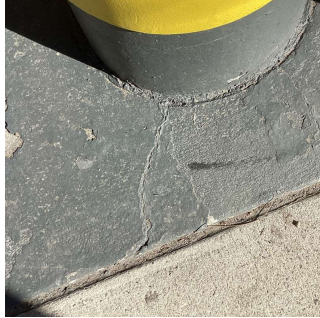
Question	Response
SITE	
PAVING	
Site Sidewalks & Walkways	
Concrete	
Purpose of Action	LEVEL 2
Deficiency Photo1

Violations	Along Mill Street No violations recorded.
Pavers	Does not Exist
DOT Sidewalk	Inspected
Asphalt	Does not Exist
Concrete	Inspected
Condition	4 - Between Fair and Poor
Deficiency	HEAVING
Deficiency Location/Instance	Along Henry Street
Deficiency Quantity	50
Quantity Uom	S.F.
Potential Action	REPLACE
Urgency of Action	PRIORITY 3
Purpose of Action	LEVEL 2
Deficiency Photo1	 
Violations	Along Henry Street No violations recorded.
Deficiency	DAMAGED/DETERIORATED/MISSING SECTIONS
Deficiency Location/Instance	Along Mill Street, Henry Street
Deficiency Quantity	700
Quantity Uom	S.F.
Potential Action	REPLACE
Urgency of Action	PRIORITY 3
Purpose of Action	LEVEL 2

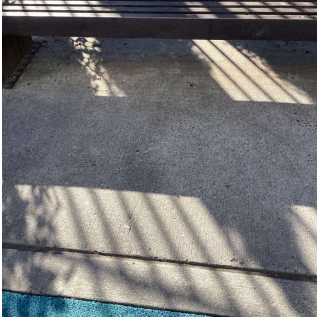
Question	Response
SITE	
PAVING	
DOT Sidewalk	
Concrete	
Deficiency Photo1	 
Violations	Along Mill Street No violations recorded.
Deficiency	DAMAGED CURBS
Deficiency Location/Instance	Along Mill Street, Henry Street
Deficiency Quantity	15
Quantity Uom	L.F.
Potential Action	REPLACE
Urgency of Action	PRIORITY 3
Purpose of Action	LEVEL 2
Deficiency Photo1	 
Violations	Along Mill Street No violations recorded.
Pavers	Does not Exist
PLAYGROUNDS	Inspected
Instance on Corner of Mill Street and Henry Street	Inspected
Benches	
Instance on Corner of Mill Street and Henry Street	Inspected
Condition	2 - Between Good and Fair
Deficiency	No deficiencies recorded
Fence	
Instance on Corner of Mill Street and Henry Street	Inspected
Condition	2 - Between Good and Fair
Deficiency	No deficiencies recorded
Pavement	
Instance on Corner of Mill Street and Henry Street	Inspected
Condition	2 - Between Good and Fair
Deficiency	CONCRETE: DAMAGED/DETERIORATED/MISSING SECTIONS

Deficiency Location/Instance	Schoolyard
Deficiency Quantity	25

Question	Response
SITE	
PLAYGROUNDS	
Pavement	
Quantity Uom	S.F.
Potential Action	REPLACE
Urgency of Action	PRIORITY 3
Purpose of Action	LEVEL 2
Deficiency Photo1

Violations	Schoolyard No violations recorded.
Deficiency	ASPHALT: CRACKS - MAJOR
Deficiency Location/Instance	Schoolyard
Deficiency Quantity	20
Quantity Uom	S.F.
Potential Action	REPLACE
Urgency of Action	PRIORITY 3
Purpose of Action	LEVEL 2
Deficiency Photo1	 
Violations	Schoolyard No violations recorded.
Play Equipment	
Instance on Corner of Mill Street and Henry Street	Inspected
Condition	2 - Between Good and Fair
Deficiency	No deficiencies recorded
Safety Surfacing	
Instance on Corner of Mill Street and Henry Street	Inspected
Condition	2 - Between Good and Fair
Deficiency	No deficiencies recorded
Unpaved Area	
Instance on Corner of Mill Street and Henry Street	Inspected
Condition	2 - Between Good and Fair
Deficiency	No deficiencies recorded
PLAYING SURFACE	Does not Exist

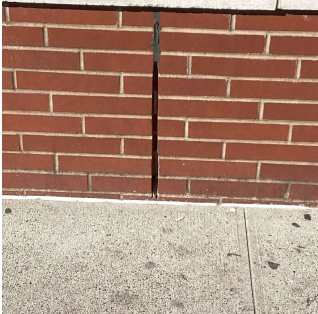
Question	Response
SITE	
RETAINING WALLS	
Are there any Retaining Walls 6' OR higher facing public street/sidewalk?	No
Condition	3 - Fair
Deficiency	BRICK: DETERIORATED CONTROL/EXPANSION JOINT
Deficiency Location/Instance	Along Henry Street
Deficiency Quantity	10
Quantity Uom	L.F.
Potential Action	REPLACE
Urgency of Action	PRIORITY 3
Purpose of Action	LEVEL 2
Deficiency Photo1

Violations	Along Henry Street No violations recorded.
Deficiency	BRICK: DETERIORATED COPING STONE
Deficiency Location/Instance	Along Mill Street, Henry Street
Deficiency Quantity	30
Quantity Uom	S.F.
Potential Action	REPLACE
Urgency of Action	PRIORITY 3
Purpose of Action	LEVEL 2
Deficiency Photo1
