**NYC Department of Education**  
**Building Condition Assessment Survey 2023 - 2024**

Architectural Inspection

**K995**

**Asset: LEARNING SUPPORT CENTER - BROOKLYN, 5613 FLATLANDS AVE, New York, 11234**

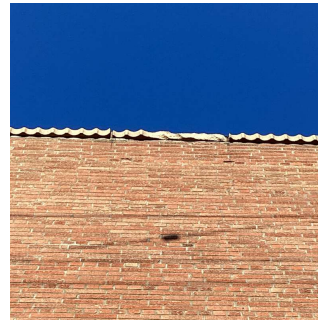
Facade A

Question	Response
<b>Architectural</b>	
<b>EXTERIOR</b>	Inspected
<b>AREAWAY</b>	Inspected
Instance on AW1	Inspected
Instance Condition	2 - Between Good and Fair
Instance Quantity	1
Instance Quantity Uom	EACH
Deficiency	No deficiencies recorded
<b>AWNINGS AND CANOPIES</b>	Inspected
Condition	2 - Between Good and Fair
Deficiency	No deficiencies recorded
<b>CHIMNEY</b>	Does not Exist
<b>COPING</b>	Inspected
Condition	3 - Fair
Deficiency	CAST STONE: CRACKED/BROKEN PIECES

10  
L.F.  
REPLACE-IN-KIND  
PRIORITY 4  
LEVEL 2

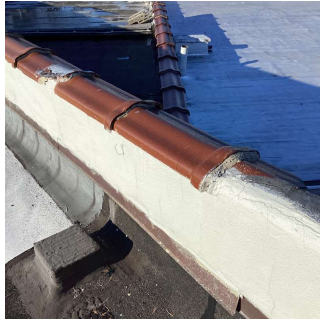
TERRA COTTA: CRACKED/BROKEN PIECES

40  
L.F.  
REPLACE-IN-KIND  
PRIORITY 4  
LEVEL 2

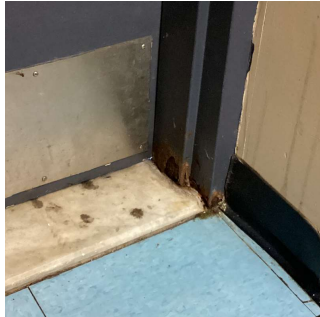
Violations	Roof 1 No violations recorded.
<b>CORNICE</b>	
Condition	Inspected
Deficiency	2 - Between Good and Fair No deficiencies recorded
<b>DOORS</b>	
<b>DOORS AND FRAMES</b>	
Condition	Inspected
Deficiency	4 - Between Fair and Poor METAL CLAD: DETERIORATED DOOR AND FRAME - MAJOR DETERIORATION
Roof Plan reference

Deficiency Quantity	1
Quantity Uom	EACH
Potential Action	REPLACE
Urgency of Action	PRIORITY 4
Purpose of Action	LEVEL 2
Deficiency Photo1

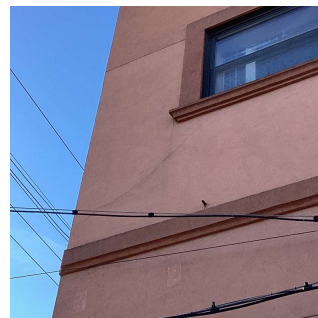
Facade D

STUCCO CEMENT SURFACE: CRACKS, SPALLING

Deficiency Quantity

50

Potential Action

REPLACE

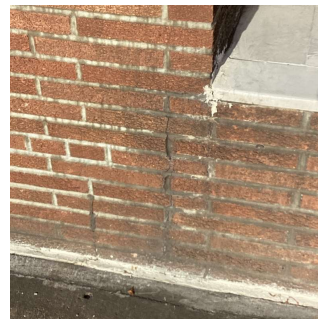
Facade A

BRICK: MINOR CRACKS AND SPALLING

Potential Action

RESTITCH

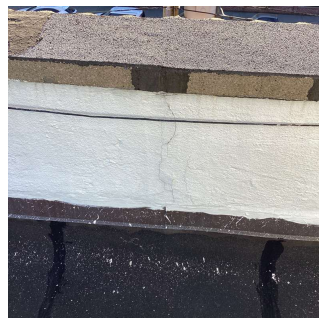
Question	Response
<b>EXTERIOR</b>	
<b>PARAPETS</b>	
Replacement Uom	C.F.
Instance on All Facades	Inspected
Instance Condition	3 - Fair
Instance Quantity	2,000
Instance Quantity Uom	C.F.
Deficiency	CONCRETE: MINOR CRACKS, SPALLING
Roof Plan reference

Deficiency Quantity	80
Quantity Uom	S.F.
Potential Action	REPAIR
Urgency of Action	PRIORITY 3
Purpose of Action	LEVEL 2
Deficiency Photo1

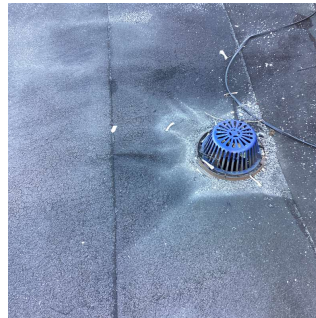
Roof 1

Deficiency	MODIFIED BITUMEN: ROOFING: DELAMINATION
------------	---

Potential Action	REPLACE ROOFING WITHOUT MAJOR EQUIPMENT REMOVAL
------------------	---

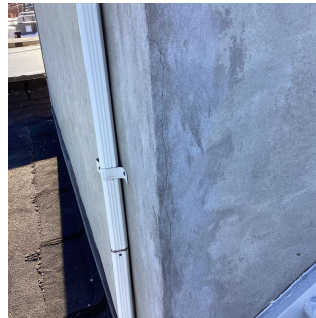
PH

Deficiency	BULKHEAD/PENTHOUSE WALLS/EXTERIOR: CRACKS/SPALLING - MINOR
------------	---

Potential Action

REPAIR

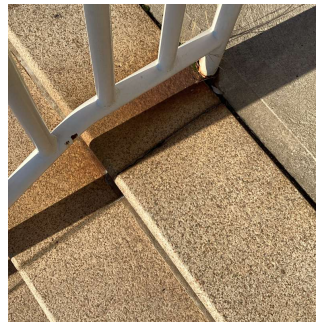
Facade A

STONE: DETERIORATED JOINTS

Potential Action

REPOINT

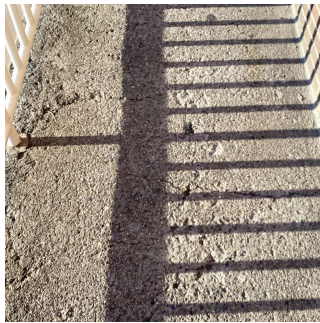
CONCRETE: CRACKS/SPALLING - MAJOR

Potential Action

REPLACE

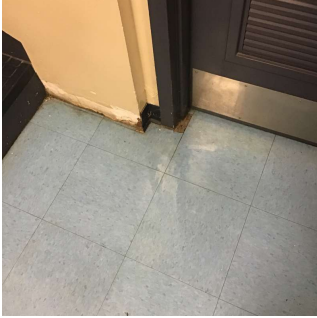
Violations	Waiting Room B No violations recorded.
<b>Door(s)</b>	
Condition	Inspected
Deficiency	2 - Between Good and Fair
Deficiency	No deficiencies recorded
<b>Floor Finish</b>	
Condition	Inspected
Deficiency	5 - Poor
Deficiency Location/Instance	VINYL TILES: BROKEN/DETERIORATED/MISSING TILES
Deficiency Quantity	Corridor near room mechanical room
Quantity Uom	10
Quantity Uom	S.F.

Question	Response
<b>INTERIOR</b>	
<b>CLASSROOMS/CORRIDORS/ADMIN SPACES</b>	
<b>Floor Finish</b>	
Potential Action	REPLACE
Urgency of Action	PRIORITY 3
Purpose of Action	LEVEL 2
Deficiency Photo1

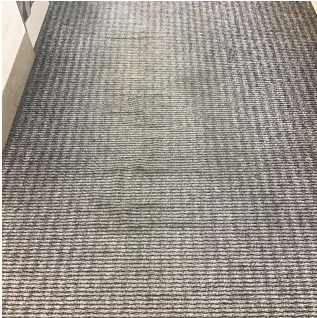
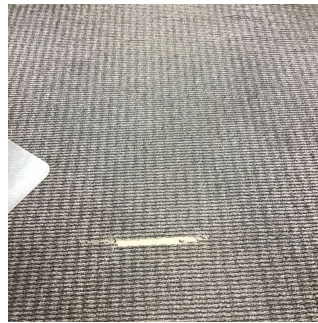
Priority Condition Exist Last Year?	Priority Category	Condition Description	Component Affected	Location Description	Person(s) Notified	Person(s) Title	PhotoImage
Yes	Tripping Hazard	Severely Damaged carpet resulting in potential tripping hazard	INTERIOR   CLASSROOMS /CORRIDORS/ ADMIN SPACES   Floor Finish	2nd Floor cubicle area	Wayne Cama	Custodian

Corridor near room mechanical room
Violations	No violations recorded.
Deficiency	CARPET: WORN/DETERIORATED
Deficiency Location/Instance	2nd Floor cubicle area
Deficiency Quantity	60
Quantity Uom	S.F.
Potential Action	REPLACE
Urgency of Action	PRIORITY 5
Purpose of Action	LEVEL 6
Deficiency Photo1

2nd Floor cubicle area
Violations	No violations recorded.
Deficiency	CARPET: WORN/DETERIORATED
Deficiency Location/Instance	2nd Floor cubicle area
Deficiency Quantity	1,600
Quantity Uom	S.F.
Potential Action	REPLACE
Urgency of Action	PRIORITY 3
Purpose of Action	LEVEL 2

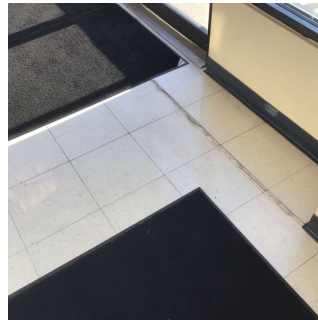
Main Entrance

VINYL TILES: DETERIORATED SUBSTRATE

Corridor near Stair A/1, Main Entrance, Mail Room, Stair A/2, 1st Floor Men, Lounge and others

Potential Action

REPLACE

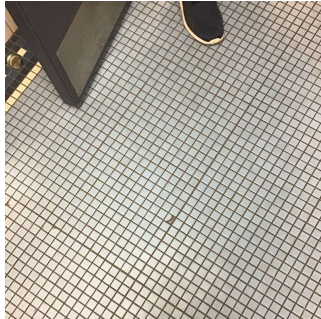
Question	Response
<b>INTERIOR</b>	
<b>TOILET ROOMS - STAFF</b>	
<b>Ceiling</b>	
Deficiency Photo1	 
Violations	2nd Floor Women No violations recorded.
<b>Door(s)</b>	Inspected
Condition	2 - Between Good and Fair
Deficiency	No deficiencies recorded
<b>Floor Finish</b>	Inspected
Condition	2 - Between Good and Fair
Deficiency	CERAMIC TILE: BROKEN/MISSING TILES
Deficiency Location/Instance	2nd Floor Womens Restrooms A, B
Deficiency Quantity	10
Quantity Uom	S.F.
Potential Action	REPLACE
Urgency of Action	PRIORITY 3
Purpose of Action	LEVEL 2
Deficiency Photo1

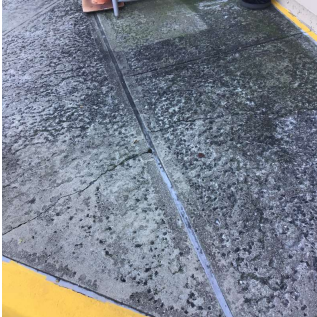
Question	Response
<b>SITE</b>	
<b>PAVING</b>	
<b>Student Non-Use</b>	
<b>Asphalt</b>	
Deficiency Photo1	 
Violations	Parking Lot No violations recorded.
<b>Concrete</b>	Does not Exist
<b>Pavers</b>	Does not Exist
<b>Student Use</b>	Does not Exist
<b>Site Sidewalks &amp; Walkways</b>	Inspected
<b>Asphalt</b>	Does not Exist
<b>Concrete</b>	Inspected
Condition	3 - Fair
Deficiency	HEAVING
Deficiency Location/Instance	Near Parking Lot
Deficiency Quantity	25
Quantity Uom	S.F.
Potential Action	REPLACE
Urgency of Action	PRIORITY 3
Purpose of Action	LEVEL 2
Deficiency Photo1	 
Violations	Near Parking Lot No violations recorded.
Deficiency	CRACKS - MAJOR
Deficiency Location/Instance	Near Parking Lot
Deficiency Quantity	50
Quantity Uom	S.F.
Potential Action	REPLACE
Urgency of Action	PRIORITY 3
Purpose of Action	LEVEL 2

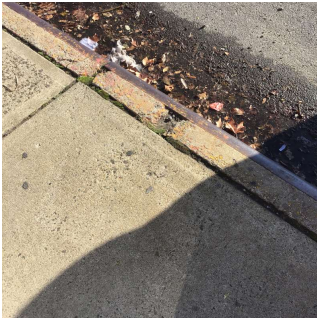
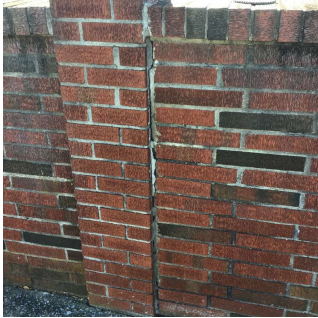
Violations	Flatlands Avenue No violations recorded.
Deficiency	DAMAGED/DETERIORATED/MISSING SECTIONS
Deficiency Location/Instance	Flatlands Avenue, E57th Street
Deficiency Quantity	250
Quantity Uom	S.F.
Potential Action	REPLACE
Urgency of Action	PRIORITY 3
Purpose of Action	LEVEL 2

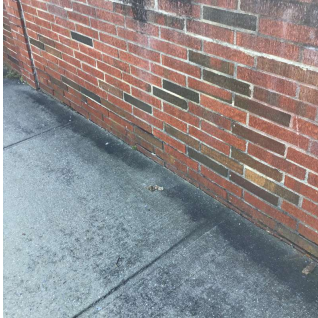
Violations	Avenue I No violations recorded.
Deficiency	BRICK: DETERIORATED JOINTS
Deficiency Location/Instance	Avenue I, E57th Street
Deficiency Quantity	60
Quantity Uom	S.F.
Potential Action	REPOINT
Urgency of Action	PRIORITY 3
Purpose of Action	LEVEL 2
Deficiency Photo1
