NYC Department of Education
Building Condition Assessment Survey 2023 - 2024

Architectural Inspection

K997

Asset: BROOKLYN HS SUPERINTENDENT - K, 1780 OCEAN AVENUE, New York, 11230

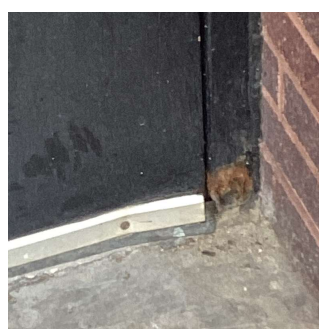
Question	Response
Architectural	
EXTERIOR	Inspected
AREAWAY	Does not Exist
AWNINGS AND CANOPIES	Does not Exist
CHIMNEY	Does not Exist
COPING	Inspected
Condition	2 - Between Good and Fair
Deficiency	No deficiencies recorded
CORNICE	Does not Exist
DOORS	Inspected
DOORS AND FRAMES	Inspected
Condition	3 - Fair
Deficiency	METAL: DETERIORATED DOOR AND FRAME - MINOR DETERIORATION

Deficiency Quantity	1
Quantity Uom	EACH
Potential Action	MAINTENANCE
Urgency of Action	PRIORITY 3
Purpose of Action	LEVEL 2
Deficiency Photo1

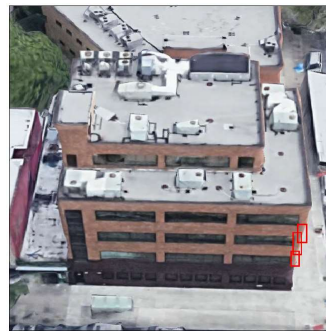
Violations	Facade B No violations recorded.
DOOR HARDWARE	Inspected
Condition	2 - Between Good and Fair
Deficiency	No deficiencies recorded
LINTELS	Inspected
Condition	2 - Between Good and Fair
Deficiency	No deficiencies recorded
TRANSOM/SIDE LIGHT	Inspected
Condition	2 - Between Good and Fair
Deficiency	No deficiencies recorded
EXTERIOR WALLS	Inspected
Material Type(s)	Masonry
Replacement Quantity	13,400
Replacement Uom	S.F.
Instance on All Facades	Inspected
Instance Condition	3 - Fair
Instance Quantity	13,400
Instance Quantity Uom	S.F.
Deficiency	BRICK: CRACKS/DISPLACED/SPALLED BRICK AT BUILDING CORNERS

REMOVE AND REBUILD

PRIORITY 4

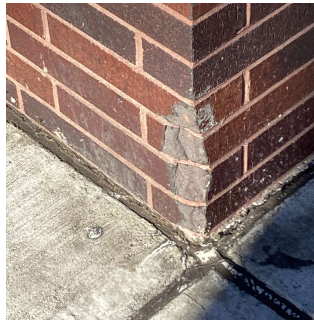
Facade B

BRICK: MAJOR / THRU CRACKS

REMOVE AND REBUILD

PRIORITY 4

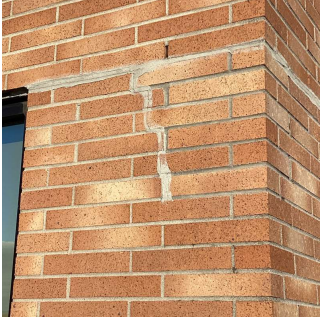
BRICK: MINOR CRACKS AND SPALLING

Violations	Facade F No violations recorded.
EXTERIOR SOFFITS	Inspected
Condition	2 - Between Good and Fair
Deficiency	No deficiencies recorded
LOADING DOCK	Does not Exist
LOUVER	Inspected
Condition	2 - Between Good and Fair
Deficiency	No deficiencies recorded
PARAPETS	Inspected
Material Type(s)	Masonry
Replacement Quantity	2,500
Replacement Uom	C.F.
Instance on All Roofs	Inspected
Instance Condition	2 - Between Good and Fair
Instance Quantity	2,500
Instance Quantity Uom	C.F.
Deficiency	No deficiencies recorded
PLAZA DECK	Does not Exist
ROOF	Inspected
Roofing	Inspected
Replacement Quantity	5,000
Replacement Uom	S.F.
ROOF HATCH/SMOKE HATCH	Does not Exist
LEADERS, GUTTERS, DOWNSPOUTS, SCUPPERS	Inspected
Condition	2 - Between Good and Fair
Deficiency	No deficiencies recorded
ROOF BARRIER/FENCE	Inspected
Condition	2 - Between Good and Fair

RESTITCH

Question	Response
EXTERIOR	
EXTERIOR WALLS	
Urgency of Action	PRIORITY 3
Purpose of Action	LEVEL 2
Deficiency Photo1

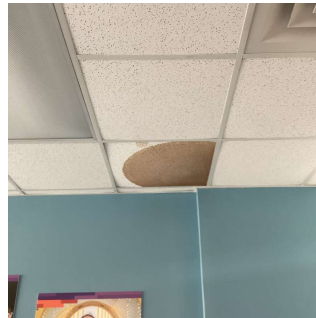
Roof 1 - Room 502 (Roof 2 - Stairwell A/4 similar)

MODIFIED BITUMEN: ROOFING: MAJOR ACTIVE ROOF LEAKS IN INSTRUCTIONAL SPACE

REPLACE ROOFING WITHOUT MAJOR EQUIPMENT REMOVAL

PRIORITY 5

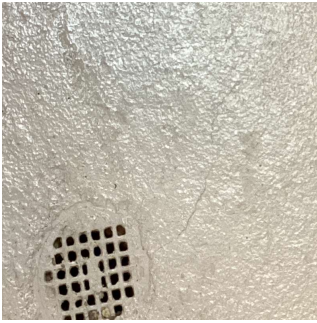
Question	Response
EXTERIOR	
WINDOWS	
WINDOWS	
Elevation	 
Deficiency Quantity	60
Quantity Uom	S.F.
Potential Action	MAINTENANCE
Urgency of Action	PRIORITY 3
Purpose of Action	LEVEL 2
Deficiency Photo1	 
Violations	Facade F No violations recorded.
INTERIOR	Inspected
POOLS	Does not Exist
STRUCTURAL	Inspected
COLUMNS/BEAMS/BEARING WALLS	Inspected
Condition	2 - Between Good and Fair
Deficiency	No deficiencies recorded
FLOOR STRUCTURE	Inspected
Condition	3 - Fair
Deficiency	CONCRETE SLAB ON GRADE: THRU CRACKS
Deficiency Location/Instance	Basement
Deficiency Quantity	10
Quantity Uom	S.F.
Potential Action	REPAIR
Urgency of Action	PRIORITY 3
Purpose of Action	LEVEL 5

Violations	Sprinkler Control Room No violations recorded.
Deficiency	CONCRETE: CRACKS/SPALLED/REINFORCEMENT EXPOSED
Deficiency Location/Instance	1st Floor
Deficiency Quantity	15
Quantity Uom	S.F.
Potential Action	REPAIR
Urgency of Action	PRIORITY 3
Purpose of Action	LEVEL 5
Deficiency Photo1

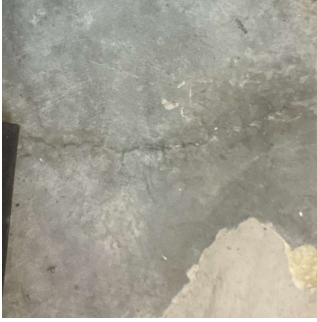
Violations	1st Floor Mechanical Room No violations recorded.
FOUNDATION WALLS	
Material Type(s)	Inspected Concrete
Condition	3 - Fair
Deficiency	CONCRETE: CRACKED/SPALLED/REINFORCEMENT EXPOSED
Deficiency Location/Instance	Basement
Deficiency Quantity	25
Quantity Uom	S.F.
Potential Action	REPAIR
Urgency of Action	PRIORITY 3
Purpose of Action	LEVEL 5

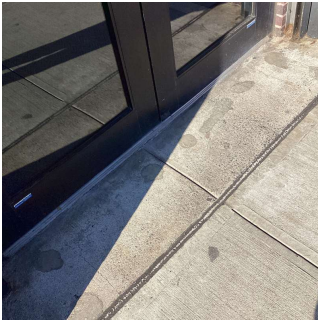
Question	Response
SITE	
Drainage System for Asphalt	Does not Exist
Drainage System for Concrete	Does not Exist
Drainage System for Soil	Does not Exist
DRINKING FOUNTAINS	Does not Exist
FENCES	Does not Exist
IRRIGATION SYSTEM	Does not Exist
PAVING	Inspected
Student Non-Use	Does not Exist
Student Use	Does not Exist
Site Sidewalks & Walkways	Inspected
Asphalt	Does not Exist
Concrete	Inspected
Condition	3 - Fair
Deficiency	CRACKS - MAJOR
Deficiency Location/Instance	Entrance, Avenue M Exit
Deficiency Quantity	50
Quantity Uom	S.F.
Potential Action	REPLACE
Urgency of Action	PRIORITY 3
Purpose of Action	LEVEL 2
Deficiency Photo1

Violations	No violations recorded.
Pavers	Does not Exist
DOT Sidewalk	Inspected
Asphalt	Does not Exist
Concrete	Inspected
Condition	2 - Between Good and Fair
Deficiency	DAMAGED CURBS
Deficiency Location/Instance	Avenue M
Deficiency Quantity	20
Quantity Uom	L.F.
Potential Action	REPLACE
Urgency of Action	PRIORITY 3

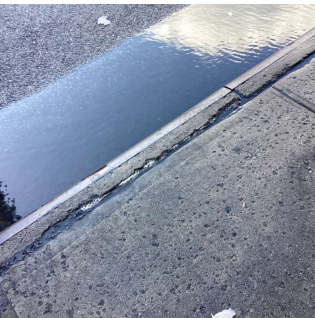
Violations	Avenue M
	No violations recorded.
Pavers	Does not Exist
PLAYGROUNDS	Does not Exist
PLAYING SURFACE	Does not Exist
RETAINING WALLS	Does not Exist
SEATING	Does not Exist
SITE WALLS (NOT RETAINING WALLS)	Does not Exist
STAIRS/RAMPS: EXTERIOR	Does not Exist
ARTWORK	Does not Exist
