**NYC Department of Education
Building Condition Assessment Survey 2023-2024**

Architectural Inspection

M005

Asset: P.S. 5 - MANHATTAN, 3703 TENTH AVENUE, MANHATTAN, NY, 10034

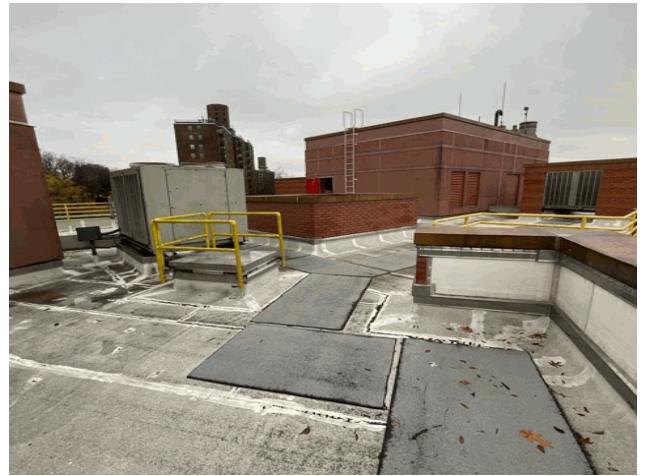
Roof 2 - North View

Roof 2
Instance Condition	3- Fair
Instance Quantity	26,000
Instance Quantity Uom	S.F.
Does the roof have major mechanical equipment sitting on Dunnage Steel less than 18" above the Roofing?	No
Does this Roof Instance have a Sustainable Roof System?	Yes
Sustainable Roof System Type	White Roof
Sustainable Roof System Location (Roof Number)	Roof 1-9 and 11
Do solar panels exist on these roofs?	No
Is/Are the roof(s) suitable for Solar Panel installation?	No
Installation Year	2018
Source of Installation Year	Documented
Deficiency	MODIFIED BITUMEN:ROOFING:DELAMINATION

REPLACE ROOFING WITHOUT MAJOR EQUIPMENT
REMOVAL
