**NYC Department of Education
Building Condition Assessment Survey 2023-2024**

Architectural Inspection

M020

Asset: P.S. 20 - MANHATTAN, 166 ESSEX STREET, MANHATTAN, NY, 10002

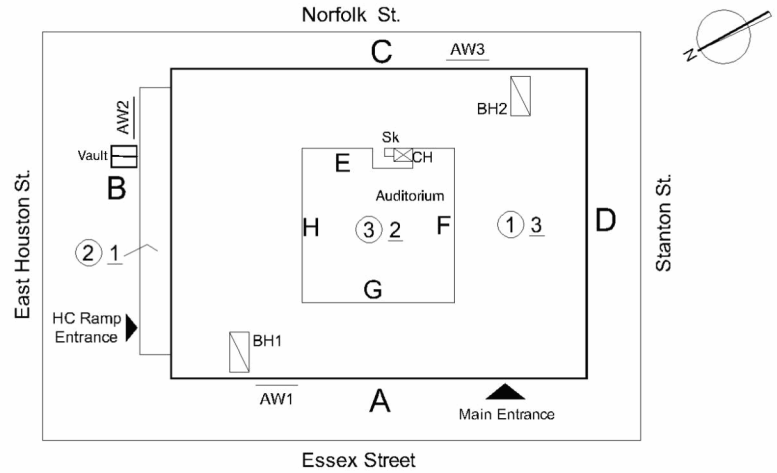
Question	Response
Architectural	Inspected
EXTERIOR	Inspected
AREAWAY	Inspected
Instance on AW1-AW3	Inspected
Instance Condition	4- Between Fair and Poor
Instance Quantity	3
Instance Quantity Uom	EACH
Deficiency	AREAWAY STAIRS:DETERIORATED MATERIAL SLIDE
Deficiency Location/Instance

Deficiency Quantity	30
Quantity Uom	S.F.
Potential Action	REPLACE
Urgency of Action	PRIORITY 3
Purpose of Action	LEVEL 2
Deficiency Photo 1
