**NYC Department of Education  
Building Condition Assessment Survey 2023-2024**

**Architectural Inspection**

**M022**

**Asset:** N.E.S.T (OLD J22) - MANHATTAN, 111 COLUMBIA STREET, MANHATTAN, NY, 10002

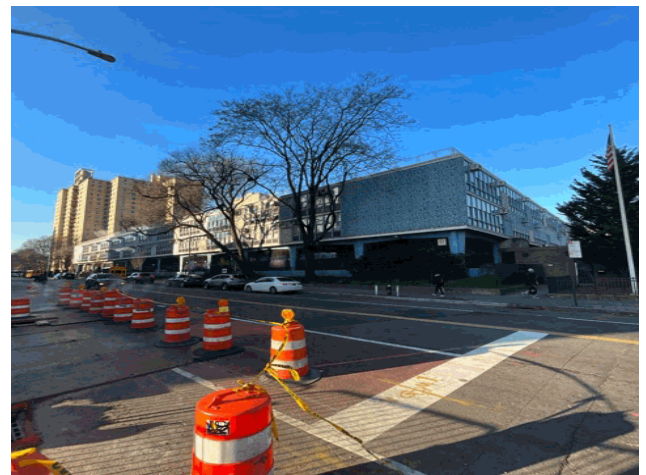
Corner of Columbia Street and East Houston Street - West View

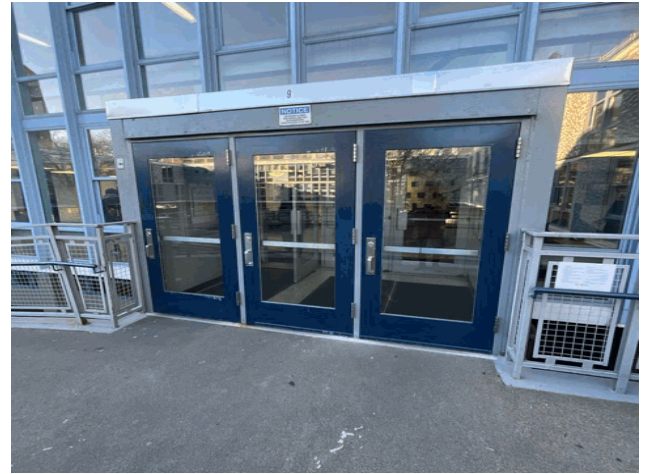
Facade G - Courtyard (Vestibule A)

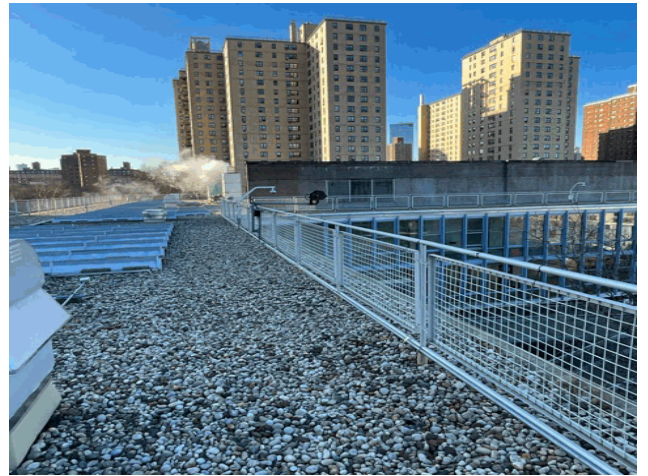
Roof 1 - Southwest View
