**NYC Department of Education  
Building Condition Assessment Survey 2023-2024**

**Architectural Inspection**

**Asset: J.H.S. 47 (SCH FOR THE DEAF) - MANHATTAN, 223 EAST 23 STREET, MANHATTAN, NY, 10010**

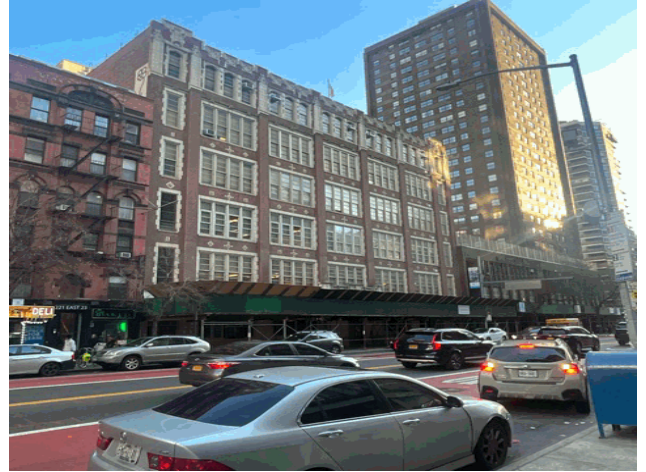
Facade Photo

East 23rd Street - East View

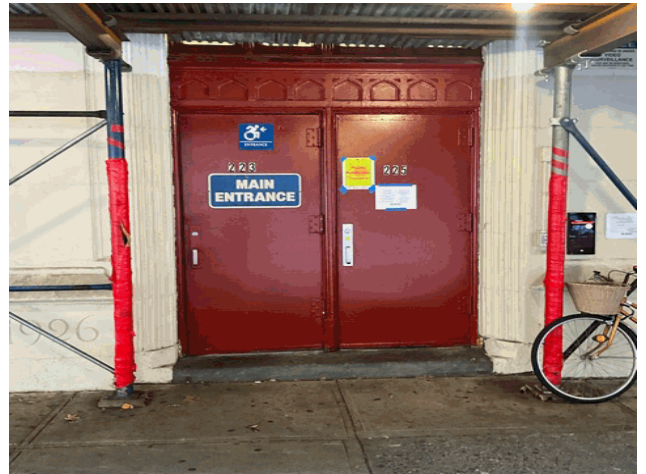
Main Entrance Photo

Facade A - East 23rd Street

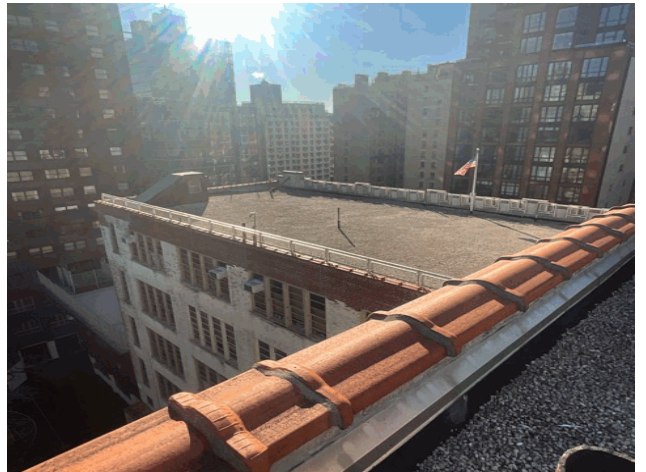
Roof Photo

Roof 3 - South View
