NYC Department of Education
Building Condition Assessment Survey 2023-2024

Architectural Inspection

Asset: P.S. 50 (UDC & ECF) - MANHATTAN, 433 EAST 100 STREET, MANHATTAN, NY, 10029

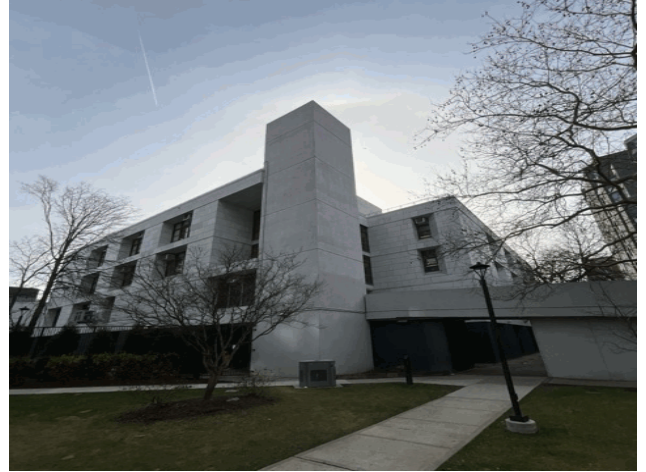
Facade Photo

East 101st Street entrance - South View

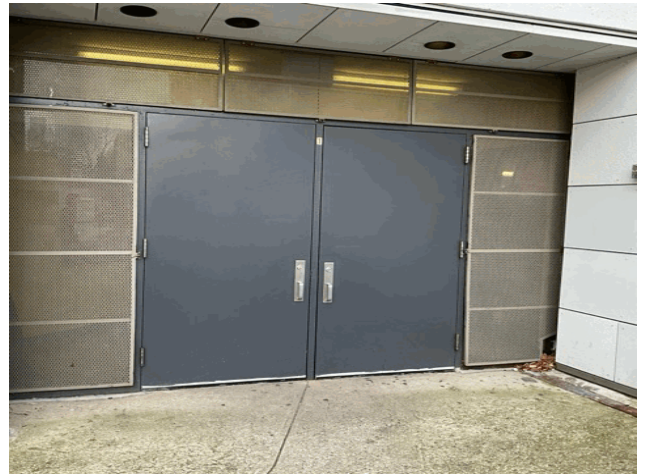
Main Entrance Photo

Facade A - East 101st Street

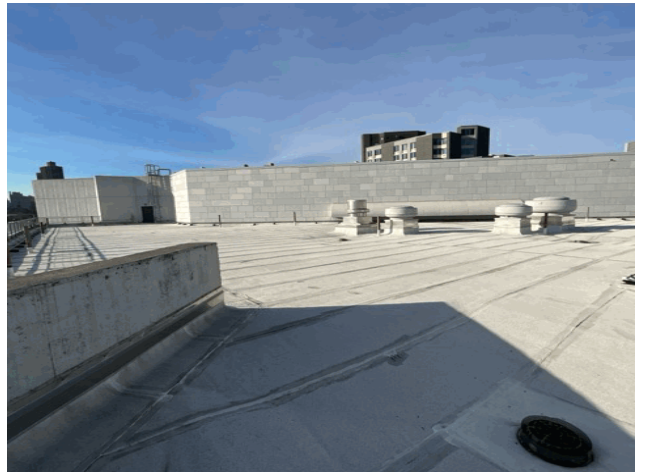
Roof Photo

Roof 3 - West View
