**NYC Department of Education
Building Condition Assessment Survey 2023-2024**

Architectural Inspection

M070

Asset: I.S. 70 - MANHATTAN, 333 WEST 17 STREET, MANHATTAN, NY, 10011

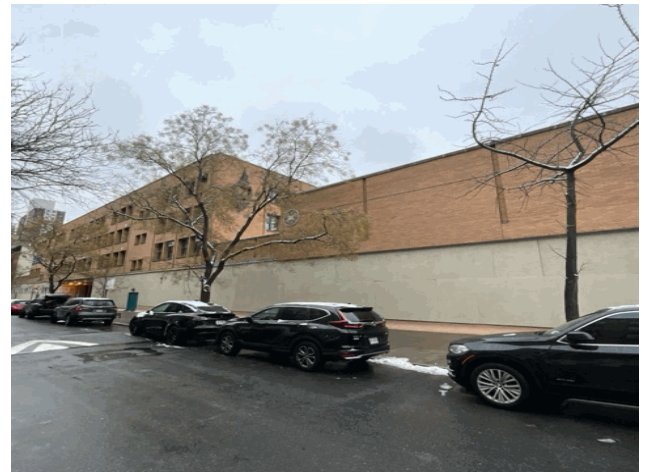
West 17th Street - North View

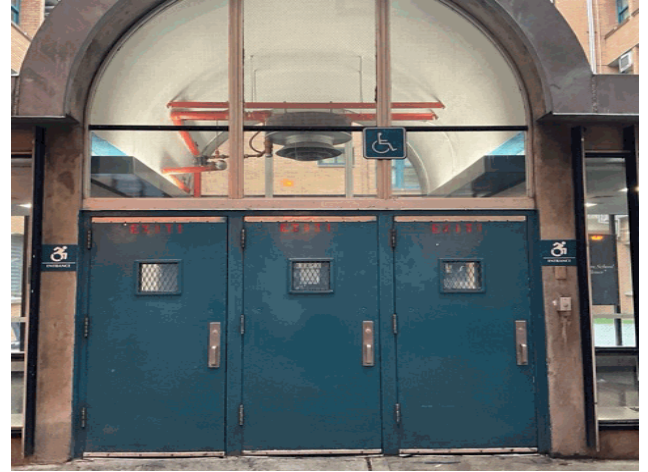
Facade A - West 17th Street

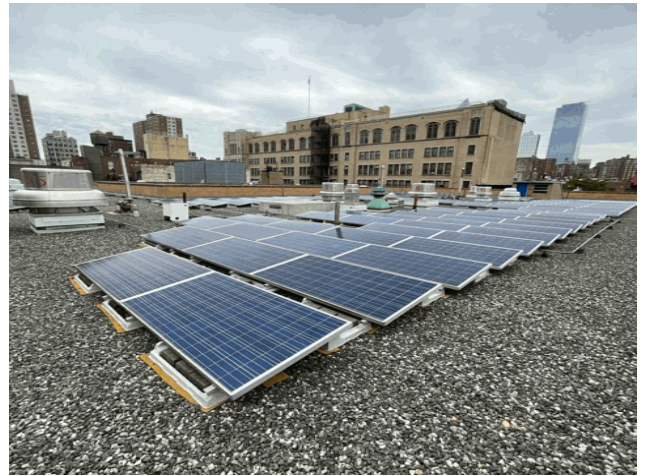
Roof 1 - North View
