**NYC Department of Education
Building Condition Assessment Survey 2023-2024**

Architectural Inspection

M089

Asset: P.S./I.S. 89 - MANHATTAN, 201 WARREN STREET, MANHATTAN, NY, 10282

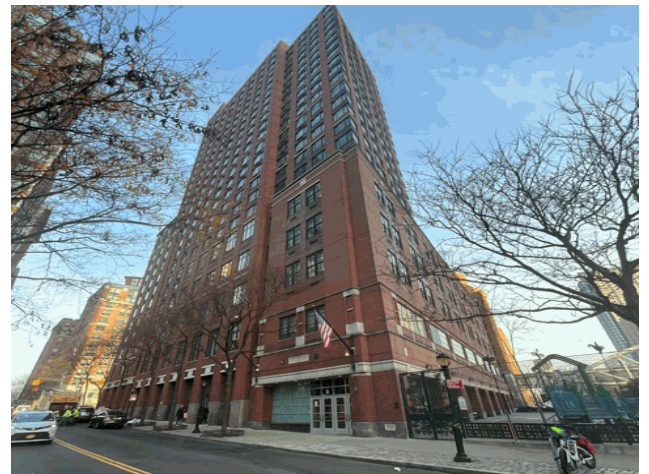
Corner of West Street and Warren Street - North View

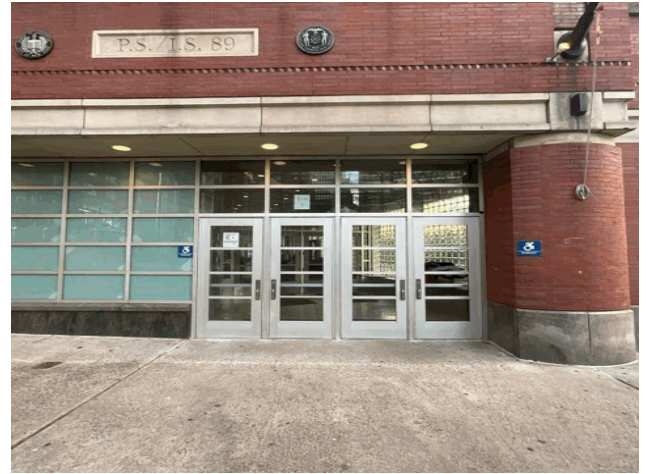
Facade A - Warren Street

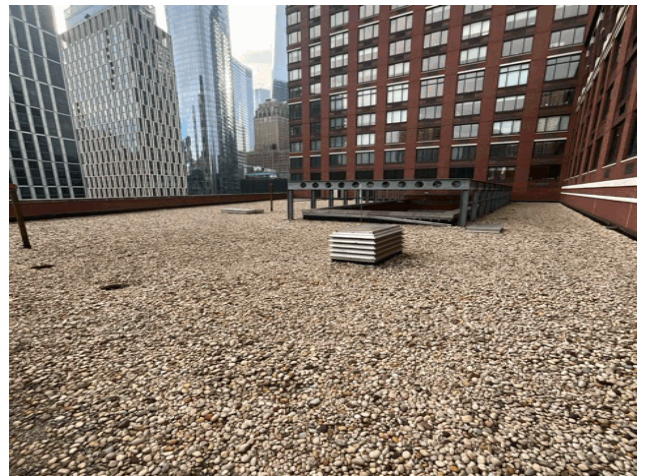
Roof 1 - South View
