**NYC Department of Education
Building Condition Assessment Survey 2023-2024**

Architectural Inspection

Asset: P.S. 110 - MANHATTAN, 285 DELANCY STREET, MANHATTAN, NY, 10002

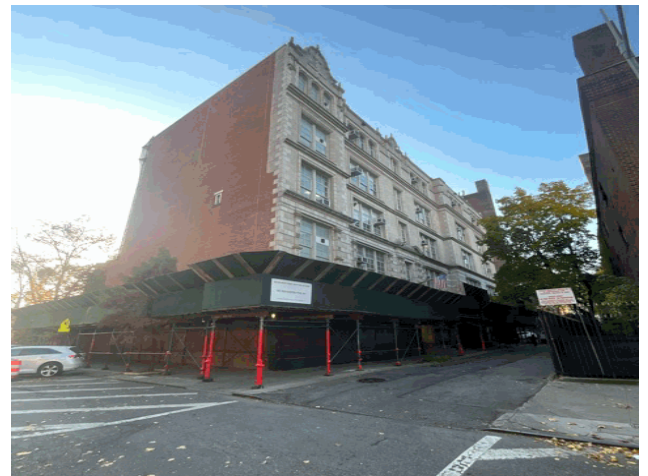
Corner of Cannon Street and Delancy Street - Southeast

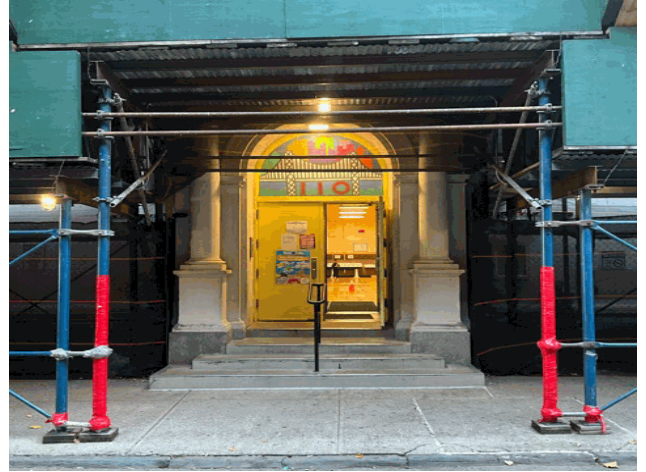
Facade A - Cannon Street

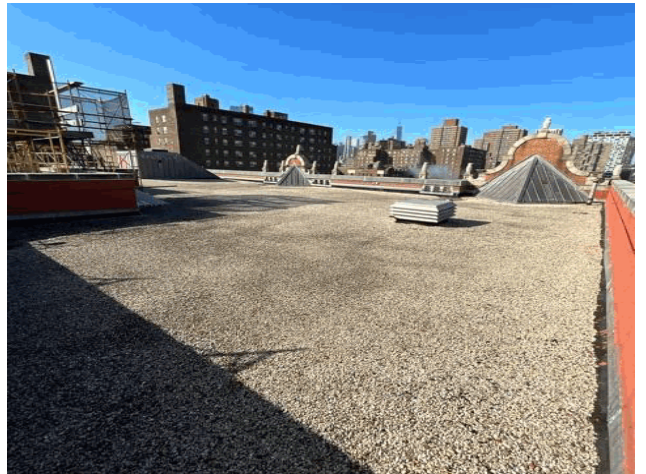
Roof 1 - West View
