**NYC Department of Education
Building Condition Assessment Survey 2023-2024**

Architectural Inspection

M113

Asset: P.S. 241 - MANHATTAN, 240 WEST 113 STREET, MANHATTAN, NY, 10026

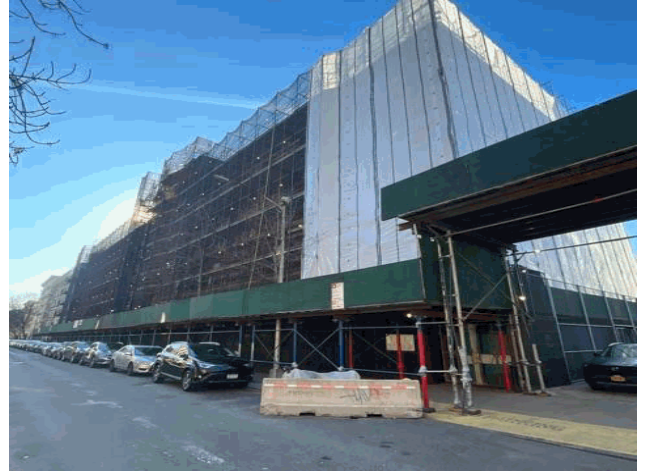
Facade Photo

West 113th Street - Southeast View

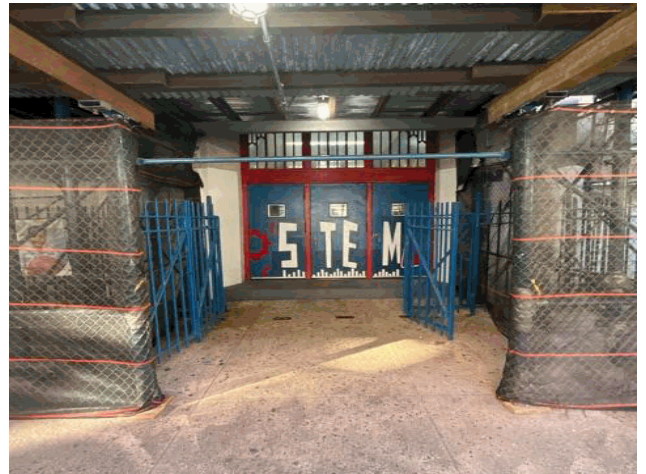
Main Entrance Photo

Facade A - West 113th Street

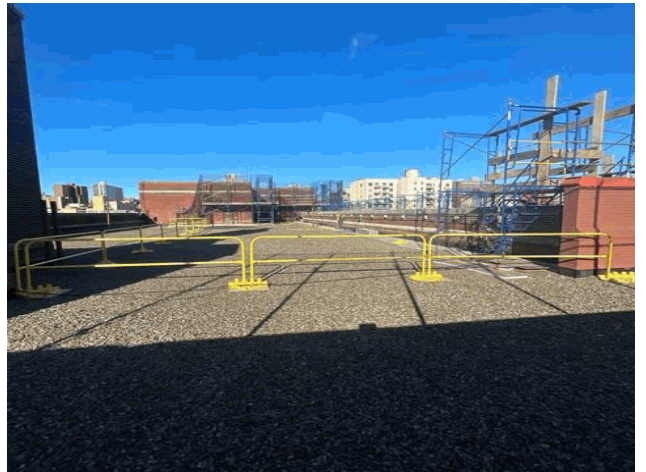
Roof Photo

Roof 3 - West View
