**NYC Department of Education
Building Condition Assessment Survey 2023-2024**

Architectural Inspection

M118

Asset: I.S. 118 - MANHATTAN, 154 WEST 93 STREET, MANHATTAN, NY, 10025

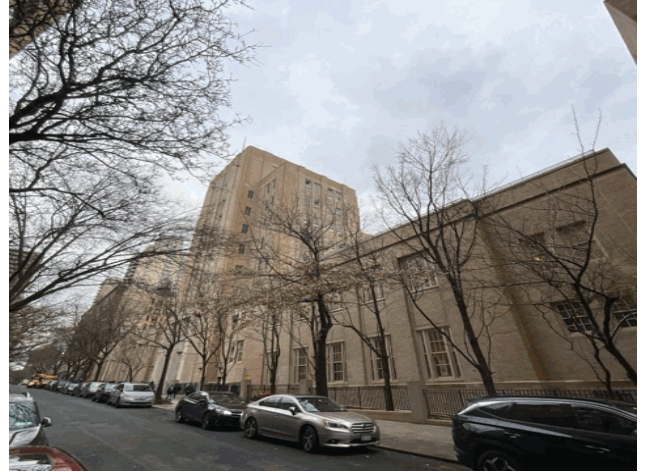
Facade Photo

West 93rd Street - South View

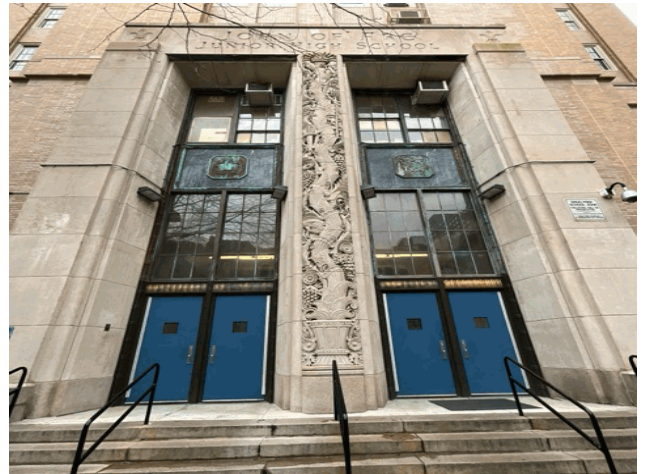
Main Entrance Photo

Facade A - West 93rd Street

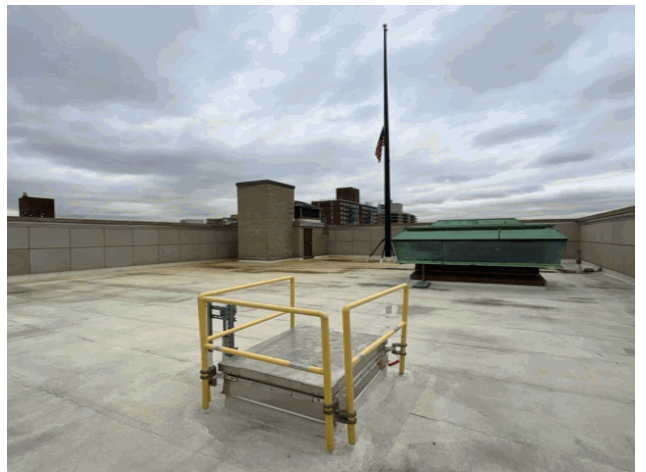
Roof Photo

Roof 1 - North View
