**NYC Department of Education  
Building Condition Assessment Survey 2023-2024**

**Architectural Inspection**

**M129**

**Asset:** P.S. 129 - MANHATTAN, 425 WEST 130 STREET, MANHATTAN, NY, 10027

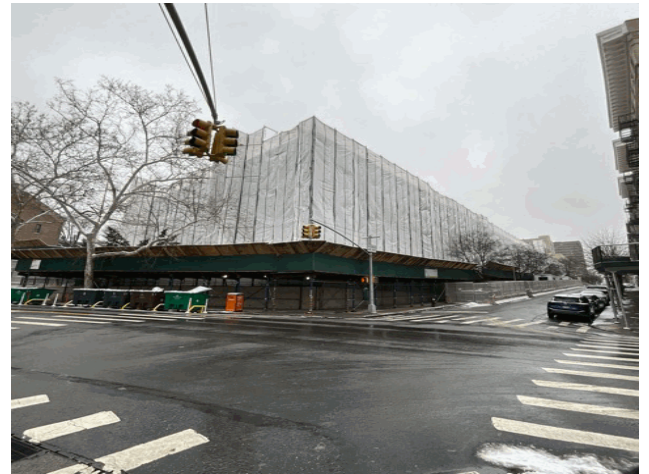
| Question | Answer |
|--|--|
| Facade Photo | |

Corner of West 130th Street and Convent Avenue - East View

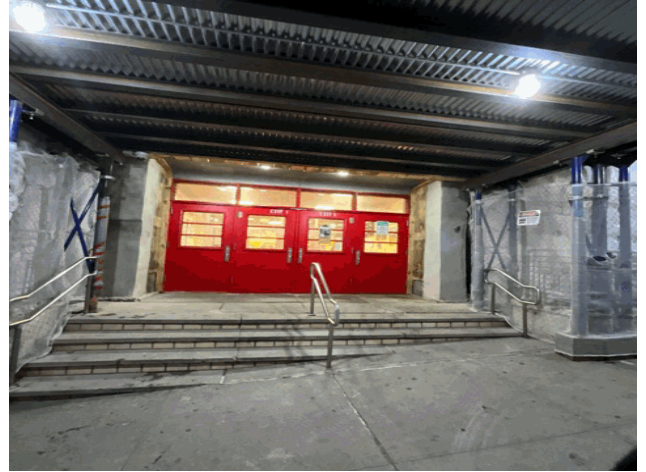
Main Entrance Photo

Facade A - West 130th Street

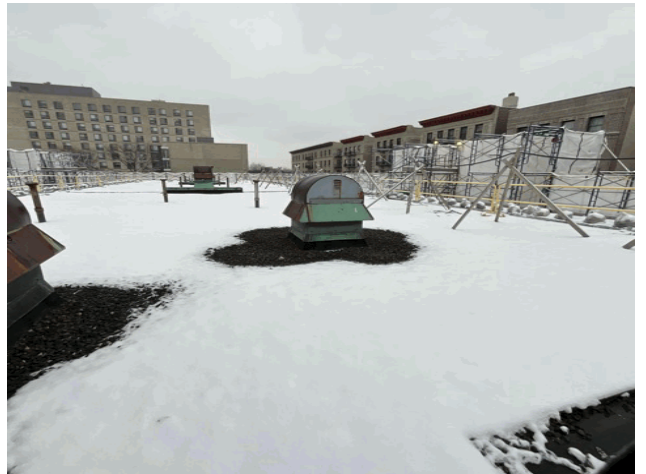
Roof Photo

Roof 1 - Southeast View
