**NYC Department of Education
Building Condition Assessment Survey 2023-2024**

Architectural Inspection

Asset: P.S. 133 - MANHATTAN, 2121 5TH AVENUE, MANHATTAN, NY, 10037

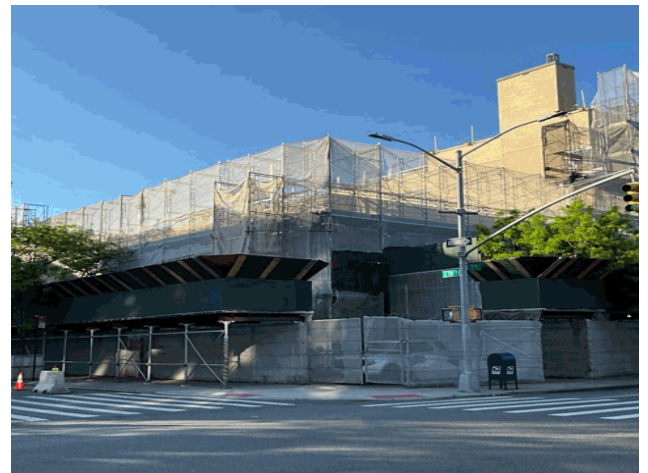
Corner of 5th Avenue and East 131st Street - South View

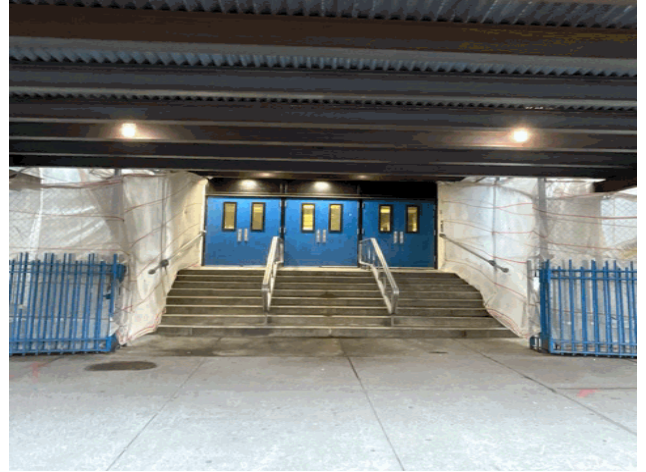
Facade A - East 131st Street

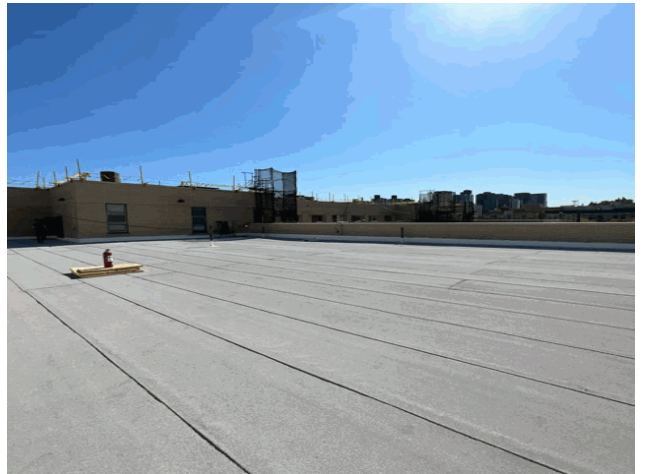
Roof 9 - East View
