**NYC Department of Education  
Building Condition Assessment Survey 2023-2024**

**Architectural Inspection**

**M155**

**Asset:** P.S. 155 - MANHATTAN, 319 EAST 117 STREET, MANHATTAN, NY, 10035

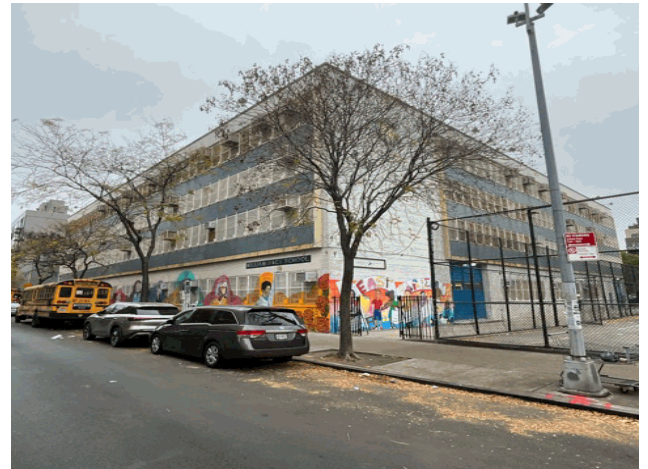
East 117th Street - North View

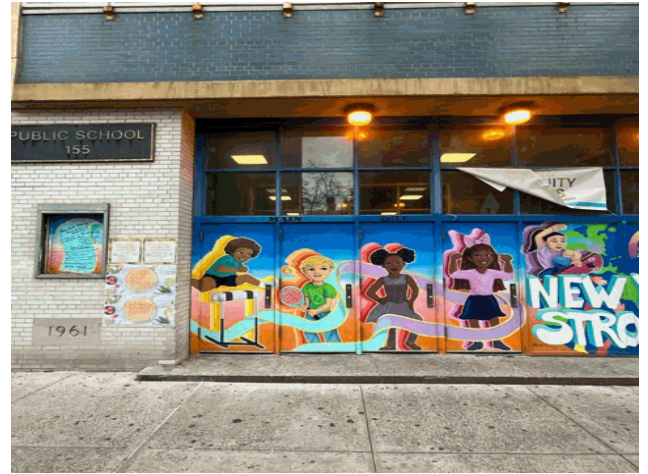
Facade A - East 117th Street

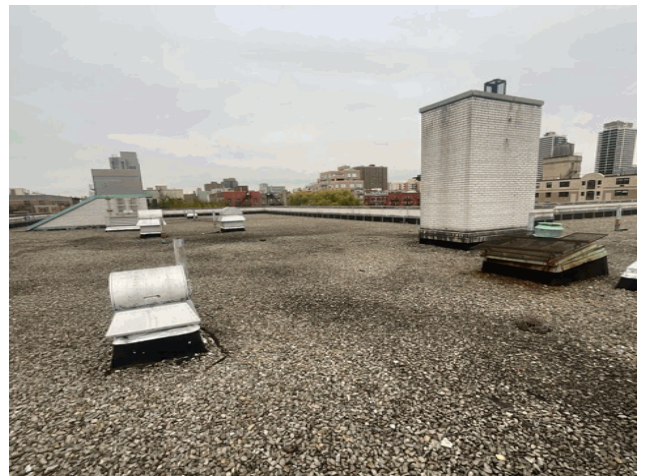
Roof 1 - Northwest View
