**NYC Department of Education
Building Condition Assessment Survey 2023-2024**

Architectural Inspection

M163

Asset: P.S. 163 - MANHATTAN, 163 WEST 97 STREET, MANHATTAN, NY, 10025

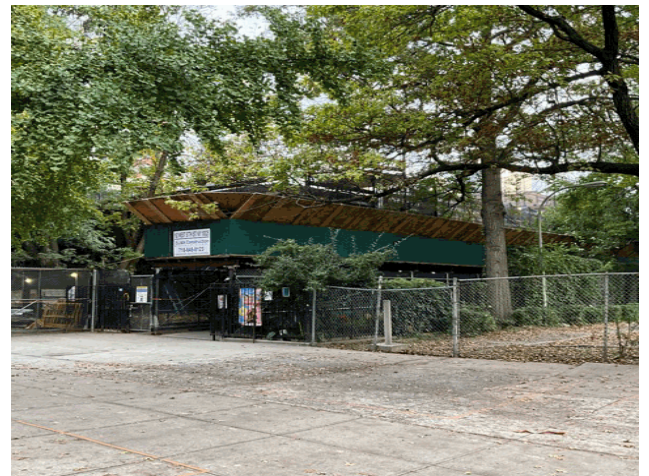
West 97th Street - South View

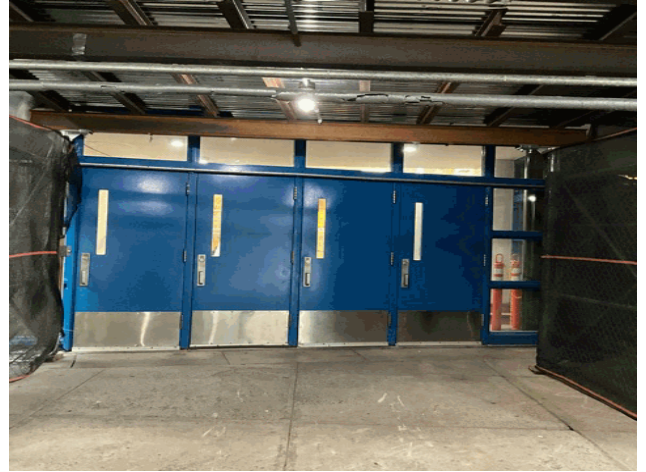
Facade A - East Parking Lot

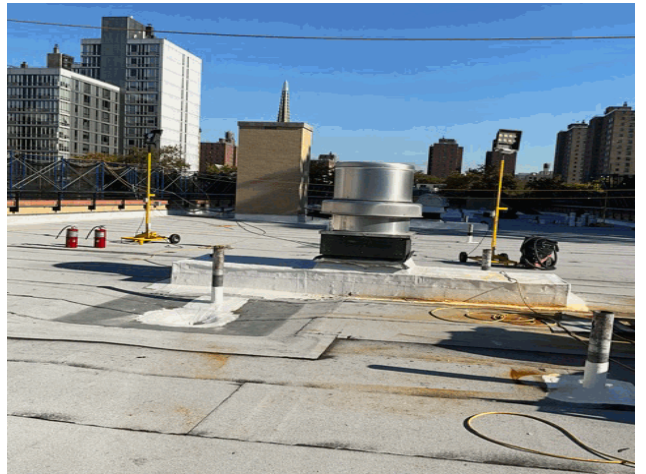
Roof 1 - North View
