**NYC Department of Education
Building Condition Assessment Survey 2023-2024**

Architectural Inspection

M176

Asset: P.S./I.S. 176 - MANHATTAN, 4862 BROADWAY, MANHATTAN, NY, 10034

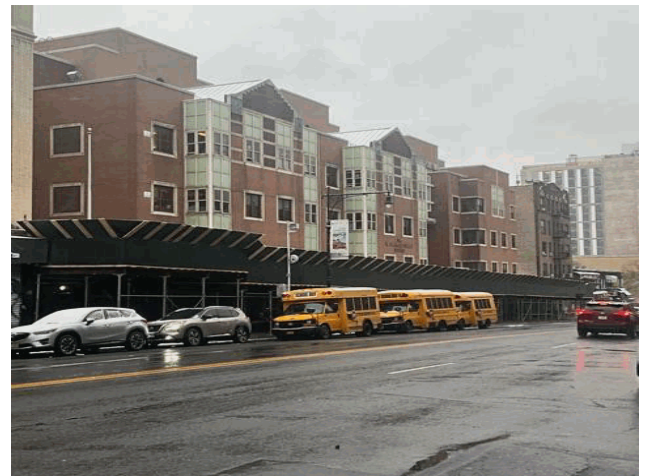
Broadway -Southwest View

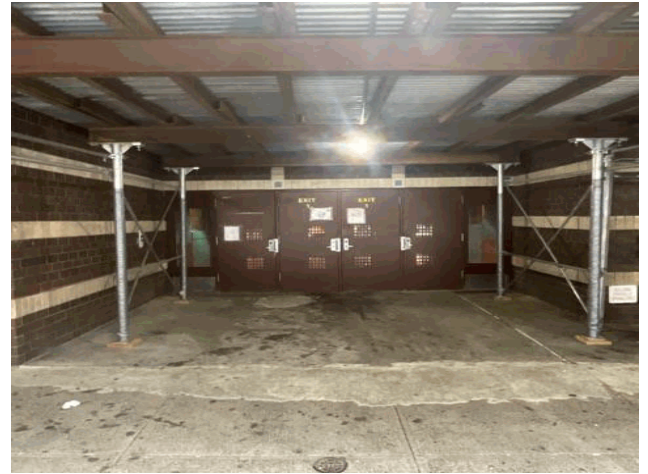
Facade A - Broadway

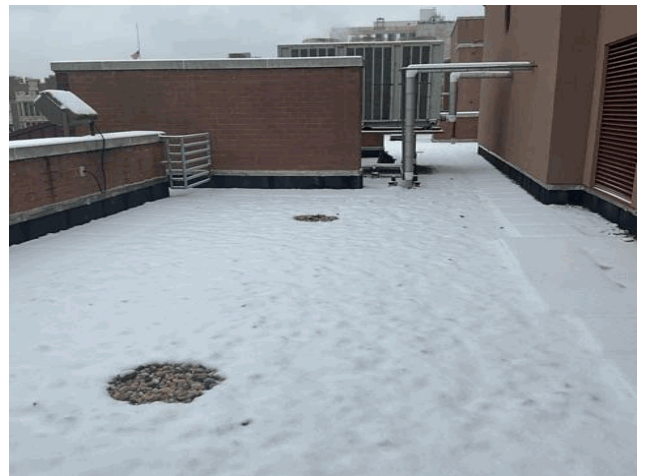
Roof 1 - Northeast View
