**NYC Department of Education
Building Condition Assessment Survey 2023-2024**

Mechanical Inspection

Asset: TERENCE D. TOLBERT EDUCATION COMPLEX - MANHATTAN, 625 WEST 133 STREET, MANHATTAN, NY, 10027

Inspection Id	Inspection Type	Time In	Last Edited
1610	MECHANICAL	2023-12-12 08:05AM	2024-01-12 01:30PM

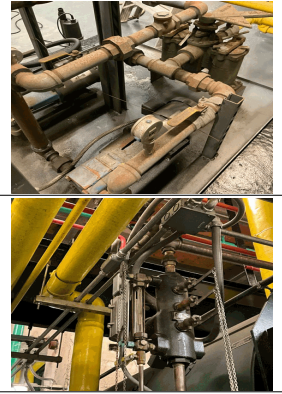
No	Defective Boiler Safety Auxiliary	Defective Fusible Link	Fuel Oil Storage/Supply System	Boiler Room @ Fuel Oil Transfer Pumps	Henry Rosa	Fireman
No	Defective Boiler Safety Auxiliary	Leaking Water Column Assembly	Steam Boiler	Boiler Room / Boilers #2, #3	Henry Rosa	Fireman
