**NYC Department of Education  
Building Condition Assessment Survey 2023-2024**

**Architectural Inspection**

**Asset: P.S. 208 (TANDEM M185) - MANHATTAN, 21 WEST 111 STREET, MANHATTAN, NY, 10026**

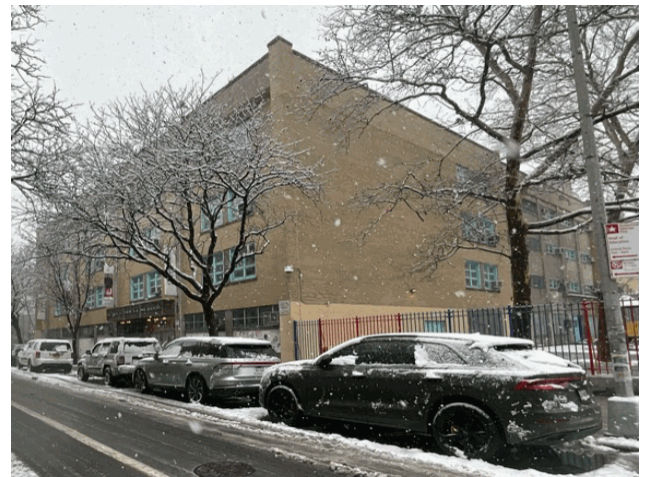
West 111th Street - North View

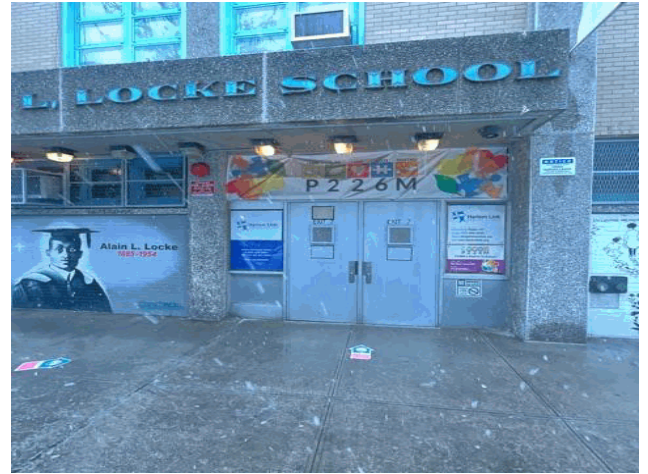
Facade A - West 111th Street

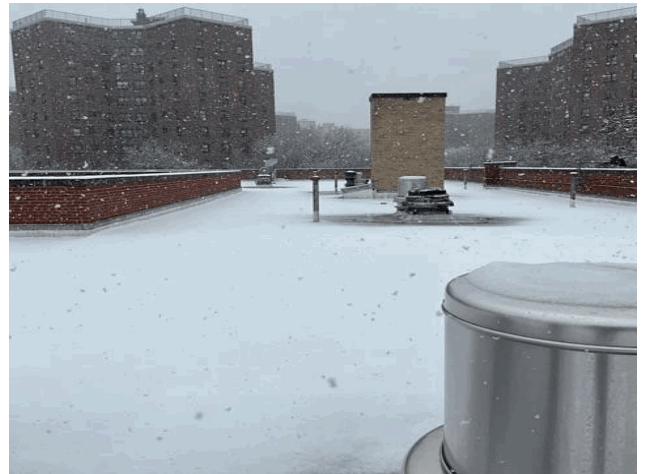
Roof 1 - Northeast View
