**NYC Department of Education
Building Condition Assessment Survey 2023-2024**

Architectural Inspection

M218

Asset: I.S. 218 - MANHATTAN, 4600 BROADWAY, MANHATTAN, NY, 10040

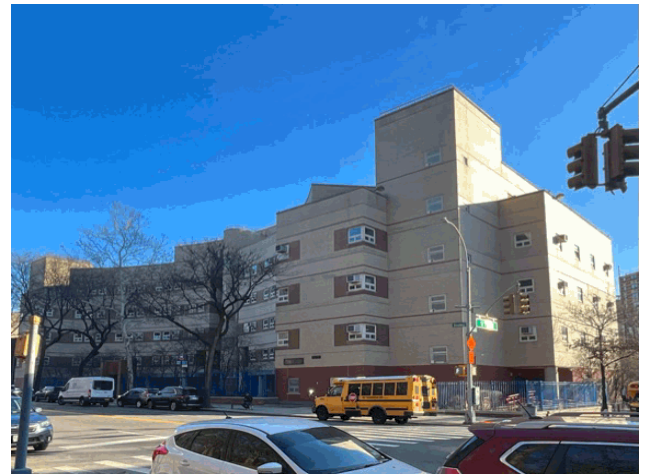
Student Population	803
Staff Population	120
Comments on the Number of Classrooms	61
Weather	Fair
Facade Photo

Corner of Broadway and West 196th Street - Northeast View

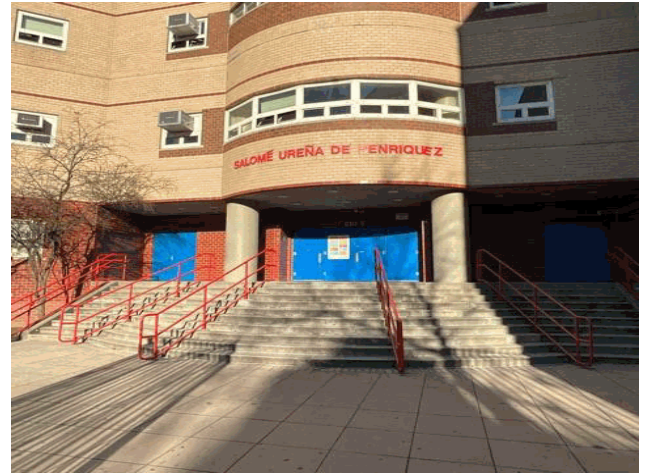
Main Entrance Photo

Facade A - West 196th Street

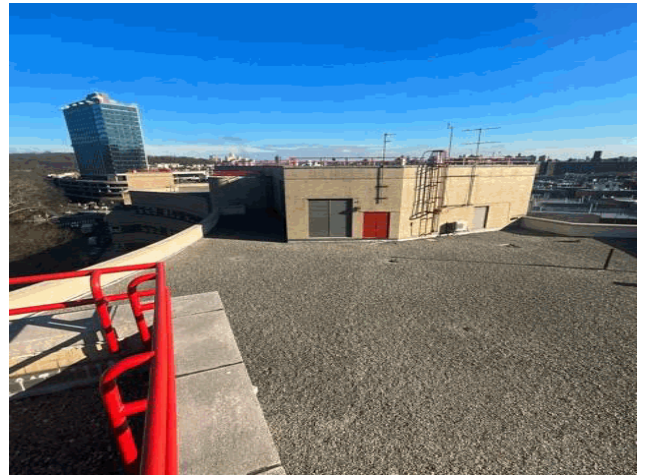
Roof Photo

Roof 5 - Northeast View
