**NYC Department of Education  
Building Condition Assessment Survey 2023-2024**

**Architectural Inspection**

**M233**

**Asset: ALTERNATIVE LEARNING CENTER - MANHATTAN, 601 WEST 183 STREET, MANHATTAN, NY, 10033**

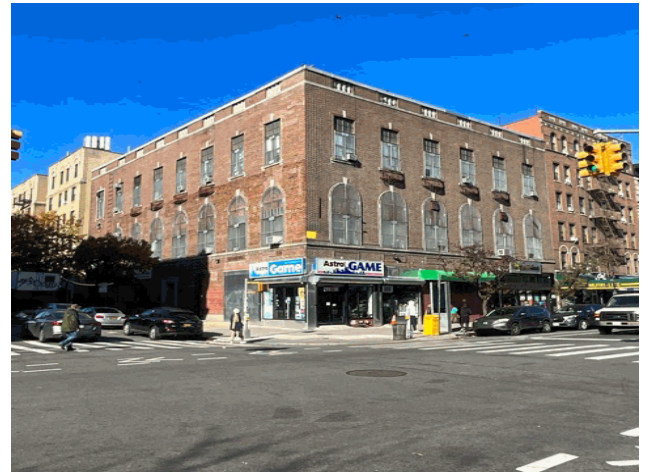
Corner of West 183rd Street and St. Nicholas Avenue - North View

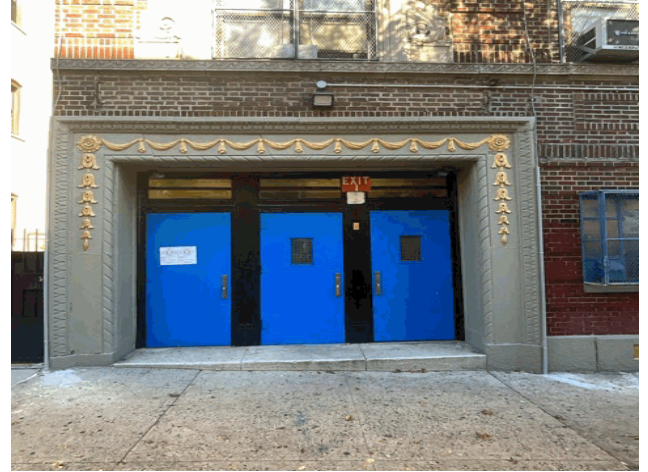
Facade A - West 183rd Street

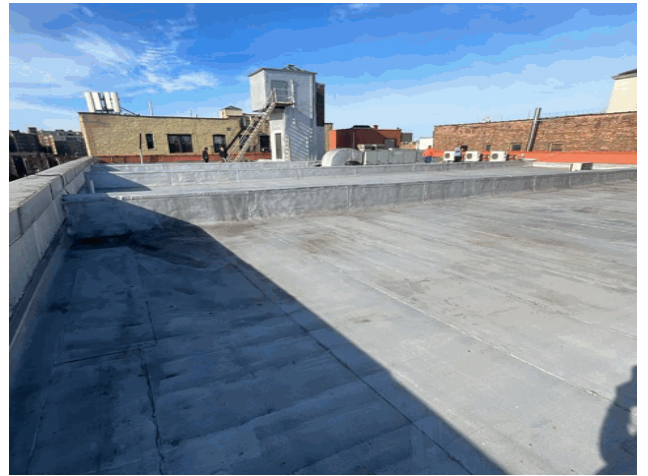
Roof 1 - North View
