**NYC Department of Education
Building Condition Assessment Survey 2023-2024**

Architectural Inspection

M281

Asset: P.S. 281 - MANHATTAN, 425 EAST 35 STREET, MANHATTAN, NY, 10016

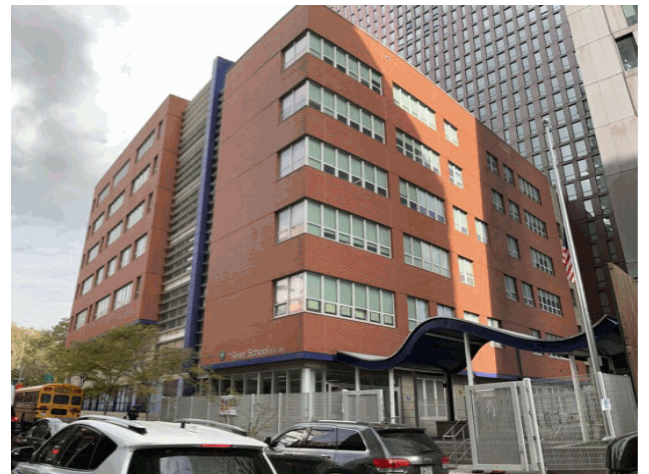
East 35th Street - North View

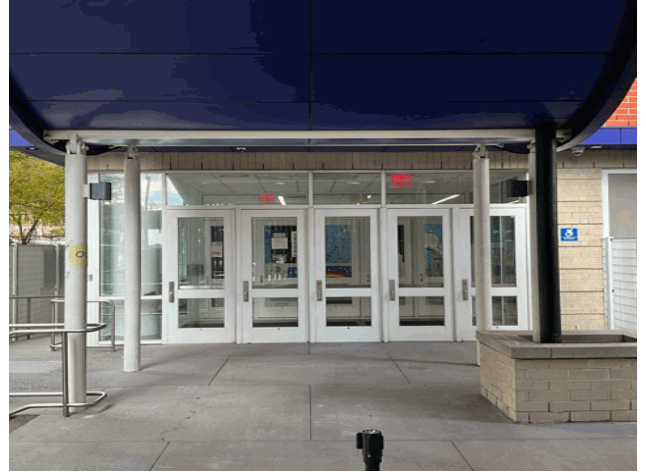
Facade A - East 35th Street

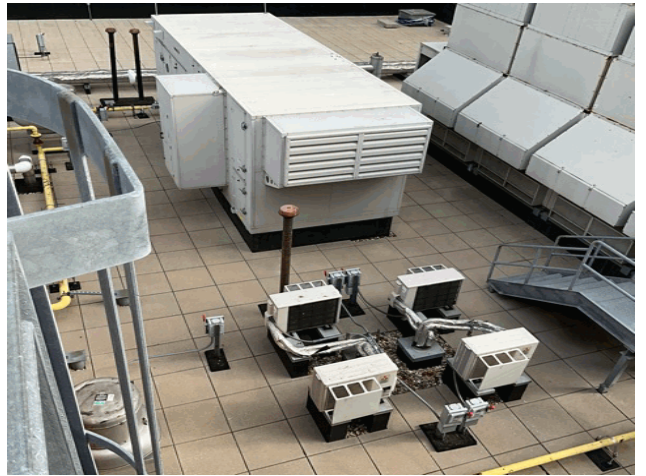
Roof 1 - Northeast View
