NYC Department of Education
Building Condition Assessment Survey 2023-2024

Architectural Inspection

M282

Asset: BROADWAY EDUCATION CAMPUS - MANHATTAN, 26 BROADWAY, MANHATTAN, NY, 10004

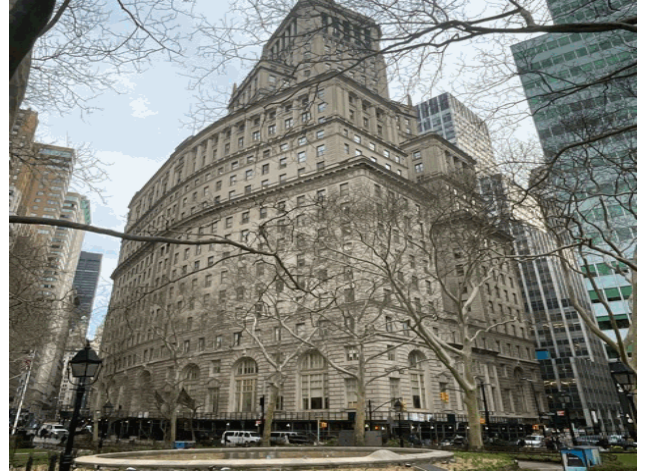
Facade Photo

Corner of Broadway and Beaver Street - Northeast View

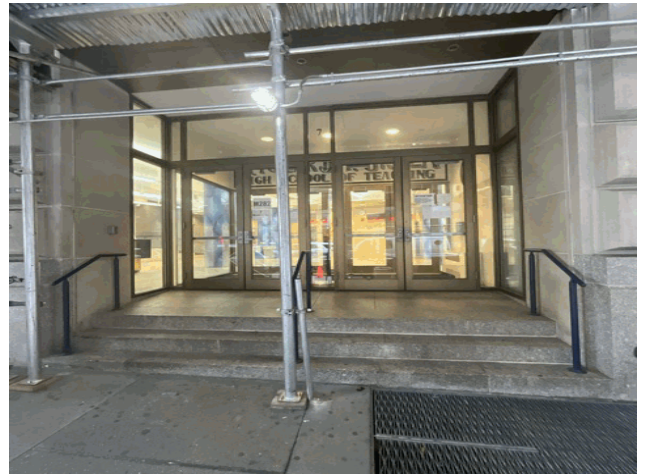
Main Entrance Photo

Facade A - Beaver Street

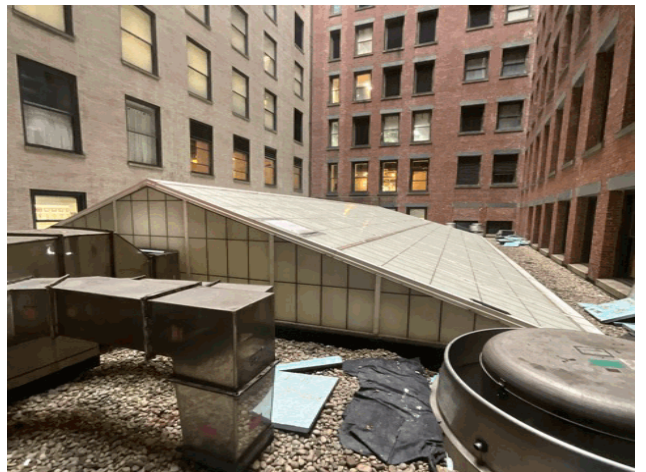
Roof Photo

Roof 1 - West View
