**NYC Department of Education
Building Condition Assessment Survey 2023-2024**

Architectural Inspection

M342

Asset: THE RIVERSIDE SCHOOL - MANHATTAN, 300 WEST 61ST STREET, MANHATTAN, NY, 10023

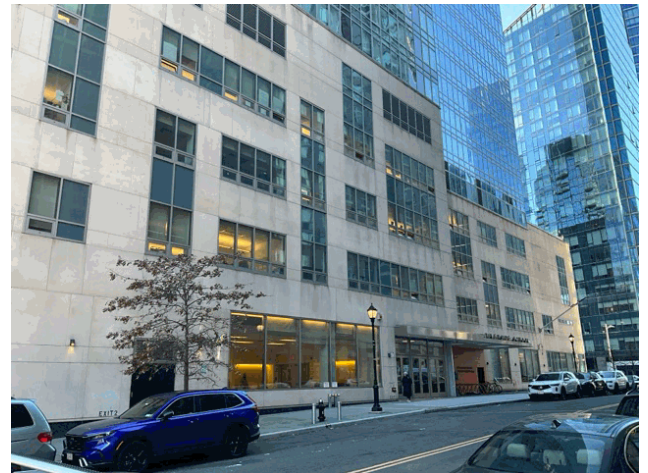
West 61st Street - South View

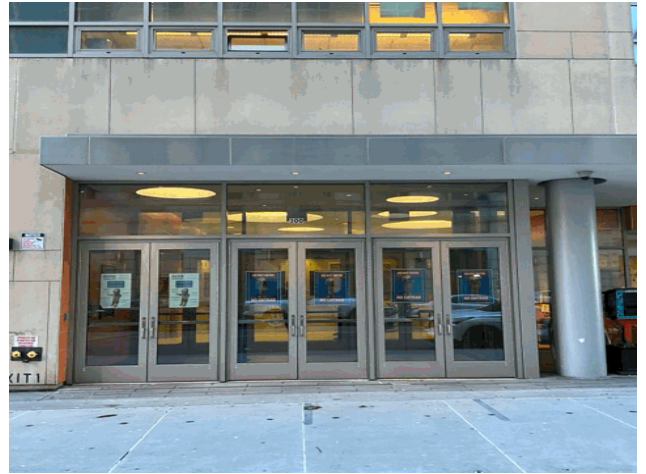
Facade A - West 61st Street
