**NYC Department of Education  
Building Condition Assessment Survey 2023-2024**

**Architectural Inspection**

**M343**

**Asset: THE PECK SLIP SCHOOL - MANHATTAN, 1 PECK SLIP, MANHATTAN, NY, 10038**

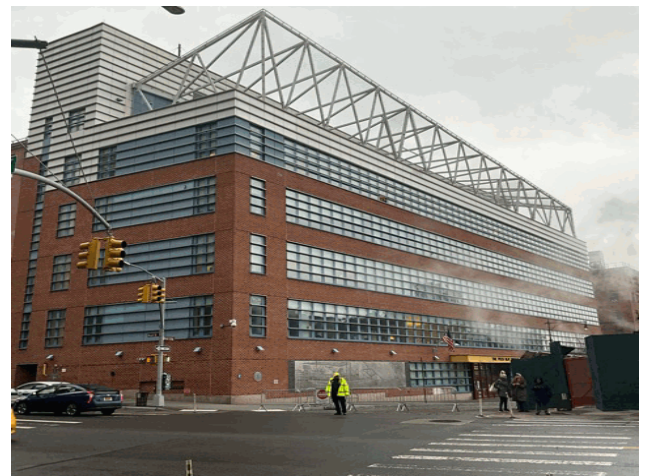
Corner of Peck Slip and Water Street - Southeast View

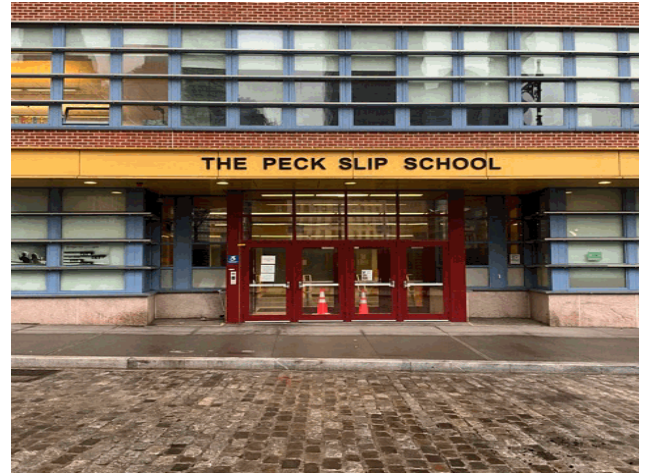
Facade A - Peck Slip

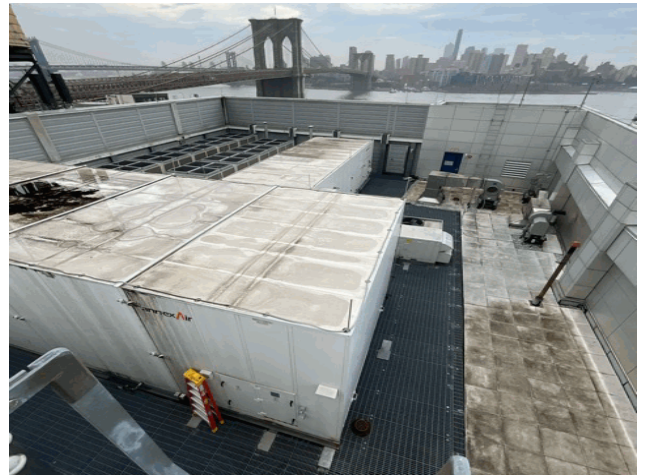
Roof 3 - Southeast View
