**NYC Department of Education
Building Condition Assessment Survey 2023-2024**

Architectural Inspection

M390

Asset: P.S. 183 GYM - MANHATTAN, 408 EAST 67 STREET, MANHATTAN, NY, 10065

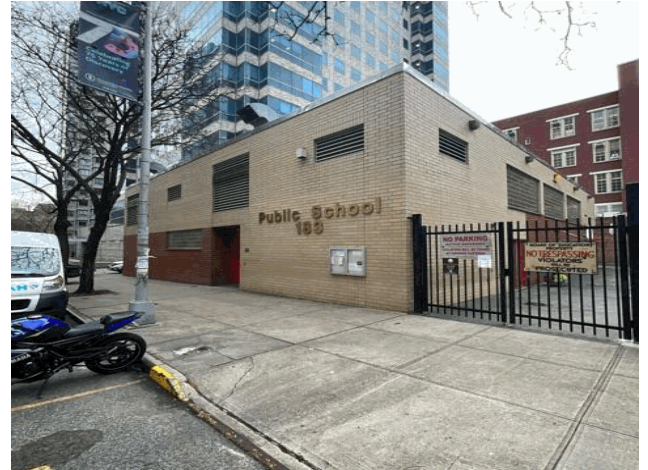
East 67th Street - South View

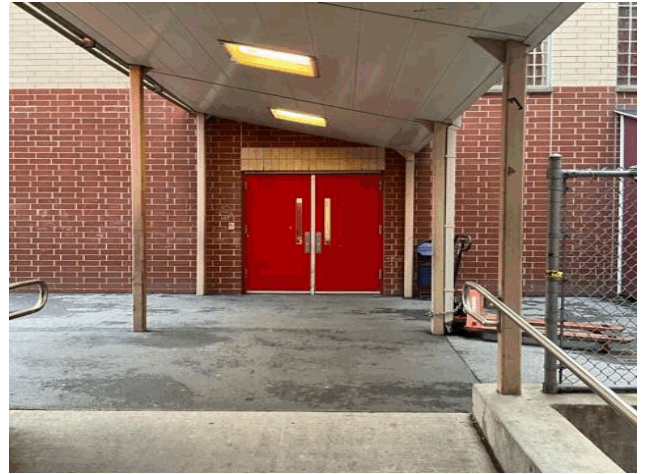
Facade C - Playground

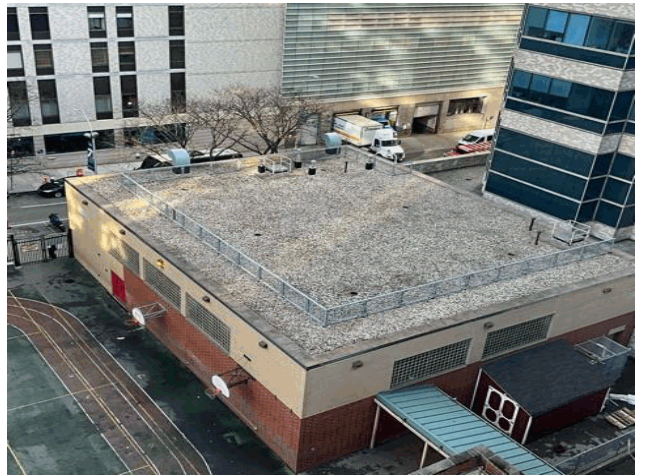
Roof 1 - Northeast View
