**NYC Department of Education  
Building Condition Assessment Survey 2023-2024**

**Architectural Inspection**

**M391**

**Asset:** PRE-K CENTER @ 2-26 WASHINGTON ST - MANHATTAN, 2-26 WASHINGTON STREET, MANHATTAN, NY, 10004

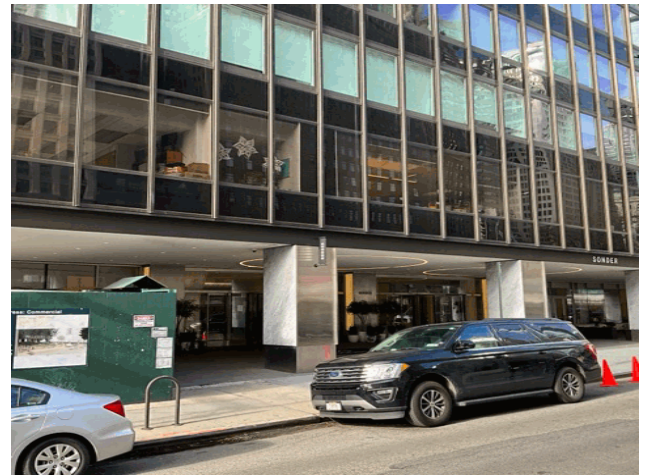
Washington Street - North View

Question	Answer
Was the Building Fully Accessible for Inspection?	Yes
Principal(s) Information	
Principal Name	Angela Rodriguez
Principal Organization	District 2 Pre-K Center
Meeting with Principal?	No
Principal Feedback	The Principal had the following comment: The main entrance door is deteriorated and needs to be replaced.
Custodian	David Digiacomio
Was the Custodian Present?	No
Fireman	Alexander Smith
Was the Fireman Present?	Yes
Building Square Footage	15,000
Comments on the Area (for Athletic Field, Playing Surfaces, Leased Spaces)	None
Comments on the Stories (Floors) plus Basements	22+B+M+PH
Comments on the Year Built	1972
Student Population	39
Staff Population	48
Comments on the Number of Classrooms	5
Weather	Fair
Facade Photo
