NYC Department of Education
Building Condition Assessment Survey 2023-2024

Architectural Inspection

M440

Asset: BAYARD RUSTIN EDUCATIONAL COMP-MANHATTAN, 351 WEST 18 STREET, MANHATTAN, NY, 10011

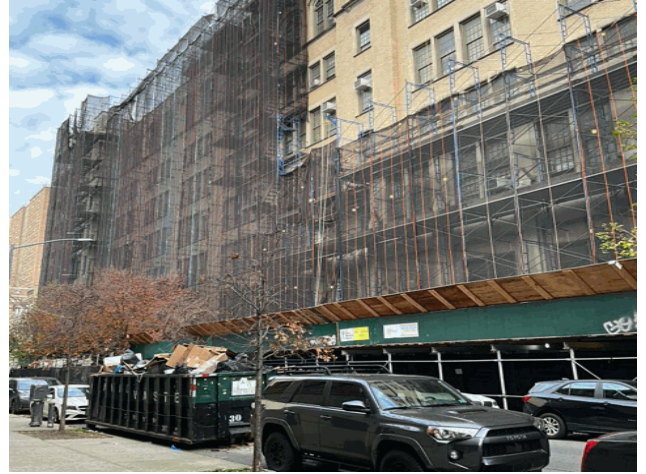
West 18th Street - North View

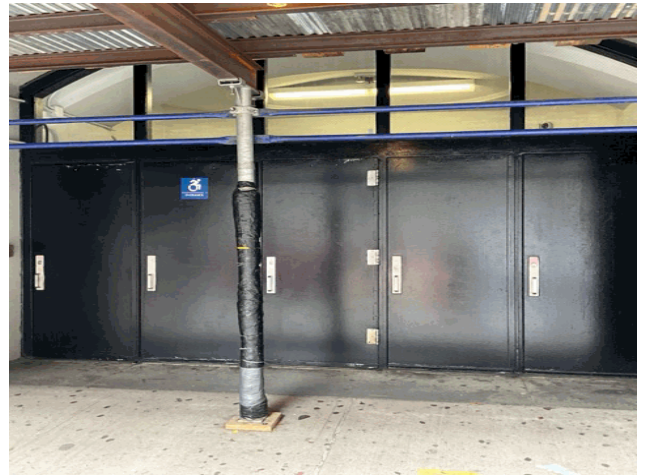
Facade A - West 18th Street

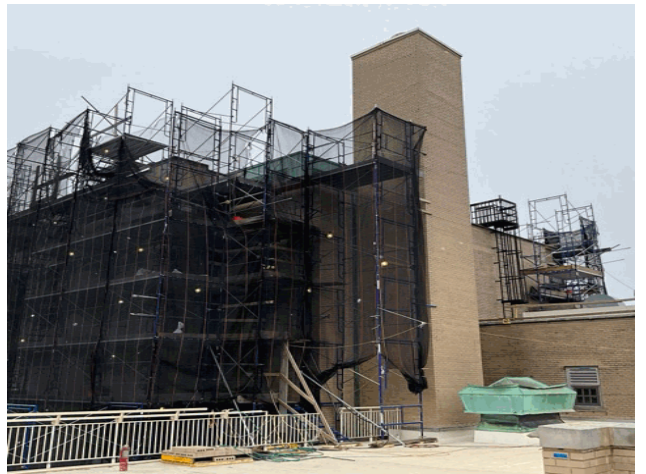
Roof 4 - West View
