**NYC Department of Education
Building Condition Assessment Survey 2023-2024**

Architectural Inspection

M465

Asset: G. WASHINGTON HS EDUC. CAMPUS - MANHATTAN, 549 AUDUBON AVENUE, MANHATTAN, NY, 10040

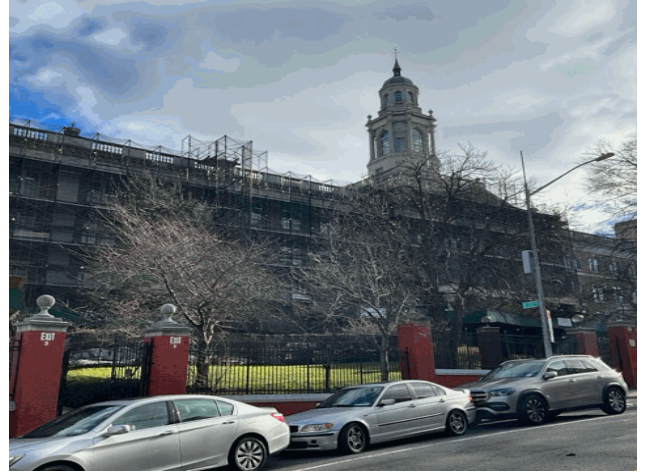
Facade Photo

Audubon Avenue - North View

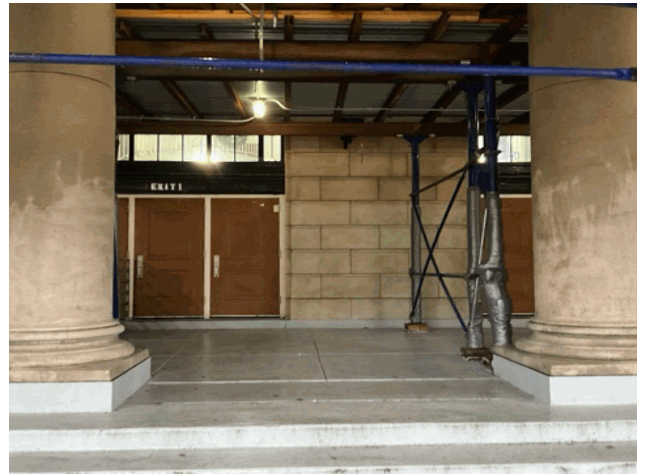
Main Entrance Photo

Facade A - Audubon Avenue

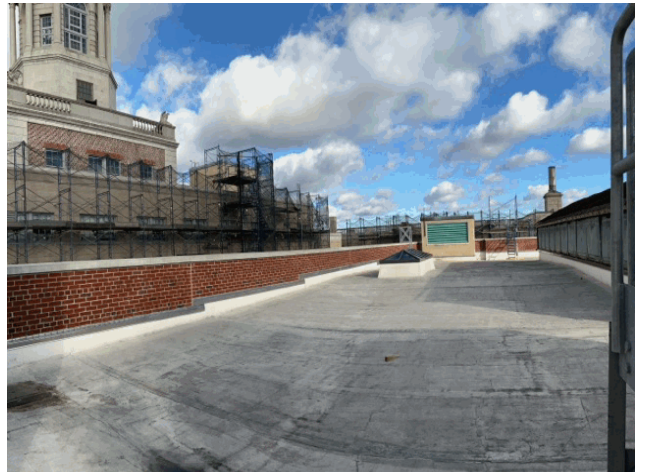
Roof Photo

Roof 5 - South View
