NYC Department of Education
Building Condition Assessment Survey 2023-2024

Architectural Inspection

M466

Asset: GEORGE WASHINGTON HS AF - MANHATTAN, 549 AUDUBON AVENUE, MANHATTAN, NY, 10040

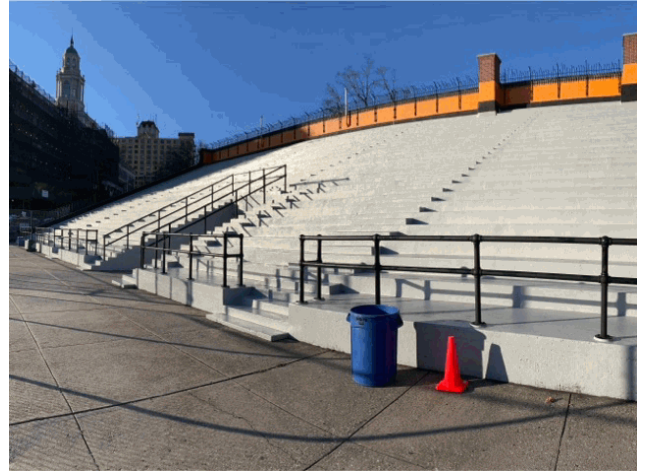
Facade Photo

Southwest View from field

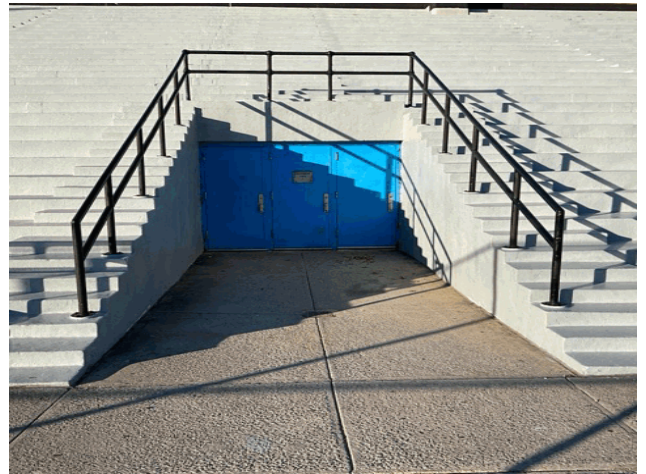
Main Entrance Photo

Facade A - East Elevation

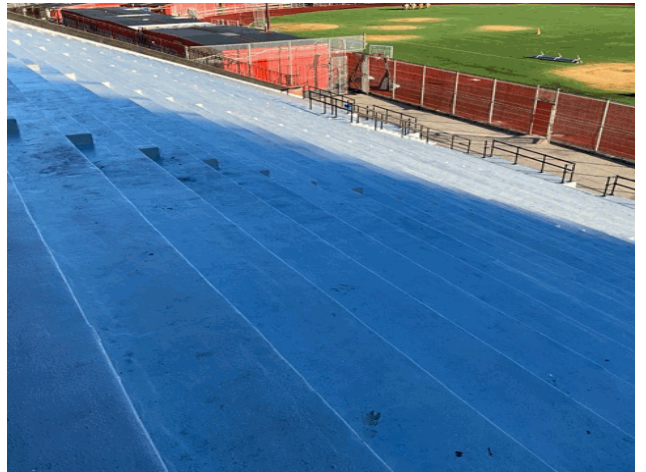
Roof Photo

Roof 1 - South View
