NYC Department of Education
Building Condition Assessment Survey 2023-2024

Architectural Inspection

M520

Asset: MURRY BERGTRAUM HS (ECF) - MANHATTAN, 411 PEARL STREET, MANHATTAN, NY, 10038

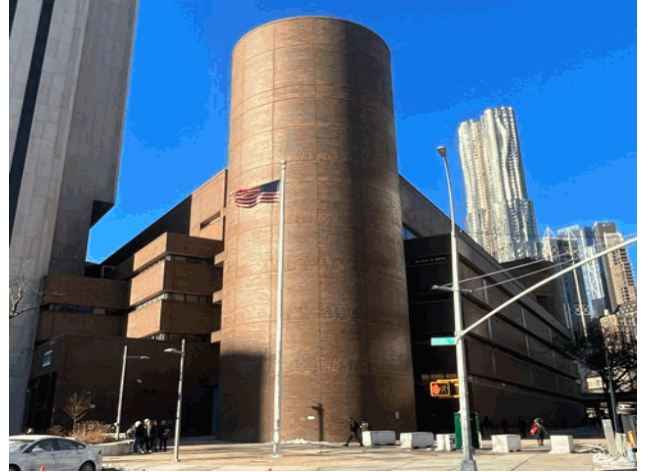
Corner of Pearl Street and Madison Street - West View

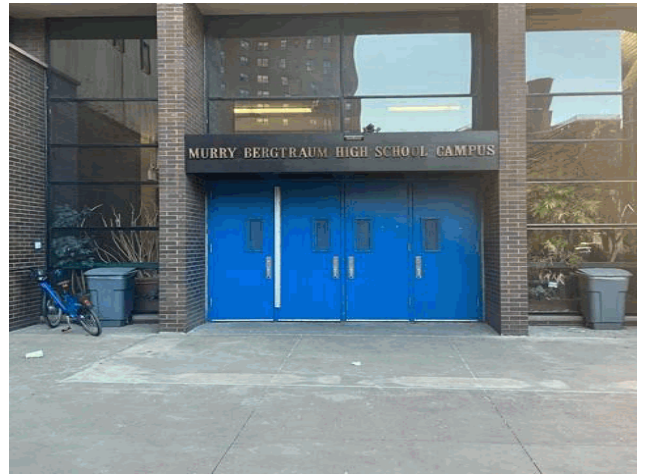
Facade A - Pearl Street

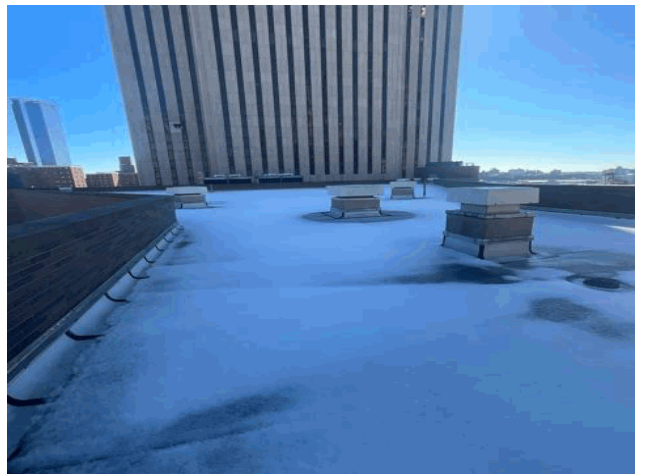
Roof 4 - Southeast View
