**NYC Department of Education
Building Condition Assessment Survey 2023-2024**

Architectural Inspection

M521

Asset: BERGTRAUM HS AF - MANHATTAN, 171 CHERRY STREET, MANHATTAN, NY, 10038

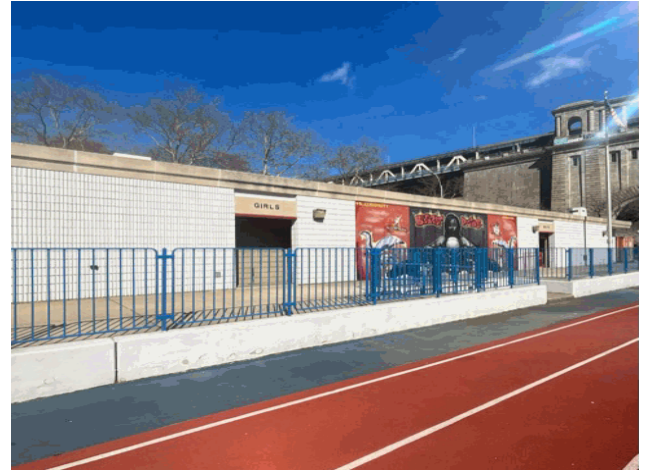
Running Track - Northeast View

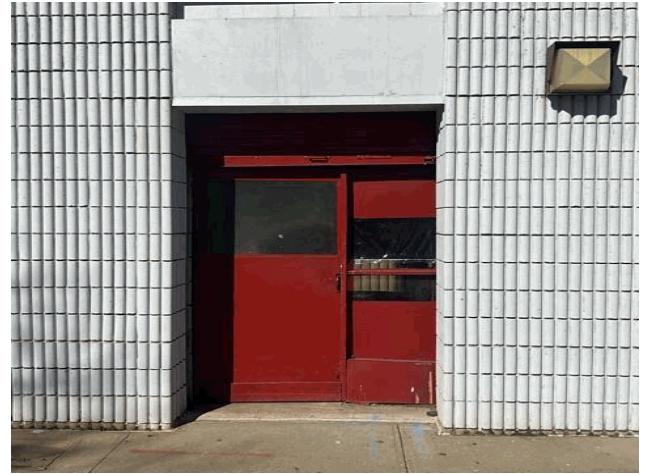
Facade A - North View

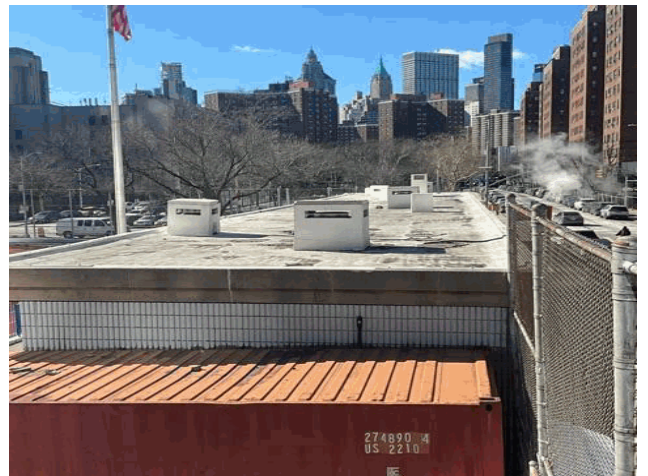
Roof 1 - West View
