**NYC Department of Education
Building Condition Assessment Survey 2023-2024**

Architectural Inspection

Asset: P.S. 751 (CAR.DEV/OLD 25) - MANHATTAN, 113 EAST 4 STREET, MANHATTAN, NY, 10003

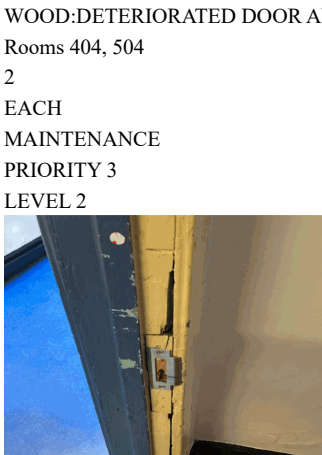
Corridor near Room 210A
Deficiency Photo 2	No photo recorded
Violations	No violations recorded
Deficiency	WOOD:DETERIORATED DOOR AND FRAME
Deficiency Location/Instance	Rooms 404, 504
Deficiency Quantity	2
Quantity Uom	EACH
Potential Action	MAINTENANCE
Urgency of Action	PRIORITY 3
Purpose of Action	LEVEL 2
Deficiency Photo 1

Room 504
Deficiency Photo 2	No photo recorded
Violations	No violations recorded
Deficiency	WOOD:DETERIORATED DOOR
Deficiency Location/Instance	Room 409
Deficiency Quantity	1
Quantity Uom	EACH
Potential Action	MAINTENANCE
Urgency of Action	PRIORITY 3
Purpose of Action	LEVEL 2
Deficiency Photo 1
