**NYC Department of Education  
Building Condition Assessment Survey 2023-2024**

**Architectural Inspection**

**M871**

**Asset: HARBOR HIGH BOATHOUSE - MANHATTAN, 134 CARDER ROAD, MANHATTAN, NY, 10004**

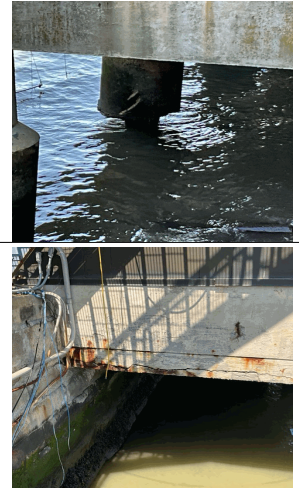
Deteriorated Concrete	Columns / Beams / Bearing Walls	Columns / Beams / Bearing Walls	Exterior columns under North facade facing water	Samuel Rodriguez	Custodian
Deteriorated Concrete	Columns / Beams / Bearing Walls	Columns / Beams / Bearing Walls	Southern Facade overhanging water	Samuel Rodriguez	Custodian
