**NYC Department of Education
Building Condition Assessment Survey 2023-2024**

Architectural Inspection

M884

Asset: P.S. 18 ANNEX (GYM) - MANHATTAN, 4130 9TH AVENUE, MANHATTAN, NY, 10034

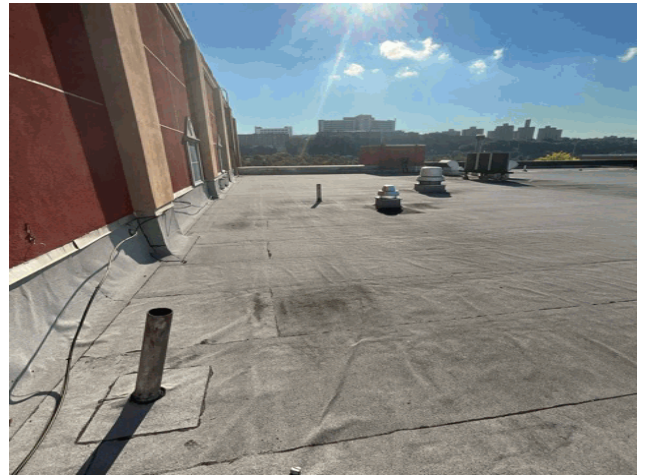
Roof 1 - Southeast View

Question	Response
EXTERIOR	
ROOF	
ROOFING	
ROOFING	
Instance Condition	4- Between Fair and Poor
Instance Quantity	6,000
Instance Quantity Uom	S.F.
Does the roof have major mechanical equipment sitting on Dunnage Steel less than 18" above the Roofing?	Yes
Does this Roof Instance have a Sustainable Roof System?	Yes
Sustainable Roof System Type	White Roof
Sustainable Roof System Location (Roof Number)	Roof 1
Do solar panels exist on these roofs?	No
Is/Are the roof(s) suitable for Solar Panel installation?	No
Installation Year	1990
Source of Installation Year	Inspector Estimate
Deficiency	MODIFIED BITUMEN:ROOFING:DELAMINATION
Deficiency Location/Instance	 
Deficiency Quantity	200
Quantity Uom	S.F.
Potential Action	REPLACE ROOFING WITHOUT MAJOR EQUIPMENT REMOVAL
Urgency of Action	PRIORITY 4
Purpose of Action	LEVEL 2
Deficiency Photo 1	 
Deficiency Photo 2	No photo recorded
Violations	No violations recorded
Deficiency	MODIFIED BITUMEN:ROOFING:BEYOND USEFUL LIFE

Deficiency Location/Instance	Modified Bitumen:Roof 1
Deficiency Quantity	6,000
Quantity Uom	S.F.
Potential Action	REPLACE ROOFING WITH MAJOR EQUIPMENT REMOVAL
Urgency of Action	PRIORITY 1
Purpose of Action	LEVEL 2
Deficiency Photo 2	No photo recorded
Violations	No violations recorded
ROOFING DRAINS	Does not exist
SPECIALTIES	Inspected
BULKHEAD/PENTHOUSE	Inspected
Condition	3- Fair
Deficiency	BULKHEAD/PENTHOUSE WALLS/EXTERIOR:CRACKS/SPALLING - MINOR
