**NYC Department of Education  
Building Condition Assessment Survey 2023-2024**

**Architectural Inspection**

**M920**

**Asset: SATELLITE ACADEMY - MANHATTAN, 120 WEST 30 STREET, MANHATTAN, NY, 10001**

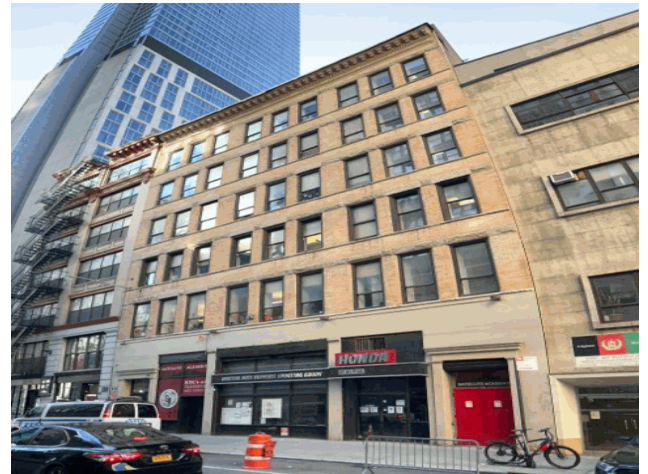
West 30th Street - South View

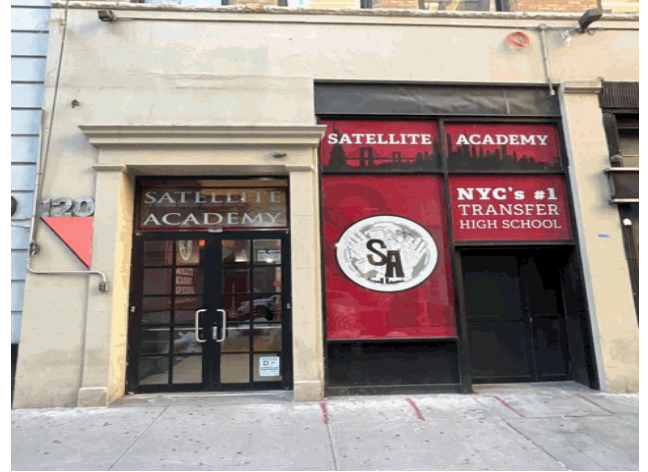
Facade A - West 30th Street

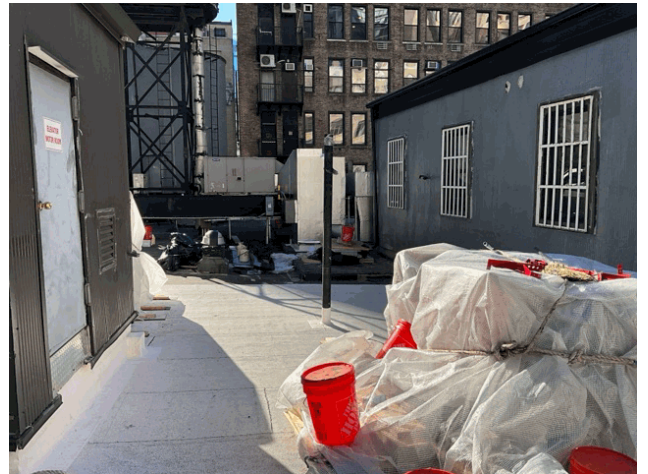
Roof 1 - South View
