**NYC Department of Education
Building Condition Assessment Survey 2023-2024**

Architectural Inspection

M965

Asset: I.S. 349 TRANSPORTABLE - MANHATTAN, 549 AUDUBON AVENUE, MANHATTAN, NY, 10040

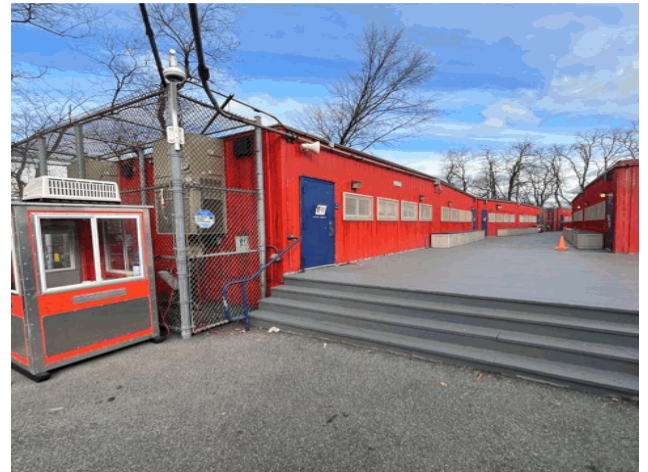
TCU T30 - North View

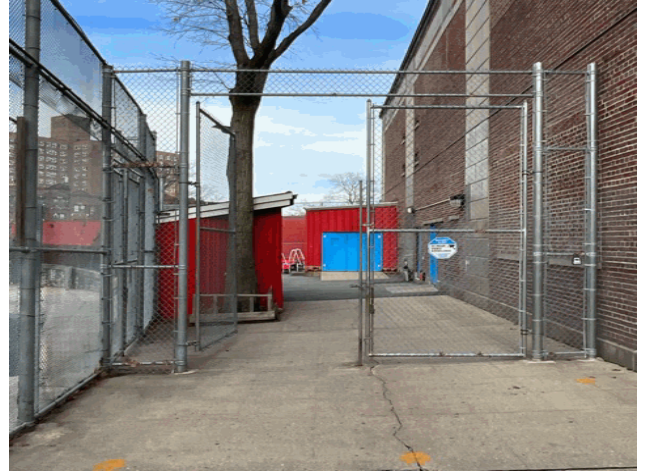
Main Entrance - Audubon Street

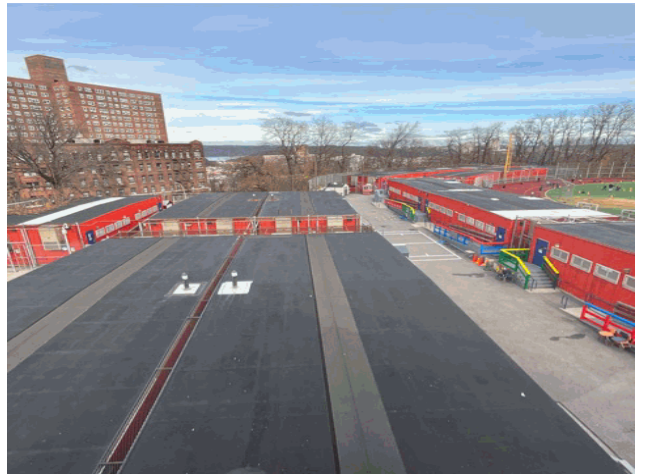
All Roofs - North View (taken from Grandstand)
