NYC Department of Education
Building Condition Assessment Survey 2023 - 2024

Architectural Inspection

Asset: P.S. 303 ADDITION - QUEENS, 108-55 69TH AVENUE, New York, 11375

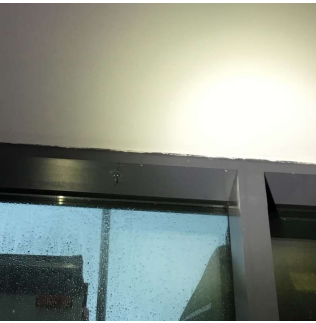
Does this roof instance have a Sustainable Roof System?	No
Do solar panels exist on these roofs?	No
Is/Are the roof(s) suitable for Solar Panel installation?	Yes
Installation Year	2019
Source of Installation	Custodial Staff
Deficiency	IRMA: ROOFING: MAJOR ACTIVE ROOF LEAKS IN INSTRUCTIONAL SPACE

Deficiency Quantity	100
Quantity Uom	S.F.
Potential Action	REPLACE ROOFING WITHOUT MAJOR EQUIPMENT REMOVAL
Urgency of Action	PRIORITY 5
Purpose of Action	LEVEL 2
Deficiency Photo1

Violations	Roof 9 - Breezeway No violations recorded.
ROOFING DRAINS	Inspected
Condition	1 - Good
Deficiency	No deficiencies recorded
Specialties	Inspected
BULKHEAD/PENTHOUSE	Inspected
Condition	2 - Between Good and Fair
Deficiency	No deficiencies recorded
CUPOLA/ SPIRES/ TOWERS	Does not Exist
DORMER	Does not Exist
DUNNAGE STEEL	Inspected
Condition	2 - Between Good and Fair
Deficiency	No deficiencies recorded
SKYLIGHT/ROOF VENT	Does not Exist
ROOF/GRAVITY TANK	Does not Exist
STAIRS/RAMPS: EXTERIOR	Inspected
BUILDING CHEEK/FLANK WALLS	Under Construction
RAILINGS	Under Construction
STAIRS/RAMPS	Under Construction
WINDOWS	Inspected

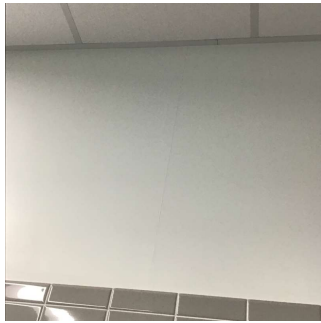
Question	Response
INTERIOR	
CAFETERIA	
Door(s)	
Deficiency	No deficiencies recorded
Fixed Equipment	
Instance on Basement	Does not Exist
Floor Finish	
Instance on Basement	Inspected
Condition	1 - Good
Deficiency	No deficiencies recorded
Sliding-folding Partition	
Instance on Basement	Does not Exist
Stage	
Instance on Basement	Does not Exist
Walls	
Instance on Basement	Inspected
Condition	2 - Between Good and Fair
Deficiency	GYP SUM BOARD: DETERIORATED
Deficiency Location/Instance	Near the wall clock
Deficiency Quantity	10
Quantity Uom	S.F.
Potential Action	REPLACE
Urgency of Action	PRIORITY 3
Purpose of Action	LEVEL 2
Deficiency Photo1

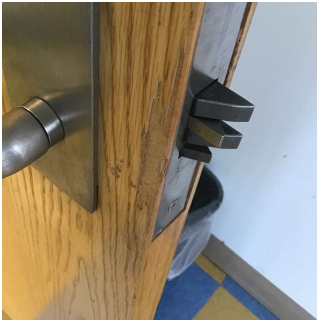
Question	Response
INTERIOR	
CLASSROOMS/CORRIDORS/ADMIN SPACES	
Ceiling	
Deficiency Photo1	 
Violations	Corridor near Room 305 No violations recorded.
Door(s)	Inspected
Condition	3 - Fair
Deficiency	WOOD: DETERIORATED DOOR
Deficiency Location/Instance	Rooms 302, 315
Deficiency Quantity	2
Quantity Uom	EACH
Potential Action	MAINTENANCE
Urgency of Action	PRIORITY 3
Purpose of Action	LEVEL 2
Deficiency Photo1

Violations	Room 302 No violations recorded.
Floor Finish	Inspected
Condition	2 - Between Good and Fair
Deficiency	VINYL TILES: BROKEN/DETERIORATED/MISSING TILES
Deficiency Location/Instance	Corridor near Room 305
Deficiency Quantity	10
Quantity Uom	S.F.
Potential Action	REPLACE
Urgency of Action	PRIORITY 3
Purpose of Action	LEVEL 2

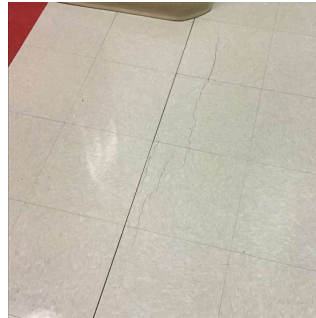
VINYL TILES: DETERIORATED SUBSTRATE

Corridor near Stair B/1

REPLACE

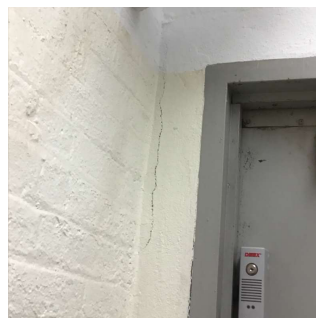
PLASTER: CRACKS/SPALLING

Exit Vestibule near Room 105

REPLACE

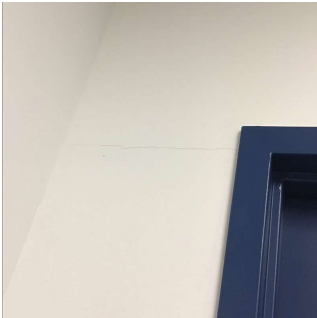
Condition	1 - Good
Deficiency	No deficiencies recorded
Walls	
Instance on Basement	Inspected
Condition	2 - Between Good and Fair
Deficiency	GYPSUM BOARD: DETERIORATED
Deficiency Location/Instance	Room

Question	Response
INTERIOR	
KITCHEN	
Walls	
Deficiency Quantity	10
Quantity Uom	S.F.
Potential Action	REPLACE
Urgency of Action	PRIORITY 3
Purpose of Action	LEVEL 2
Deficiency Photo1

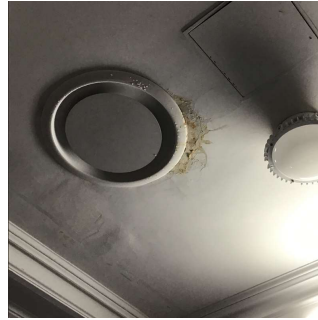
Near Right Stage

Deficiency	PLASTER: CRACKS/SPALLING
Deficiency Location/Instance	Near Right Stage, on Stage

Deficiency Quantity	20
Quantity Uom	S.F.
Potential Action	REPLACE
Urgency of Action	PRIORITY 3
Purpose of Action	LEVEL 2
Deficiency Photo1

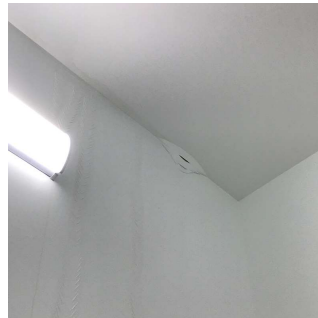
Deficiency	GYPSUM BOARD: DAMAGED/DETERIORATED
Deficiency Location/Instance	Next to Left Stage/Ramp
Deficiency Quantity	10
Quantity Uom	S.F.
Potential Action	REPLACE
Urgency of Action	PRIORITY 3
Purpose of Action	LEVEL 2
Deficiency Photo1

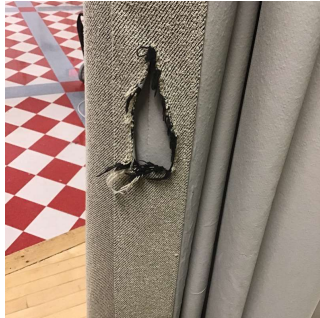
Main Curtain
Violations	No violations recorded.
Walls	
Instance on 2nd Floor (2,500 SF)	Inspected

Deficiency	WORN/DETERIORATED
Deficiency Location/Instance	Main Curtain
Deficiency Quantity	100
Quantity Uom	S.F.
Potential Action	REPLACE
Urgency of Action	PRIORITY 3
Purpose of Action	LEVEL 2
Deficiency Photo1

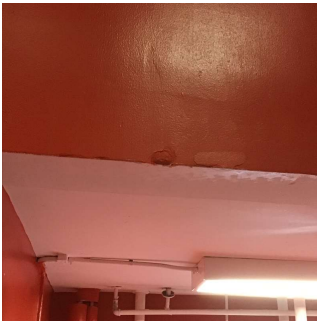
Question	Response
INTERIOR	
MULTI-PURPOSE ROOM	
Walls	
Condition	2 - Between Good and Fair
Deficiency	GYPSUM BOARD: DETERIORATED
Deficiency Location/Instance	Next to Left Stage/Ramp
Deficiency Quantity	40
Quantity Uom	S.F.
Potential Action	REPLACE
Urgency of Action	PRIORITY 3
Purpose of Action	LEVEL 2
Deficiency Photo1	 
Violations	Next to Left Stage/Ramp No violations recorded.
Window Curtains/Shades/Blinds	
Instance on Basement	Inspected
Condition	1 - Good
Deficiency	No deficiencies recorded
Instance on 2nd Floor (2,500 SF)	Does not Exist
SCIENCE DEMO ROOM	Does not Exist
SCIENCE LAB	Inspected
Instance on Room 180	Inspected
Alternative use	No
Fixed Equipment	
Instance on Room 180	Inspected
Condition	1 - Good
Deficiency	No deficiencies recorded
SCIENCE PREP ROOM	Does not Exist
SHOWER ROOM	Does not Exist
STAIRS/RAMPS: INTERIOR	Inspected
Do Letter Stair Signs Exist?	Yes
Ceiling	
Condition	2 - Between Good and Fair
Deficiency	PLASTER: CRACKS/SPALLING

Deficiency Location/Instance	Stair B/3
Deficiency Quantity	10
Quantity Uom	S.F.
Potential Action	REPLACE
Urgency of Action	PRIORITY 3
Purpose of Action	LEVEL 2

Violations	Stair B/3 No violations recorded.
Door(s)	Inspected
Condition	2 - Between Good and Fair
Deficiency	No deficiencies recorded
Partition	Does not Exist
Railings	Inspected
Condition	2 - Between Good and Fair
Deficiency	No deficiencies recorded
Stairs and Landings	Inspected
Condition	2 - Between Good and Fair
Deficiency	STONE: BROKEN/MISSING
Deficiency Location/Instance	Corridor stair by Room 207/Exit 3
Deficiency Quantity	40
Quantity Uom	S.F.
Potential Action	REPLACE
Urgency of Action	PRIORITY 3
Purpose of Action	LEVEL 2
Deficiency Photo1

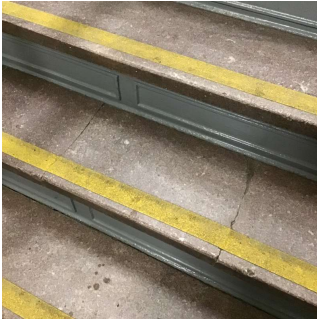
Violations	Corridor stair by Room 207/Exit 3 No violations recorded.
Deficiency	CONCRETE: CRACKS/SPALLING - MAJOR
Deficiency Location/Instance	Stairs B/1,2, C/1, D/2, G/1, and others
Deficiency Quantity	80
Quantity Uom	S.F.
Potential Action	REPLACE
Urgency of Action	PRIORITY 3
Purpose of Action	LEVEL 2

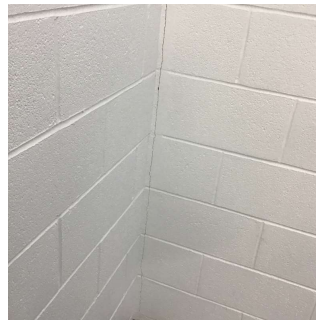
MASONRY: CRACKS/SPALLING

Stair G/2

REPLACE

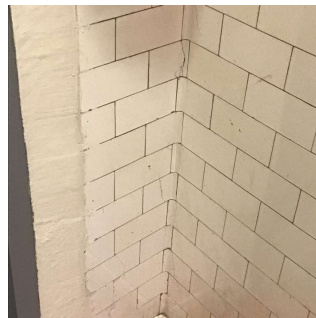
CERAMIC TILE: BROKEN/ MISSING

Stair A/1 Vestibule

REPLACE

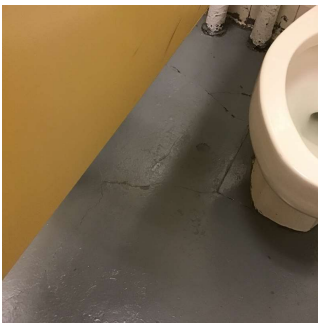
Question	Response
INTERIOR	
STAIRS/RAMPS: INTERIOR	Inspected
Walls	Inspected
Violations	Stair A/1 Vestibule No violations recorded.
TOILET ROOMS - STAFF	Inspected
Ceiling	Inspected
Condition	2 - Between Good and Fair
Deficiency	No deficiencies recorded
Door(s)	Inspected
Condition	5 - Poor
Deficiency	WOOD: DETERIORATED DOOR
Deficiency Location/Instance	Men inside Stair B/3
Deficiency Quantity	1
Quantity Uom	EACH
Potential Action	MAINTENANCE
Urgency of Action	PRIORITY 3
Purpose of Action	LEVEL 2
Deficiency Photo1	No photo recorded
Violations	No violations recorded.
Deficiency	METAL CLAD WOOD: DETERIORATED DOOR
Deficiency Location/Instance	Women inside Stair A/3
Deficiency Quantity	1
Quantity Uom	EACH
Potential Action	MAINTENANCE
Urgency of Action	PRIORITY 3
Purpose of Action	LEVEL 2
Deficiency Photo1	 
Violations	Women inside Stair A/3 No violations recorded.
Floor Finish	Inspected
Condition	2 - Between Good and Fair
Deficiency	CONCRETE: CRACKS

Deficiency Location/Instance	Women inside Stair A/3
Deficiency Quantity	10
Quantity Uom	S.F.
Potential Action	REPLACE
Urgency of Action	PRIORITY 3
Purpose of Action	LEVEL 2

Violations	Women inside Stair A/3 No violations recorded.
Stalls	Inspected
Condition	2 - Between Good and Fair
Deficiency	No deficiencies recorded
Walls	Inspected
Condition	2 - Between Good and Fair
Deficiency	CERAMIC TILE: BROKEN/ MISSING
Deficiency Location/Instance	Women inside Stair A/3, Men inside Stair B/3
Deficiency Quantity	20
Quantity Uom	S.F.
Potential Action	REPLACE
Urgency of Action	PRIORITY 3
Purpose of Action	LEVEL 2
Deficiency Photo1

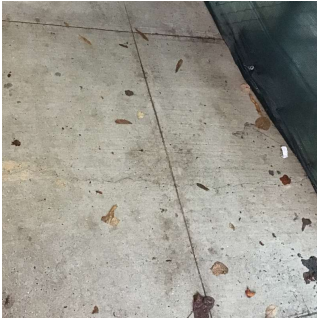
Question	Response
SITE	
Drainage System for Soil	Inspected
Culverts - Soil Covering	Does not Exist
DRINKING FOUNTAINS	Does not Exist
FENCES	Inspected
Condition	2 - Between Good and Fair
Deficiency	No deficiencies recorded
IRRIGATION SYSTEM	Does not Exist
PAVING	Inspected
Student Non-Use	Inspected
Gravel Exists?	No
Asphalt	Inspected
Condition	1 - Good
Deficiency	No deficiencies recorded
Concrete	Does not Exist
Pavers	Does not Exist
Student Use	Inspected
Gravel Exists?	No
Asphalt	Inaccessible
Concrete	Inaccessible
Pavers	Does not Exist
Site Sidewalks & Walkways	Inspected
Asphalt	Does not Exist
Concrete	Inspected
Condition	3 - Fair
Deficiency	DAMAGED/DETERIORATED/MISSING SECTIONS
Deficiency Location/Instance	69th Avenue
Deficiency Quantity	50
Quantity Uom	S.F.
Potential Action	REPLACE
Urgency of Action	PRIORITY 3
Purpose of Action	LEVEL 2
Deficiency Photo1

Violations	69th Avenue No violations recorded.
Pavers	Does not Exist

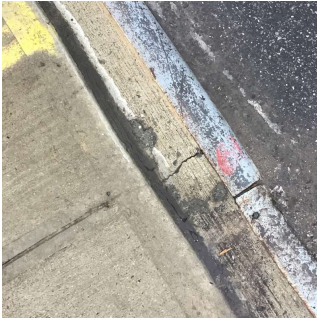
DOT Sidewalk	Inspected
Asphalt	Does not Exist
Concrete	Inspected
Condition	2 - Between Good and Fair
Deficiency	DAMAGED CURBS

Question	Response
SITE	
PAVING	
DOT Sidewalk	
Concrete	
Deficiency Location/Instance	69th Avenue
Deficiency Quantity	10
Quantity Uom	L.F.
Potential Action	REPLACE
Urgency of Action	PRIORITY 3
Purpose of Action	LEVEL 2
Deficiency Photo1

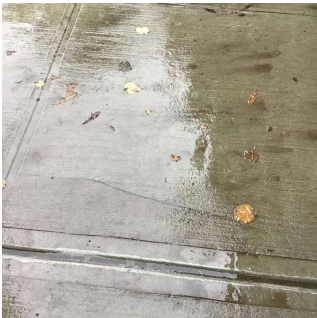
Violations	69th Avenue No violations recorded.
Deficiency	DAMAGED/DETERIORATED/MISSING SECTIONS
Deficiency Location/Instance	69th Avenue
Deficiency Quantity	25
Quantity Uom	S.F.
Potential Action	REPLACE
Urgency of Action	PRIORITY 3
Purpose of Action	LEVEL 2
Deficiency Photo1
