**NYC Department of Education**  
**Building Condition Assessment Survey 2023 - 2024**

Architectural Inspection

Q007

**Asset:** P.S. 7 - QUEENS, 80-55 CORNISH AVE, New York, 11373

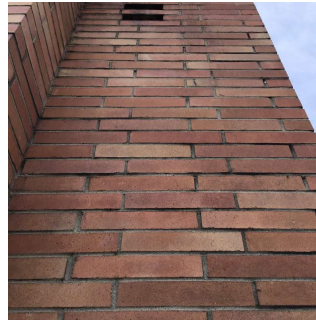
CHI

**BRICK: DETERIORATED JOINTS**

50  
 S.F.  
 REPOINT  
 PRIORITY 3  
 LEVEL 2

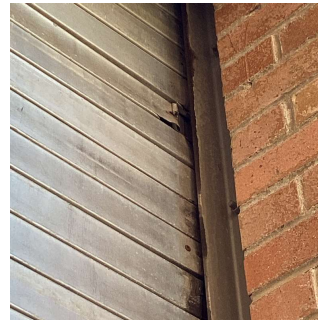
Facade F

Violations	Roof 3 No violations recorded.
<b>CORNICE</b>	Does not Exist
<b>DOORS</b>	Inspected
<b>DOORS AND FRAMES</b>	Inspected
Condition	4 - Between Fair and Poor
Deficiency	ROLL-UP DOOR: DETERIORATED DOOR - MAJOR DETERIORATION

300  
S.F.  
REPLACE  
PRIORITY 4  
LEVEL 2

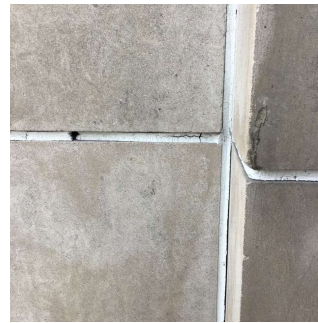
Facade A

STONE: DETERIORATED JOINTS

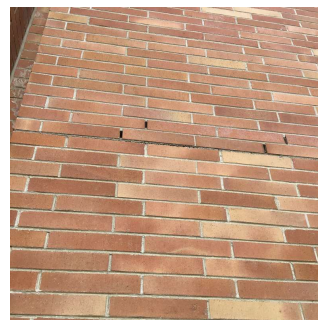
Facade F

**BRICK: DETERIORATED JOINTS**

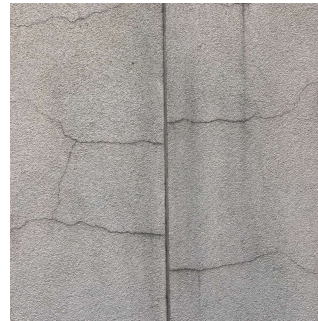
Facade F

**STUCCO CEMENT SURFACE: CRACKS, SPALLING**

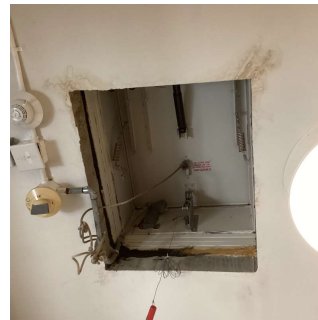
Stair D/2

**WATER INFILTRATION**

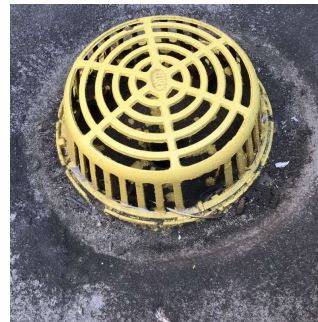
Roof 4

DETERIORATED

4  
 EACH  
 REPLACE  
 PRIORITY 4  
 LEVEL 2

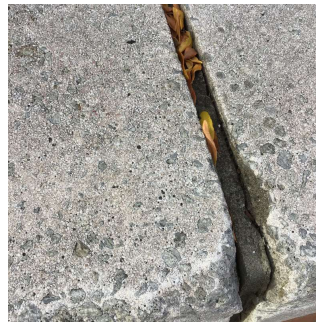
Facade E

STONE: DETERIORATED COPING STONE

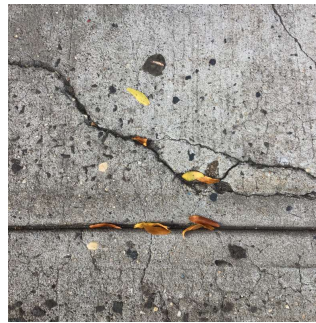
Facade E

**CONCRETE: CRACKS/SPALLING - MAJOR**

20  
 S.F.  
 REPLACE  
 PRIORITY 4  
 LEVEL 2

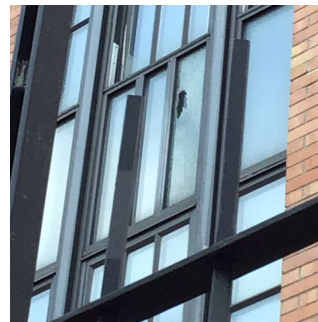
Facade H

Instance on Aluminum - Other: Facades A, B, C, E, G, H	Inspected
Instance Condition	4 - Between Fair and Poor
Instance Quantity	2,000
Instance Quantity Uom	S.F.
Are these windows insulated	Yes
Installation Year	1994
Source of Installation	Custodial Staff
Deficiency	ALUMINUM - OTHER: BROKEN PANE

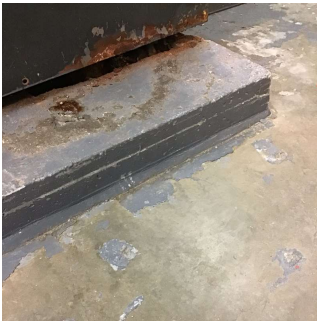
Violations	Basement - Electrical Room No violations recorded.
Deficiency	CONCRETE: CRACKS/SPALLED/REINFORCEMENT EXPOSED
Deficiency Location/Instance	Mechanical Room Unit 8, Basement - Storage Room, Boiler Room, Oil Tank Room
Deficiency Quantity	70
Quantity Uom	S.F.
Potential Action	REPAIR
Urgency of Action	PRIORITY 4
Purpose of Action	LEVEL 5
Deficiency Photo1

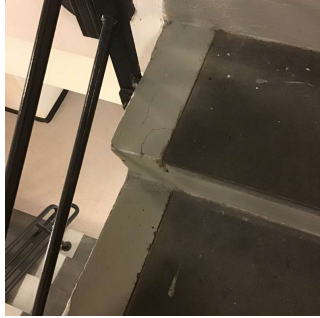
Stair C/3
Violations	No violations recorded.
Deficiency	STONE: BROKEN/MISSING
Deficiency Location/Instance	Stairs A/2, B/1
Deficiency Quantity	30
Quantity Uom	S.F.
Potential Action	REPLACE
Urgency of Action	PRIORITY 3
Purpose of Action	LEVEL 2
Deficiency Photo1	 
	Stair B/1
Violations	No violations recorded.
Deficiency	VINYL TILES: BROKEN/DETERIORATED/MISSING TILES
Deficiency Location/Instance	Stairs C/2, 3, G/1, E/1, 2, and others.
Deficiency Quantity	50
Quantity Uom	S.F.
Potential Action	REPLACE
Urgency of Action	PRIORITY 3
Purpose of Action	LEVEL 2

Question	Response
<b>INTERIOR</b>	
<b>STAIRS/RAMPS: INTERIOR</b>	
<b>Stairs and Landings</b>	
Potential Action	REPLACE
Urgency of Action	PRIORITY 3
Purpose of Action	LEVEL 2
Deficiency Photo1

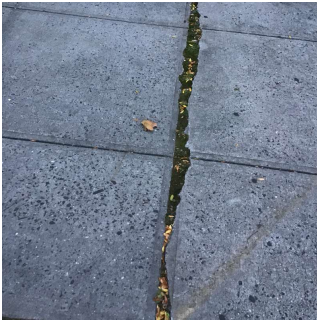
Cornish Avenue
Violations	No violations recorded.
<b>Pavers</b>	Inspected
Condition	2 - Between Good and Fair
Deficiency	No deficiencies recorded
<b>DOT Sidewalk</b>	Inspected
<b>Asphalt</b>	Does not Exist
<b>Concrete</b>	Inspected
Condition	4 - Between Fair and Poor
Deficiency	DAMAGED/DETERIORATED/MISSING SECTIONS
Deficiency Location/Instance	Barnwell Avenue, Cornish Avenue, Poyer Street

Near Main Entrance
Violations	No violations recorded.
<b>Site Sidewalks &amp; Walkways</b>	Inspected
<b>Asphalt</b>	Does not Exist
<b>Concrete</b>	Inspected
Condition	3 - Fair
Deficiency	DAMAGED/DETERIORATED/MISSING SECTIONS
Deficiency Location/Instance	Near Emergency Exit Cornish Avenue
Deficiency Quantity	100
Quantity Uom	S.F.
Potential Action	REPLACE
Urgency of Action	PRIORITY 3
Purpose of Action	LEVEL 2
Deficiency Photo1

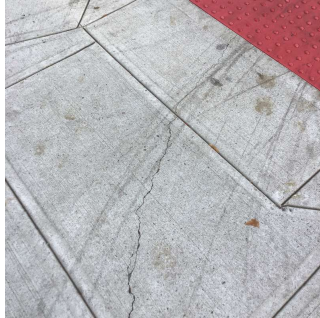
Poyer Street
Violations	No violations recorded.
Deficiency	DAMAGED CURBS
Deficiency Location/Instance	Barnwell Avenue, Cornish Avenue, Poyer Street
Deficiency Quantity	180
Quantity Uom	L.F.
Potential Action	REPLACE
Urgency of Action	PRIORITY 3
Purpose of Action	LEVEL 2
Deficiency Photo1

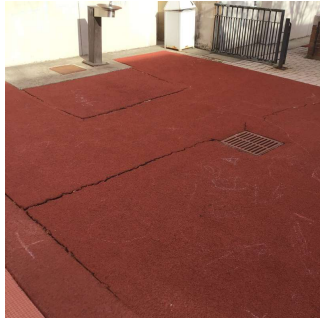
Violations	Near Drinking Fountain No violations recorded.
Instance on Exit 9	Inspected
Condition	3 - Fair
Deficiency	DETERIORATED/MISSING
Deficiency Location/Instance	Near Exit 9, Center, Borders.
Deficiency Quantity	50
Quantity Uom	S.F.
Potential Action	REPLACE
Urgency of Action	PRIORITY 3
Purpose of Action	LEVEL 2
Deficiency Photo1

Question	Response
<b>SITE</b>	
<b>PLAYGROUNDS</b>	
<b>Safety Surfacing</b>	
Deficiency	DETERIORATED/MISSING
Deficiency Location/Instance	Near Drinking Fountain, Near Entrance Gate
Deficiency Quantity	120
Quantity Uom	S.F.
Potential Action	REPLACE
Urgency of Action	PRIORITY 3
Purpose of Action	LEVEL 2
Deficiency Photo1

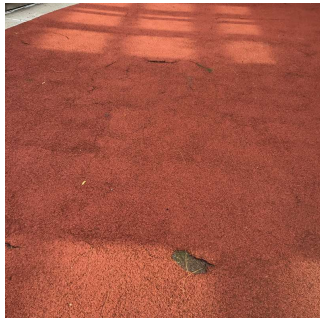
Violations	Near Exit 10 No violations recorded.
Instance on Exit 1	Inspected
Condition	3 - Fair
Deficiency	DETERIORATED/MISSING
Deficiency Location/Instance	Near Center, Exit 1, Borders.
Deficiency Quantity	50
Quantity Uom	S.F.
Potential Action	REPLACE
Urgency of Action	PRIORITY 3

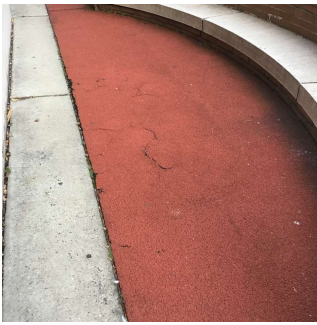
Violations	Near Center No violations recorded.
<b>Unpaved Area</b>	
Instance on Exit 9	Does not Exist
Instance on Schoolyard-Main Playground	Does not Exist
Instance on Exit 1	Does not Exist
<b>PLAYING SURFACE</b>	Does not Exist
<b>RETAINING WALLS</b>	Does not Exist
<b>SEATING</b>	Inspected
<b>Benches</b>	Inspected
<b>Concrete</b>	Inspected
Condition	3 - Fair
Deficiency	CRACKS/SPALLING - MAJOR
Deficiency Location/Instance	Schoolyard
Deficiency Quantity	1
Quantity Uom	EACH
Potential Action	REPLACE
Urgency of Action	PRIORITY 3
Purpose of Action	LEVEL 2
Deficiency Photo1
