**NYC Department of Education**  
**Building Condition Assessment Survey 2023 - 2024**

Architectural Inspection

**Q008**

**Asset: J.H.S. 8 - QUEENS, 108-35 167 STREET, New York, 11433**

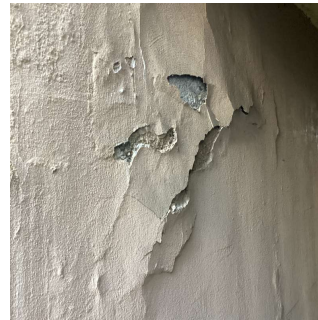
Facade A - AW1

Question	Response
<b>Architectural</b>	
<b>EXTERIOR</b>	Inspected
<b>AREAWAY</b>	Inspected
Instance on AW1-AW4	Inspected
Instance Condition	3 - Fair
Instance Quantity	4
Instance Quantity Uom	EACH
Deficiency	AREAWAY WALLS: CRACKS AND SPALLING

REPAIR

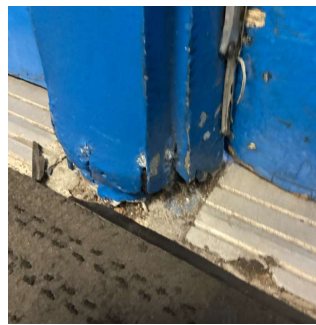
Facade A

Question	Response
<b>EXTERIOR</b>	
<b>CHIMNEY</b>	
Deficiency Photo1	 
Violations	Roof 1 No violations recorded.
<b>COPING</b>	Inspected
Condition	2 - Between Good and Fair
Deficiency	No deficiencies recorded
<b>CORNICE</b>	Does not Exist
<b>DOORS</b>	Inspected
<b>DOORS AND FRAMES</b>	Inspected
Condition	5 - Poor
Deficiency	METAL: DETERIORATED DOOR AND FRAME - MAJOR DETERIORATION
Roof Plan reference	 
Deficiency Quantity	2
Quantity Uom	EACH
Potential Action	REPLACE
Urgency of Action	PRIORITY 4
Purpose of Action	LEVEL 2
Deficiency Photo1	 
Violations	Facade H No violations recorded.
Deficiency	METAL CLAD: DETERIORATED DOOR AND FRAME - MAJOR DETERIORATION

10  
 EACH  
 REPLACE  
 PRIORITY 4  
 LEVEL 2

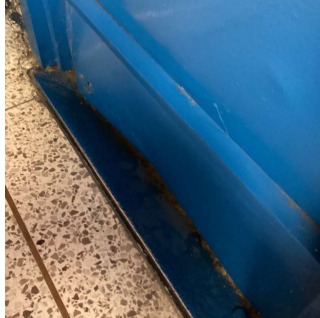
METAL: DENTED, MAJOR RUSTING

Violations	Facade A No violations recorded.
<b>EXTERIOR WALLS</b>	
Material Type(s)	Inspected Masonry
Replacement Quantity	40,000
Replacement Uom	S.F.
Instance on All Facades	Inspected
Instance Condition	3 - Fair
Instance Quantity	40,000
Instance Quantity Uom	S.F.
Deficiency	STONE: DETERIORATED JOINTS
Roof Plan reference

20  
 S.F.  
 REPLACE

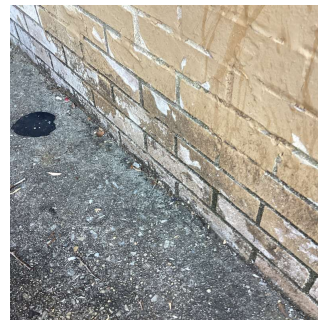
Facade J

BRICK: DETERIORATED JOINTS

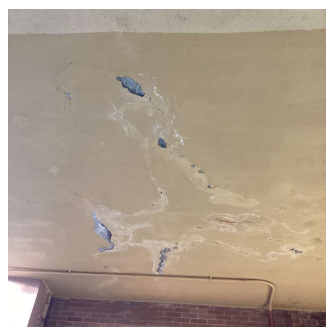
Question	Response
<b>EXTERIOR</b>	
<b>EXTERIOR WALLS</b>	Inspected
	Facade K
Violations	No violations recorded.
<b>EXTERIOR SOFFITS</b>	
Condition	Inspected
Deficiency	3 - Fair
Roof Plan reference	CONCRETE: DETERIORATED
Elevation

Violations	Facade K No violations recorded.
<b>LOADING DOCK</b>	Does not Exist
<b>LOUVER</b>	
Condition	Inspected
Deficiency	2 - Between Good and Fair
Deficiency	No deficiencies recorded
<b>PARAPETS</b>	
Material Type(s)	Inspected Masonry, Metal
Replacement Quantity	7,000
Replacement Uom	C.F.

Deficiency Quantity	30
Quantity Uom	S.F.
Potential Action	REPLACE
Urgency of Action	PRIORITY 4
Purpose of Action	LEVEL 2
Deficiency Photo1

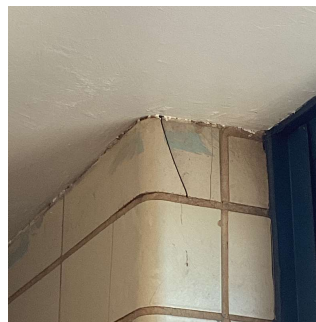
Roof 1 - Bulkhead 2

BULKHEAD/PENTHOUSE WALLS/INTERIOR: SALT GLAZED BRICK CRACKS/SPALLING

10  
S.F.  
REPLACE  
PRIORITY 3  
LEVEL 2

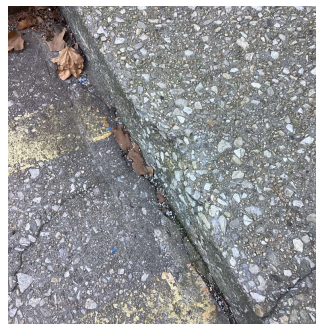
Facade D
Violations	No violations recorded.
Deficiency	CONCRETE: WORN-OUT TREAD/RISER/NOSING

10  
S.F.  
REPLACE  
PRIORITY 4  
LEVEL 2

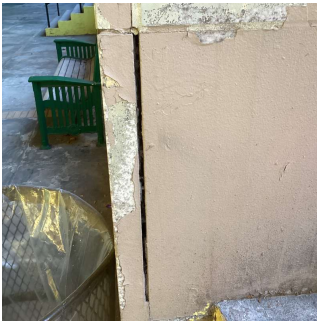
STEEL COLUMNS/BEAMS: DETERIORATED MASONRY  
FIREPROOFING

Violations	<p>Facade K</p> <p>No violations recorded.</p>
<b>FLOOR STRUCTURE</b>	
Condition	<p>Inspected</p> <p>5 - Poor</p>
Deficiency	<p>CONCRETE SLAB ON GRADE: WATER INFILTRATION IN NON-INSTRUCTIONAL SPACE</p>
Deficiency Location/Instance	<p>Basement - Boiler Room Pit</p>
Deficiency Quantity	<p>500</p>
Quantity Uom	<p>S.F.</p>
Potential Action	<p>INSTALL WATERPROOFING</p>
Urgency of Action	<p>PRIORITY 5</p>
Purpose of Action	<p>LEVEL 5</p>
Deficiency Photo1

REPLACE

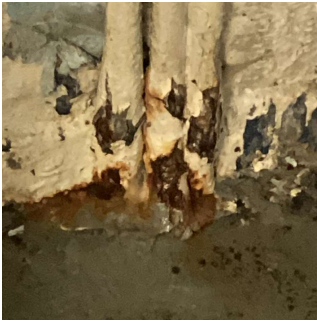
Violations	<p>Basement - Boiler Room Pit</p> <p>No violations recorded.</p>
<b>FOUNDATION WALLS</b>	
Material Type(s)	<p>Inspected</p> <p>Concrete</p>
Condition	<p>4 - Between Fair and Poor</p>
Deficiency	<p>CONCRETE: WATER INFILTRATION IN NON- INSTRUCTIONAL SPACE</p>
Deficiency Location/Instance	<p>Basement - Boiler Room Pit</p>

Basement - Boiler Room Pit
Violations	35657759J
Deficiency	CONCRETE: CRACKED/SPALLED/REINFORCEMENT EXPOSED
Deficiency Location/Instance	Facade G - AW3
Deficiency Quantity	10
Quantity Uom	S.F.
Potential Action	REPAIR
Urgency of Action	PRIORITY 3
Purpose of Action	LEVEL 5
Deficiency Photo1

Deficiency Quantity	<p>200</p>
Quantity Uom	<p>S.F.</p>
Potential Action	<p>INSTALL WATERPROOFING</p>
Urgency of Action	<p>PRIORITY 5</p>
Purpose of Action	<p>LEVEL 5</p>

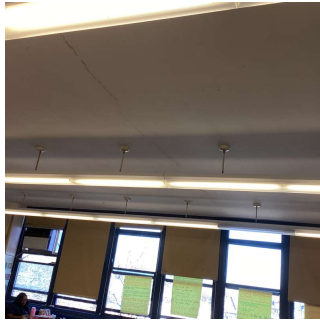
Question	Response
<b>INTERIOR</b>	
<b>CLASSROOMS/CORRIDORS/ADMIN SPACES</b>	
<b>Ceiling</b>	
Deficiency Quantity	100
Quantity Uom	S.F.
Potential Action	REPLACE
Urgency of Action	PRIORITY 3
Purpose of Action	LEVEL 2
Deficiency Photo1

Room 320
Violations	No violations recorded.
Deficiency	ACOUSTIC TILES ON PLASTER: DAMAGED/MISSING - ACTIVE LEAK
Deficiency Location/Instance	Lobby near Auditorium Entrance
Deficiency Quantity	10
Quantity Uom	S.F.
Potential Action	REPLACE
Urgency of Action	PRIORITY 5
Purpose of Action	LEVEL 2
Deficiency Photo1

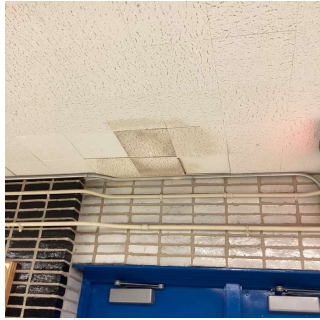
Lobby near Auditorium Entrance
Violations	No violations recorded.
Deficiency	ACOUSTIC TILES ON PLASTER: DAMAGED/MISSING
Deficiency Location/Instance	Rooms B/1, B/4, B8, 201, Near Vestibule Exit 3, and others.
Deficiency Quantity	200
Quantity Uom	S.F.
Potential Action	REPLACE
Urgency of Action	PRIORITY 3
Purpose of Action	LEVEL 2

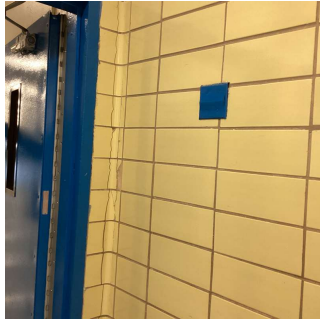
Question	Response
<b>INTERIOR</b>	
<b>CLASSROOMS/CORRIDORS/ADMIN SPACES</b>	
<b>Walls</b>	Inspected
Condition	2 - Between Good and Fair
Deficiency	GLAZED BLOCK: CRACKS/SPALLING
Deficiency Location/Instance	Corridor near Rooms 221, 429, and others.
Deficiency Quantity	40
Quantity Uom	S.F.
Potential Action	REPLACE
Urgency of Action	PRIORITY 3
Purpose of Action	LEVEL 2
Deficiency Photo1

Corridor near Room 221
Violations	No violations recorded.
Deficiency	PLASTER: CRACKS/SPALLING
Deficiency Location/Instance	Rooms 205, 402, 404, Corridor near Room 401, 435, and others.
Deficiency Quantity	200
Quantity Uom	S.F.
Potential Action	REPLACE
Urgency of Action	PRIORITY 3
Purpose of Action	LEVEL 2
Deficiency Photo1

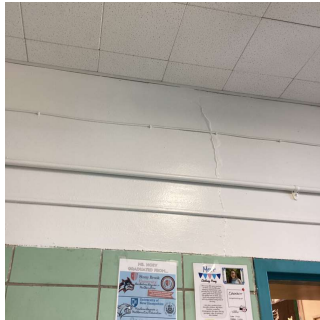
Corridor near Room 435
Violations	No violations recorded.
Deficiency	BRICK: CRACKS/SPALLING
Deficiency Location/Instance	Main Entrance Area
Deficiency Quantity	10
Quantity Uom	S.F.
Potential Action	REPLACE
Urgency of Action	PRIORITY 3

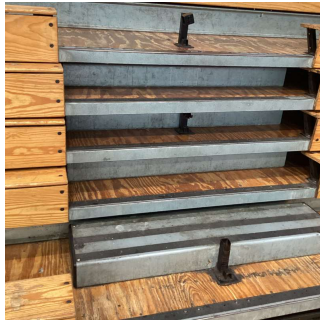
Violations	Drinking Fountain Area No violations recorded.
<b>Seating</b>	
Instance on 1st Floor	Inspected
Condition	5 - Poor
Deficiency	DAMAGED BLEACHERS
Deficiency Location/Instance	Near Windows - Right Side
Deficiency Quantity	20
Quantity Uom	S.F.
Potential Action	REPLACE
Urgency of Action	PRIORITY 5
Purpose of Action	LEVEL 6
Deficiency Photo1

Violations	Near Windows - Right Side No violations recorded.
Deficiency	INOPERABLE BLEACHERS
Deficiency Location/Instance	Near Windows
Deficiency Quantity	720
Quantity Uom	S.F.
Potential Action	REPLACE
Urgency of Action	PRIORITY 3
Purpose of Action	LEVEL 2
Deficiency Photo1	No photo recorded
Violations	No violations recorded.
<b>Sliding-folding Partition</b>	
Instance on 1st Floor	Inspected
Condition	5 - Poor
Deficiency	MOVABLE PANELS: DAMAGED
Deficiency Location/Instance	Center

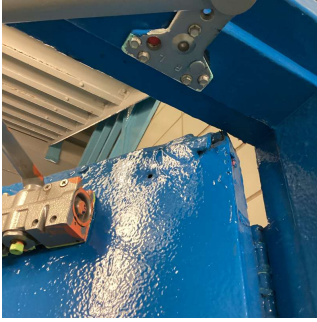
Violations	Stair DE/Basement No violations recorded.
Deficiency	METAL: DETERIORATED DOOR
Deficiency Location/Instance	Stairs A/2, 4, BC/Basement
Deficiency Quantity	6
Quantity Uom	EACH
Potential Action	MAINTENANCE
Urgency of Action	PRIORITY 3
Purpose of Action	LEVEL 2
Deficiency Photo1

Violations	Stair BC/Basement No violations recorded.
<b>Partition</b>	Does not Exist
<b>Railings</b>	Inspected
Condition	4 - Between Fair and Poor
Deficiency	METAL: DAMAGED
Deficiency Location/Instance	Stair F/4
Deficiency Quantity	10
Quantity Uom	L.F.
Potential Action	REPLACE
Urgency of Action	PRIORITY 3
Purpose of Action	LEVEL 2
