NYC Department of Education
Building Condition Assessment Survey 2023 - 2024

Architectural Inspection

Asset: P.S. 9 (W REED SCHOOL) - QUEENS, 58-74 57 STREET, New York, 11378

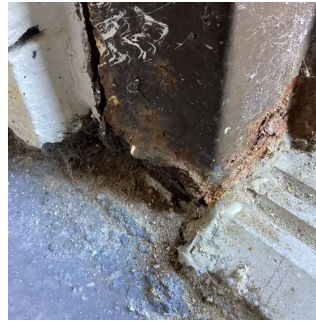
Facade D

Question	Response
EXTERIOR	
DOORS	Inspected
DOORS AND FRAMES	Inspected
Condition	5 - Poor
Deficiency	METAL CLAD: DETERIORATED DOOR AND FRAME - MAJOR DETERIORATION
Roof Plan reference	
Deficiency Quantity	1
Quantity Uom	EACH
Potential Action	REPLACE
Urgency of Action	PRIORITY 4
Purpose of Action	LEVEL 2
Deficiency Photo1	
Violations	Facade C No violations recorded.
Deficiency	METAL: DETERIORATED DOOR AND FRAME - MAJOR DETERIORATION
Roof Plan reference	
Deficiency Quantity	3
Quantity Uom	EACH
Potential Action	REPLACE
Urgency of Action	PRIORITY 4
Purpose of Action	LEVEL 2

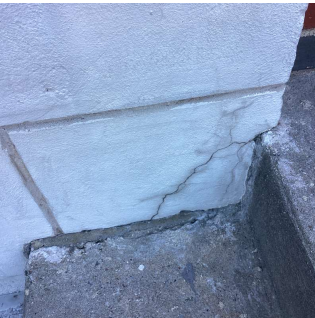
STONE: CHIPPED/SPALLED/BROKEN PIECES - MINOR

Deficiency Quantity	10
Quantity Uom	S.F.
Potential Action	REPAIR
Urgency of Action	PRIORITY 3
Purpose of Action	LEVEL 2
Deficiency Photo1

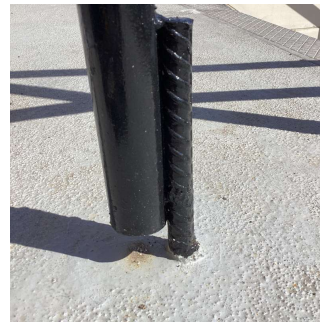
Facade A

<p>Facade C No violations recorded.</p>
Deficiency Quantity	
Quantity Uom	
Potential Action	
Urgency of Action	
Purpose of Action	
Deficiency Photo1	
RAILINGS	Inspected
Condition	5 - Poor
Deficiency	DAMAGED

50
 L.F.
 REPLACE
 PRIORITY 4
 LEVEL 2

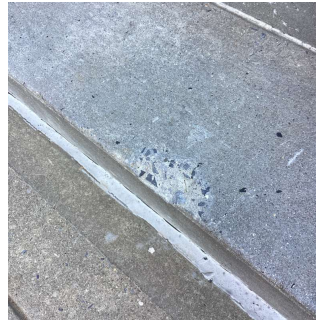
Facade D

CONCRETE: WORN-OUT TREAD/RISER/NOSING

10
 S.F.
 REPLACE
 PRIORITY 4
 LEVEL 2

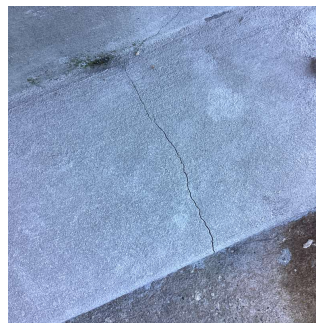
Facade C

CONCRETE: CRACKS/SPALLING - MINOR

REPAIR

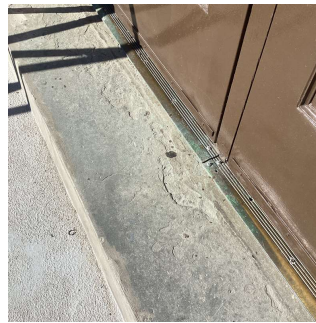
Facade A

STONE: WORN-OUT TREAD/RISER/NOSING

10
S.F.
REPLACE
PRIORITY 4
LEVEL 2

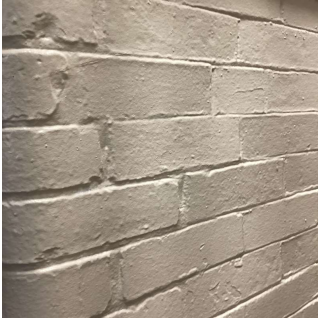
Question	Response
INTERIOR	
STRUCTURAL	Inspected
COLUMNS/BEAMS/BEARING WALLS	Inspected
Condition	3 - Fair
Deficiency	MASONRY BEARING WALL: CRACKED/SPALLED
Deficiency Location/Instance	Basement - Corridor
Deficiency Quantity	30
Quantity Uom	S.F.
Potential Action	RESTITCH
Urgency of Action	PRIORITY 3
Purpose of Action	LEVEL 5
Deficiency Photo1

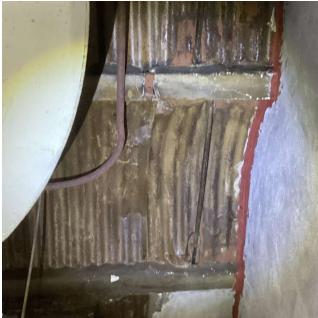
Basement - Corridor
Violations	No violations recorded.
FLOOR STRUCTURE	Inspected
Condition	3 - Fair
Deficiency	CINDER CONCRETE ARCH: METAL PAN DETERIORATED, SPALLED
Deficiency Location/Instance	Basement - Storage
Deficiency Quantity	30
Quantity Uom	S.F.
Potential Action	REPAIR
Urgency of Action	PRIORITY 3
Purpose of Action	LEVEL 5
Deficiency Photo1

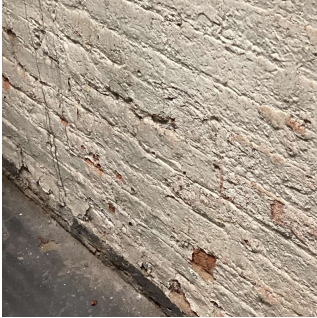
Basement - Storage
Violations	No violations recorded.
FOUNDATION WALLS	Inspected
Material Type(s)	Masonry
Condition	3 - Fair
Deficiency	BRICK: CRACKED/SPALLED
Deficiency Location/Instance	Basement - Boiler Room, Cafeteria
Deficiency Quantity	200

Question	Response
INTERIOR	
STRUCTURAL	
FOUNDATION WALLS	
Potential Action	RESTITCH
Urgency of Action	PRIORITY 3
Purpose of Action	LEVEL 5
Deficiency Photo1

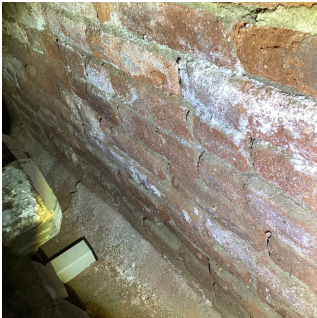
Basement - Boiler Room
Violations	No violations recorded.
ROOF STRUCTURE	Inspected
Condition	2 - Between Good and Fair
Deficiency	No deficiencies recorded
VAULTS-BUNKERS	Inspected
Foundation Walls	Inspected
Condition	4 - Between Fair and Poor
Deficiency	DETERIORATED JOINTS
Deficiency Location/Instance	Basement -Vault
Deficiency Quantity	100
Quantity Uom	S.F.
Potential Action	REPOINT
Urgency of Action	PRIORITY 4
Purpose of Action	LEVEL 5
Deficiency Photo1

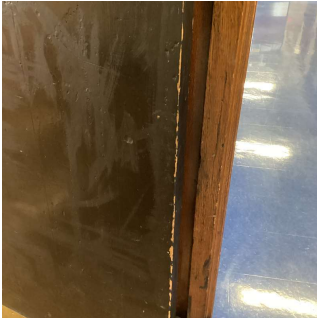
Question	Response
INTERIOR	
AUDITORIUM	
Ceiling	
Deficiency	No deficiencies recorded
Door(s)	
Instance on 1st Floor (259 Seats)	Inspected
Condition	5 - Poor
Deficiency	WOOD: DETERIORATED DOOR
Deficiency Location/Instance	Entrances, Emergency Exit
Deficiency Quantity	4
Quantity Uom	EACH
Potential Action	MAINTENANCE
Urgency of Action	PRIORITY 3
Purpose of Action	LEVEL 2
Deficiency Photo1

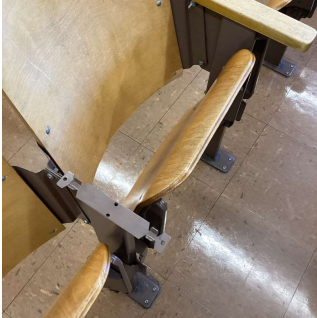
Entrance
Violations	No violations recorded.
Fixed H/C Lift	
Instance on 1st Floor (259 Seats)	Does not Exist
Fixed Seating	
Instance on 1st Floor (259 Seats)	Inspected
Condition	5 - Poor
Deficiency	DAMAGED/BROKEN/INOPERABLE
Deficiency Location/Instance	Seat C/16
Deficiency Quantity	1
Quantity Uom	EACH
Potential Action	REPLACE
Urgency of Action	PRIORITY 5
Purpose of Action	LEVEL 6
Deficiency Photo1

Seat C/16
Violations	No violations recorded.
Deficiency	DAMAGED/BROKEN/INOPERABLE
Deficiency Location/Instance	Seats C/8, H/6, 14, 18, I/6, and others

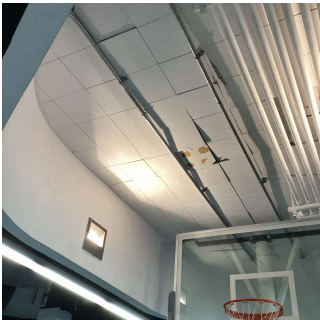
Question	Response
INTERIOR	
AUDITORIUM	Inspected
Window Curtains/Shades/Blinds	
Condition	1 - Good
Deficiency	No deficiencies recorded
CAFETERIA	Inspected
Instance on Basement	Inspected
Ceiling	
Instance on Basement	Inspected
Condition	2 - Between Good and Fair
Deficiency	ACOUSTIC TILES ON PLASTER: DAMAGED/MISSING
Deficiency Location/Instance	Near center
Deficiency Quantity	10
Quantity Uom	S.F.
Potential Action	REPLACE
Urgency of Action	PRIORITY 3
Purpose of Action	LEVEL 2
Deficiency Photo1

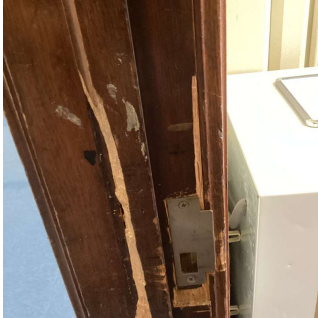
Question	Response
INTERIOR	
CAFETERIA	Inspected
Floor Finish	
Deficiency Photo1	 
	Near Stair D
Violations	No violations recorded.
Sliding-folding Partition	
Instance on Basement	Does not Exist
Stage	
Instance on Basement	Does not Exist
Walls	
Instance on Basement	Inspected
Condition	2 - Between Good and Fair
Deficiency	No deficiencies recorded
Window Curtains/Shades/Blinds	
Instance on Basement	Does not Exist
CLASSROOMS/CORRIDORS/ADMIN SPACES	
Ceiling	Inspected
Condition	2 - Between Good and Fair
Deficiency	PLASTER: CRACKS/SPALLING
Deficiency Location/Instance	Room 201
Deficiency Quantity	20
Quantity Uom	S.F.
Potential Action	REPLACE
Urgency of Action	PRIORITY 3
Purpose of Action	LEVEL 2
Deficiency Photo1	 
	Room 201
Violations	No violations recorded.
Door(s)	Inspected
Condition	5 - Poor
Deficiency	WOOD: DETERIORATED DOOR AND FRAME
Deficiency Location/Instance	Room 350
Deficiency Quantity	1

Question	Response
INTERIOR	
CLASSROOMS/CORRIDORS/ADMIN SPACES	
Door(s)	
Quantity Uom	EACH
Potential Action	MAINTENANCE
Urgency of Action	PRIORITY 3
Purpose of Action	LEVEL 2
Deficiency Photo1

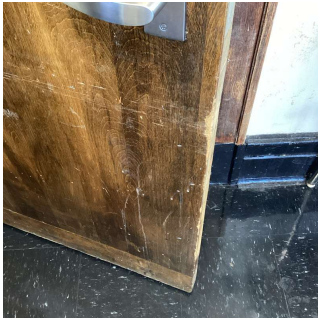
Room 350
Violations	No violations recorded.
Deficiency	WOOD: DETERIORATED DOOR
Deficiency Location/Instance	Rooms 102, 150, 203, 305, and others
Deficiency Quantity	15
Quantity Uom	EACH
Potential Action	MAINTENANCE
Urgency of Action	PRIORITY 3
Purpose of Action	LEVEL 2
Deficiency Photo1

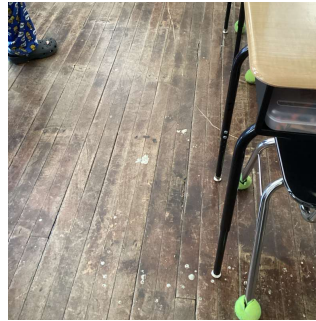
Room 301
Violations	No violations recorded.
Floor Finish	Inspected
Condition	2 - Between Good and Fair
Deficiency	WOOD: DAMAGED/DETERIORATED
Deficiency Location/Instance	Room 302
Deficiency Quantity	40
Quantity Uom	S.F.
Potential Action	REPLACE
Urgency of Action	PRIORITY 3
Purpose of Action	LEVEL 2

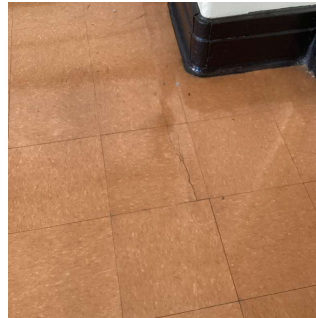
Room 305

VINYL TILES: BROKEN/DETERIORATED/MISSING TILES

REPLACE

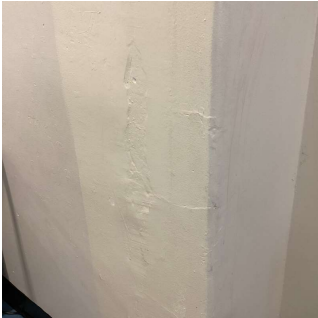
Corridor near Room 302

Violations	Main Entrance Vestibule No violations recorded.
Deficiency	PLASTER: CRACKS/SPALLING
Deficiency Location/Instance	Rooms 201, 217, 310, Corridor near Rooms 202, 302, and others
Deficiency Quantity	250
Quantity Uom	S.F.
Potential Action	REPLACE
Urgency of Action	PRIORITY 3
Purpose of Action	LEVEL 2
Deficiency Photo1

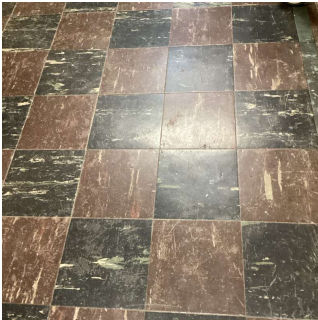
Question	Response
INTERIOR	
KITCHEN	Inspected
Floor Finish	
Instance on Basement (300SF)	Inspected
Condition	5 - Poor
Deficiency	VINYL TILES: BROKEN/DETERIORATED/MISSING TILES
Deficiency Location/Instance	Locker Room Outside Kitchen (Cafeteria)
Deficiency Quantity	120
Quantity Uom	S.F.
Potential Action	REPLACE
Urgency of Action	PRIORITY 3
Purpose of Action	LEVEL 2
Deficiency Photo1

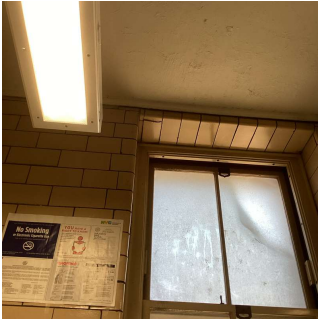
Violations	Locker Room Outside Kitchen (Cafeteria) No violations recorded.
Walls	
Instance on Basement (300SF)	Inspected
Condition	2 - Between Good and Fair
Deficiency	GLAZED BLOCK: CRACKS/SPALLING
Deficiency Location/Instance	Near Windows
Deficiency Quantity	10
Quantity Uom	S.F.
Potential Action	REPLACE
Urgency of Action	PRIORITY 3
Purpose of Action	LEVEL 2
Deficiency Photo1

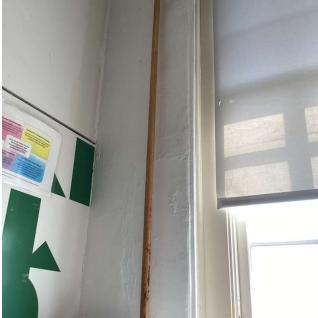
Question	Response
INTERIOR	
LIBRARY	
Walls	
Condition	2 - Between Good and Fair
Deficiency	PLASTER: CRACKS/SPALLING
Deficiency Location/Instance	Near Windows
Deficiency Quantity	50
Quantity Uom	S.F.
Potential Action	REPLACE
Urgency of Action	PRIORITY 3
Purpose of Action	LEVEL 2
Deficiency Photo1

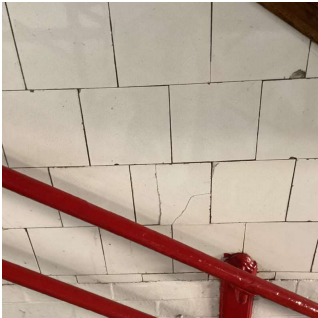
Violations	Stair CD/1 No violations recorded.
Deficiency	CERAMIC TILE: BROKEN/ MISSING
Deficiency Location/Instance	Stairs AB/2, CD/1, 2
Deficiency Quantity	30
Quantity Uom	S.F.
Potential Action	REPLACE
Urgency of Action	PRIORITY 3
Purpose of Action	LEVEL 2
Deficiency Photo1

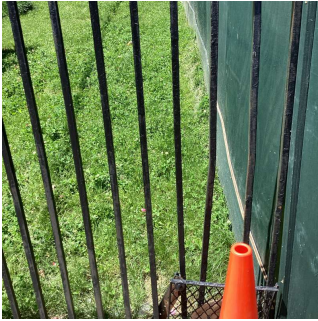
Question	Response
SITE	
FENCES	
Condition	3 - Fair
Deficiency	WROUGHT IRON: DAMAGED/DETERIORATED
Deficiency Location/Instance	57th Street
Deficiency Quantity	120
Quantity Uom	S.F.
Potential Action	REPLACE
Urgency of Action	PRIORITY 3
Purpose of Action	LEVEL 2
Deficiency Photo1

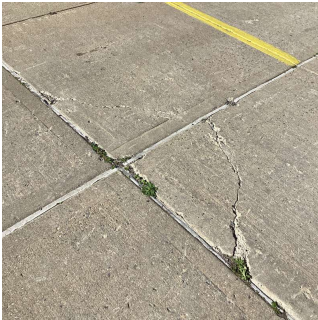
Violations	57th Street No violations recorded.
IRRIGATION SYSTEM	Does not Exist
PAVING	Inspected
Student Non-Use	Inspected
Gravel Exists?	No
Asphalt	Does not Exist
Concrete	Inspected
Condition	4 - Between Fair and Poor
Deficiency	DAMAGED/DETERIORATED/MISSING SECTIONS
Deficiency Location/Instance	Parking Area
Deficiency Quantity	575
Quantity Uom	S.F.
Potential Action	REPLACE
Urgency of Action	PRIORITY 3
Purpose of Action	LEVEL 2
Deficiency Photo1

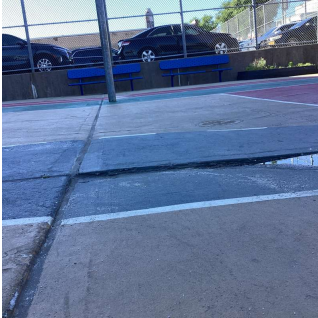
Priority Condition Exist Last Year?	Priority Category	Condition Description	Component Affected	Location Description	Person(s) Notified	Person(s) Title	PhotoImage
No	Tripping Hazard	Severely Heaving concrete is a potential tripping hazard condition	SITE PAVING Student Use Concrete	Near center	Jovan Cruz	Fireman

Question	Response
SITE	
PAVING	
Student Use	
Asphalt	Does not Exist
Concrete	Inspected
Condition	3 - Fair
Deficiency	HEAVING
Deficiency Location/Instance	Near center
Deficiency Quantity	25
Quantity Uom	S.F.
Potential Action	REPLACE
Urgency of Action	PRIORITY 5
Purpose of Action	LEVEL 6
Deficiency Photo1

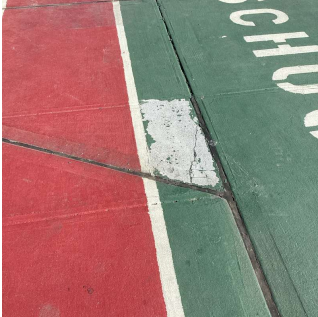
Near Center
Violations	No violations recorded.
Deficiency	DAMAGED/DETERIORATED/MISSING SECTIONS
Deficiency Location/Instance	Near 56st Street
Deficiency Quantity	75
Quantity Uom	S.F.
Potential Action	REPLACE
Urgency of Action	PRIORITY 3
Purpose of Action	LEVEL 2
Deficiency Photo1

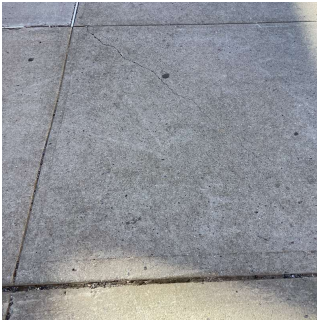
Question	Response
SITE	
PAVING	
DOT Sidewalk	Inspected
Asphalt	Does not Exist
Concrete	Inspected
Condition	3 - Fair
Deficiency	DAMAGED/DETERIORATED/MISSING SECTIONS
Deficiency Location/Instance	56th Street, 57th Street
Deficiency Quantity	425
Quantity Uom	S.F.
Potential Action	REPLACE
Urgency of Action	PRIORITY 3
Purpose of Action	LEVEL 2
Deficiency Photo1

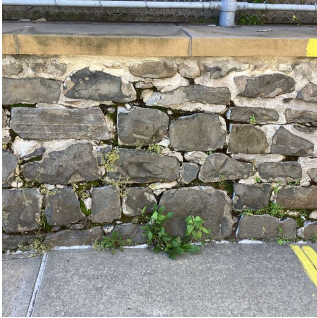
Question	Response
SITE	
PLAYGROUNDS	
Safety Surfacing	
Violations	Near 57th Street No violations recorded.
Unpaved Area	
Instance on North Side of building	Does not Exist
PLAYING SURFACE	
	Does not Exist
RETAINING WALLS	
Are there any Retaining Walls 6' OR higher facing public street/sidewalk?	Inspected No
Condition	3 - Fair
Deficiency	STONE: DETERIORATED JOINTS
Deficiency Location/Instance	Parking Area
Deficiency Quantity	50
Quantity Uom	S.F.
Potential Action	REPOINT
Urgency of Action	PRIORITY 3
Purpose of Action	LEVEL 2
Deficiency Photo1

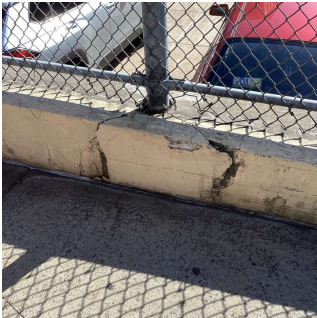
Violations	Parking Area No violations recorded.
Deficiency	CAST IN PLACE CONCRETE: CRACKS/SPALLING - MAJOR
Deficiency Location/Instance	56th Street, Parking Area, Student Use Area, Playground Area
Deficiency Quantity	150
Quantity Uom	S.F.
Potential Action	REPLACE
Urgency of Action	PRIORITY 3
Purpose of Action	LEVEL 2
Deficiency Photo1
