**NYC Department of Education
Building Condition Assessment Survey 2023 - 2024**

Architectural Inspection

Asset: I.S. 10 - QUEENS, 45-11 31 AVENUE, New York, 11103

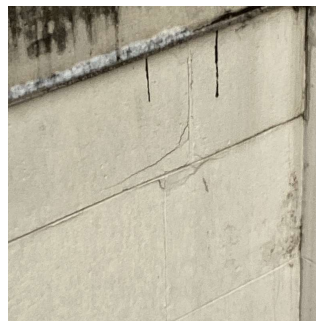
AW2

AREAWAY WALLS: CRACKS AND SPALLING

40
S.F.
REPAIR
PRIORITY 3
LEVEL 2

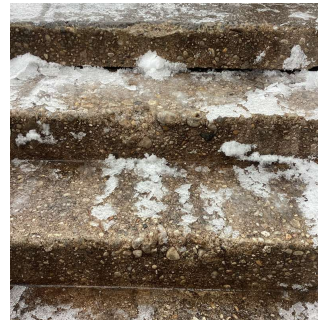
AW3
No violations recorded.

AREAWAY STAIRS: DETERIORATED TREADS/RISERS/NOSINGS

20
S.F.
REPAIR
PRIORITY 3
LEVEL 2

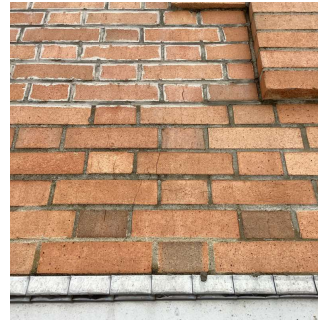
CH

BRICK: MINOR CRACKS AND SPALLING

40
S.F.
RESTITCH
PRIORITY 3
LEVEL 2

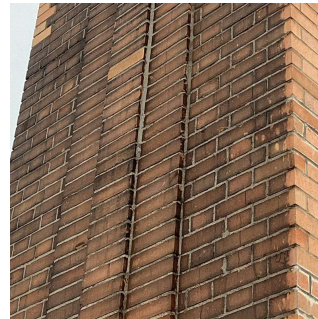
CH

BRICK: DETERIORATED JOINTS

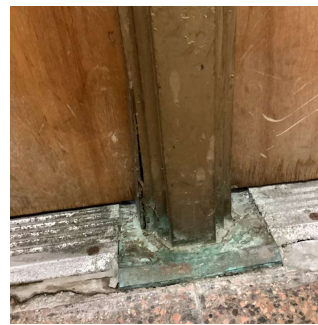
Facade A - Exit 6

METAL CLAD: DETERIORATED DOOR AND FRAME - MAJOR DETERIORATION

2
EACH
REPLACE
PRIORITY 4
LEVEL 2

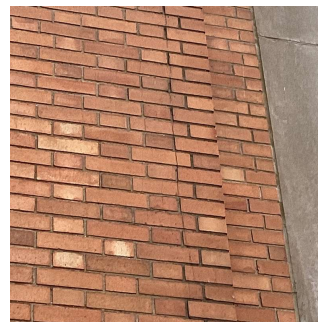
Facade J

BRICK: MINOR CRACKS AND SPALLING

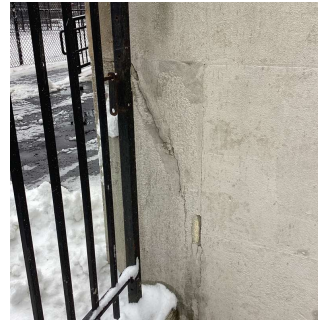
Facade B

STONE: CRACKS AT BUILDING CORNERS

REPLACE

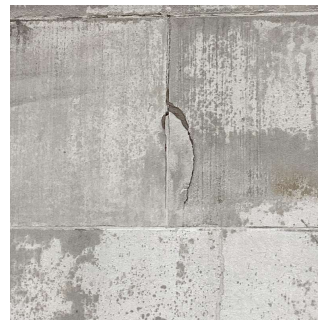
Facade J

STONE: CHIPPED/SPALLED/BROKEN PIECES - MINOR

REPAIR

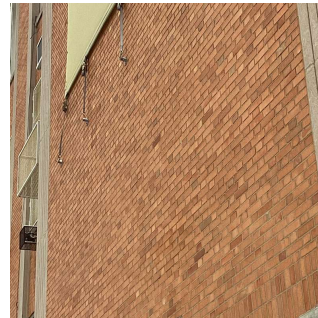
Facade A

BRICK: DETERIORATED JOINTS

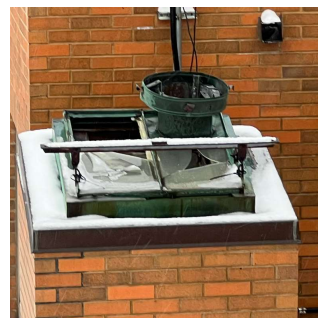
SHAFT VENTS DAMAGED

1
EACH
MAINTENANCE
PRIORITY 3
LEVEL 2

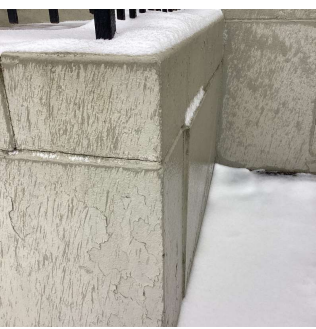
Question	Response
EXTERIOR	
ROOF	Inspected
Specialties	Inspected
SKYLIGHT/ROOF VENT	Inspected
Violations	No violations recorded.
ROOF/GRAVITY TANK	Does not Exist
STAIRS/RAMPS: EXTERIOR	Inspected
BUILDING CHEEK/FLANK WALLS	Inspected
Condition	3 - Fair
Deficiency	STONE: BULGING/DISPLACED
Roof Plan reference

Deficiency Quantity	10
Quantity Uom	S.F.
Potential Action	REPLACE
Urgency of Action	PRIORITY 4
Purpose of Action	LEVEL 2
Deficiency Photo1

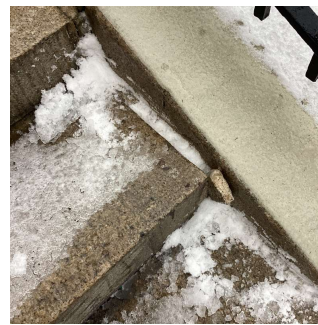
Facade H
No violations recorded.

Question	Response
EXTERIOR	
STAIRS/RAMPS: EXTERIOR	Inspected
RAILINGS	
Quantity Uom	L.F.
Potential Action	REPLACE
Urgency of Action	PRIORITY 4
Purpose of Action	LEVEL 2
Deficiency Photo1	 
Violations	Facade A No violations recorded.
Deficiency	DAMAGED
Roof Plan reference	 
Deficiency Quantity	10
Quantity Uom	L.F.
Potential Action	REPLACE
Urgency of Action	PRIORITY 4
Purpose of Action	LEVEL 2
Deficiency Photo1	 
Violations	Facade E No violations recorded.
STAIRS/RAMPS	Inspected
Condition	5 - Poor
Deficiency	STONE: DETERIORATED JOINTS

20
L.F.
REPOINT
PRIORITY 4
LEVEL 2

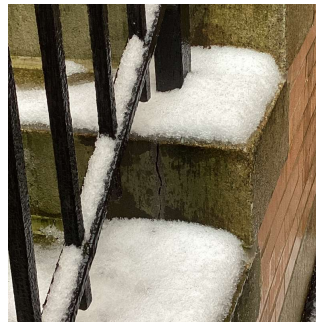
Facade F

STONE: CRACKS/SPALLING - MAJOR

10
S.F.
REPLACE
PRIORITY 4
LEVEL 2

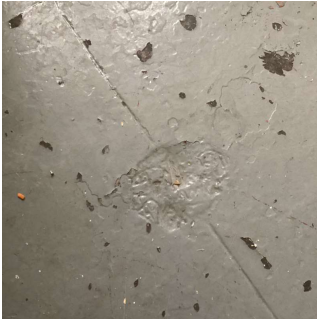
Question	Response
INTERIOR	
STRUCTURAL	
COLUMNS/BEAMS/BEARING WALLS	Inspected
Violations	No violations recorded.
FLOOR STRUCTURE	Inspected
Condition	3 - Fair
Deficiency	CONCRETE: CRACKS/SPALLED/REINFORCEMENT EXPOSED
Deficiency Location/Instance	4th Floor Gymnasium Storage Room
Deficiency Quantity	10
Quantity Uom	S.F.
Potential Action	REPAIR
Urgency of Action	PRIORITY 4
Purpose of Action	LEVEL 5
Deficiency Photo1

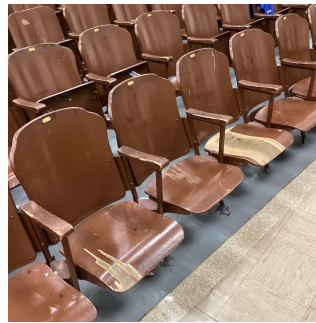
Seats B8-10

Question	Response
INTERIOR	
AUDITORIUM	
Ceiling	
Deficiency Photo1	 
Violations	Near stage No violations recorded.
Door(s)	
Instance on 1st Floor (575 Seats)	Inspected
Condition	2 - Between Good and Fair
Deficiency	No deficiencies recorded
Fixed H/C Lift	
Instance on 1st Floor (575 Seats)	Does not Exist
Fixed Seating	
Instance on 1st Floor (575 Seats)	Inspected
Condition	5 - Poor
Deficiency	DAMAGED/BROKEN/INOPERABLE
Deficiency Location/Instance	Seats A/1, B/2,F/2
Deficiency Quantity	3
Quantity Uom	EACH
Potential Action	REPLACE
Urgency of Action	PRIORITY 5
Purpose of Action	LEVEL 6
Deficiency Photo1	 
Violations	Seat B/2 No violations recorded.
Deficiency	DAMAGED/BROKEN/INOPERABLE
Deficiency Location/Instance	Seats B/6, 8, 10,12 18 and others
Deficiency Quantity	220
Quantity Uom	EACH
Potential Action	REPLACE
Urgency of Action	PRIORITY 3
Purpose of Action	LEVEL 2

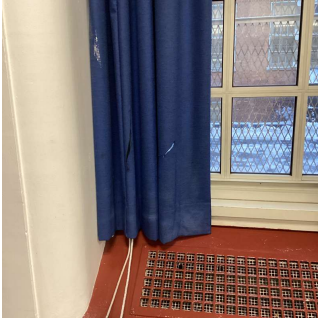
Question	Response
INTERIOR	
AUDITORIUM	
Window Curtains/Shades/Blinds	
Instance on 1st Floor (575 Seats)	Inspected
Condition	2 - Between Good and Fair
Deficiency	WORN/DAMAGED CURTAINS
Deficiency Location/Instance	Right side
Deficiency Quantity	20
Quantity Uom	S.F.
Potential Action	MAINTENANCE
Urgency of Action	PRIORITY 3
Purpose of Action	LEVEL 2
Deficiency Photo1

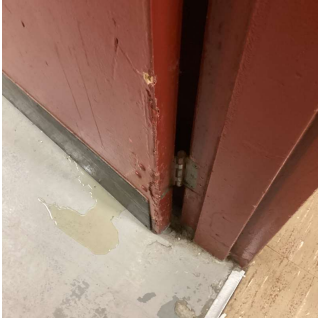
Violations	Near exit 8 No violations recorded.
Door(s)	
Instance on Basement	Inspected
Condition	3 - Fair
Deficiency	WOOD: DETERIORATED DOOR

Question	Response
INTERIOR	
CAFETERIA	
Door(s)	
Deficiency Location/Instance	Door to Elevator Lobby
Deficiency Quantity	1
Quantity Uom	EACH
Potential Action	MAINTENANCE
Urgency of Action	PRIORITY 3
Purpose of Action	LEVEL 2
Deficiency Photo1

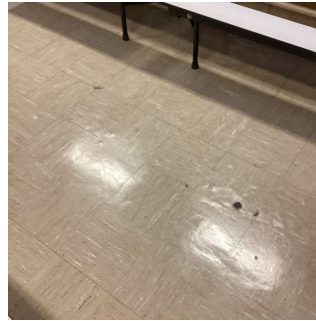
Violations	Rear No violations recorded.
Deficiency	VINYL TILES: BROKEN/DETERIORATED/MISSING TILES
Deficiency Location/Instance	Near Windows
Deficiency Quantity	80
Quantity Uom	S.F.
Potential Action	REPLACE
Urgency of Action	PRIORITY 3
Purpose of Action	LEVEL 2

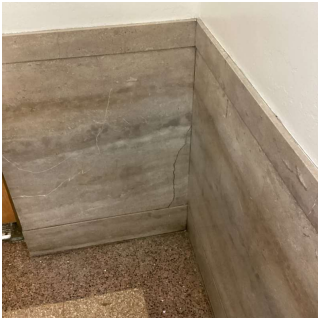
Question	Response
INTERIOR	
CLASSROOMS/CORRIDORS/ADMIN SPACES	
Walls	
Violations	Room 423 No violations recorded.
Deficiency	STONE: CRACKS/SPALLING
Deficiency Location/Instance	Near Exit 1
Deficiency Quantity	10
Quantity Uom	S.F.
Potential Action	REPLACE
Urgency of Action	PRIORITY 3
Purpose of Action	LEVEL 2
Deficiency Photo1

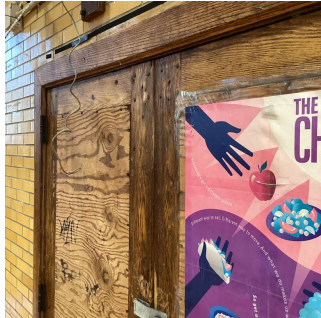
Question	Response
INTERIOR	
GYMNASIUM	
Door(s)	
Deficiency	WOOD: DETERIORATED DOOR
Deficiency Location/Instance	Storage Room
Deficiency Quantity	2
Quantity Uom	EACH
Potential Action	MAINTENANCE
Urgency of Action	PRIORITY 3
Purpose of Action	LEVEL 2
Deficiency Photo1

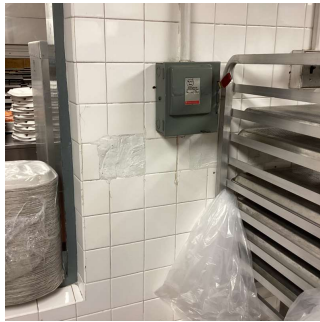
Storage Room
Violations	No violations recorded.
Deficiency	CERAMIC TILE: BROKEN/ MISSING
Deficiency Location/Instance	Near servery
Deficiency Quantity	10
Quantity Uom	S.F.
Potential Action	REPLACE
Urgency of Action	PRIORITY 3
Purpose of Action	LEVEL 2
Deficiency Photo1
