NYC Department of Education
Building Condition Assessment Survey 2023 - 2024

Architectural Inspection

Q011

Asset: P.S. 11 - QUEENS, 54-25 SKILLMAN AVENUE, New York, 11377

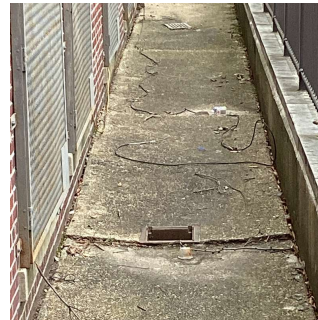
Violations	AW2 No violations recorded.
Deficiency	AREAWAY SLAB: DISPLACED

REPLACE

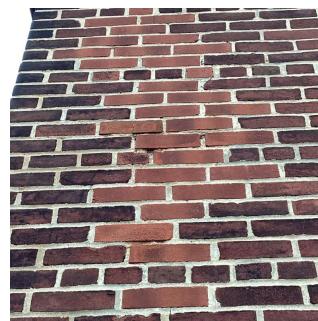
CH1

BRICK: DETERIORATED JOINTS

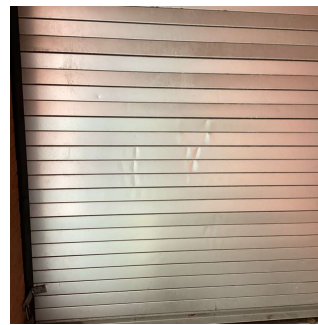
Facade E
No violations recorded.

ROLL-UP DOOR: DETERIORATED DOOR AND FRAME - MINOR DETERIORATION

60
S.F.
MAINTENANCE
PRIORITY 3
LEVEL 2

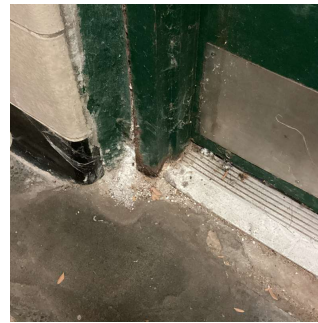
Facade H - Exit 5

METAL CLAD: DETERIORATED DOOR AND FRAME - MINOR DETERIORATION

1
EACH
MAINTENANCE
PRIORITY 3
LEVEL 2

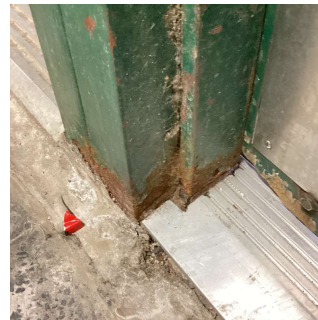
Facade A - Exit 20/21

METAL CLAD: DETERIORATED DOOR AND FRAME - MAJOR DETERIORATION

REPLACE

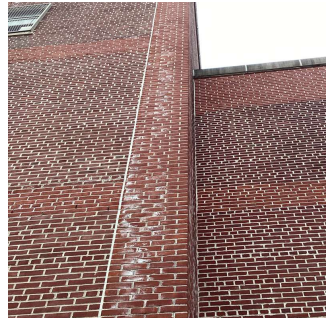
Question	Response
EXTERIOR	
EXTERIOR WALLS	Inspected
Material Type(s)	Masonry
Replacement Quantity	66,000
Replacement Uom	S.F.
Instance on All Facades	Inspected
Instance Condition	3 - Fair
Instance Quantity	66,000
Instance Quantity Uom	S.F.
Deficiency	BRICK: EFFLORESCENCE
Roof Plan reference

Deficiency Quantity	150
Quantity Uom	S.F.
Potential Action	MAINTENANCE
Urgency of Action	PRIORITY 1
Purpose of Action	LEVEL 1
Deficiency Photo1

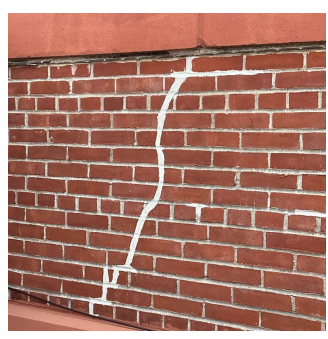
Question	Response
EXTERIOR	
EXTERIOR WALLS	Inspected
Violations	No violations recorded.
EXTERIOR SOFFITS	Inspected
Condition	2 - Between Good and Fair
Deficiency	No deficiencies recorded
LOADING DOCK	Does not Exist
LOUVER	Inspected
Condition	2 - Between Good and Fair
Deficiency	No deficiencies recorded
PARAPETS	Inspected
Material Type(s)	Masonry
Replacement Quantity	13,000
Replacement Uom	C.F.
Instance on All Roofs	Inspected
Instance Condition	3 - Fair
Instance Quantity	13,000
Instance Quantity Uom	C.F.
Deficiency	BRICK: MINOR CRACKS, SPALLING
Roof Plan reference

Deficiency Quantity	10
Quantity Uom	S.F.
Potential Action	REPAIR
Urgency of Action	PRIORITY 3
Purpose of Action	LEVEL 2
Deficiency Photo1

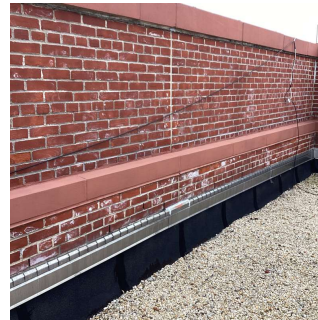
Violations	Roof 1 - Facade A No violations recorded.
Deficiency	BRICK: EFFLORESCENCE

300
 S.F.
 MAINTENANCE
 PRIORITY 1
 LEVEL 1

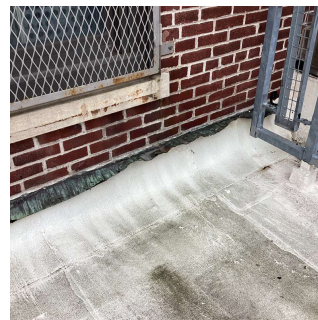
Roof 5 - Facade E

Sustainable Roof Location (Roof Number)	Roof 5
Do solar panels exist on these roofs?	No
Is/Are the roof(s) suitable for Solar Panel installation?	No
Installation Year	2018
Source of Installation	Custodial Staff
Deficiency	MODIFIED BITUMEN: FLASHING: CAP FLASHING DAMAGED

50
 L.F.
 REPLACE
 PRIORITY 4
 LEVEL 2

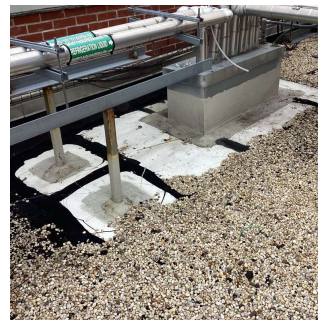
Roof 1

BUILT-UP: ROOFING: LOSS OF GRAVEL

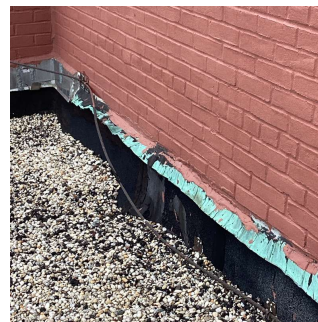
Roof 1 - BH1

BUILT-UP: FLASHING: CAP FLASHING DAMAGED

30
L.F.
REPLACE
PRIORITY 4
LEVEL 2

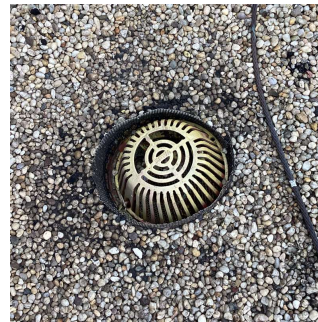
Roof 1

DETERIORATED

REPLACE

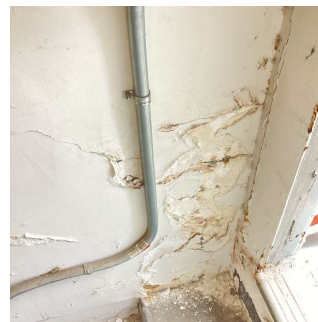
BH3
No violations recorded.

BULKHEAD/PENTHOUSE WALLS/EXTERIOR: WATER INFILTRATION

200
S.F.
REPAIR
PRIORITY 5
LEVEL 2

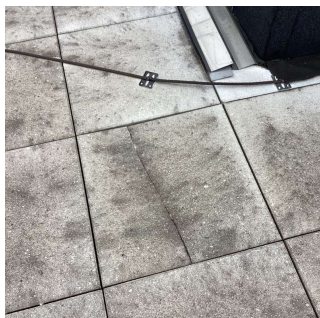
Violations	BH2 No violations recorded.
Deficiency	BULKHEAD/PENTHOUSE ROOF: DETERIORATED
Roof Plan reference

Deficiency Quantity	10
Quantity Uom	S.F.
Potential Action	REPLACE
Urgency of Action	PRIORITY 4
Purpose of Action	LEVEL 2
Deficiency Photo1

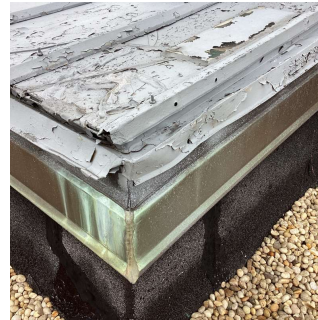
SK1

BROKEN FRAMING

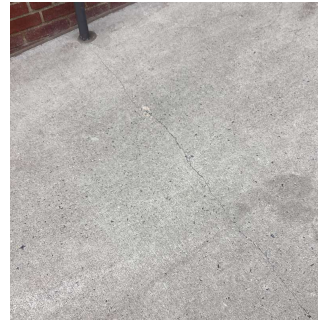
Facade A - Ramp

CONCRETE: CRACKS/SPALLING - MINOR

REPAIR

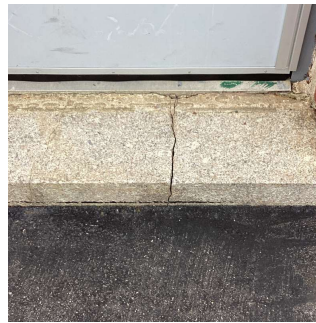
Facade G

STONE: CRACKS/SPALLING - MAJOR

REPLACE

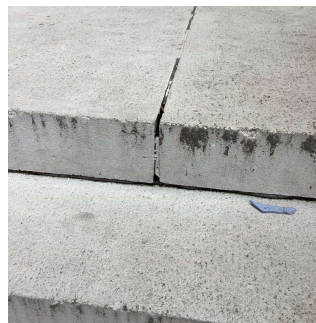
Facade E - Exit 13

STONE: DETERIORATED JOINTS

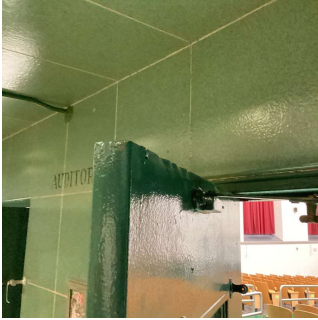
Instance on Ground Floor (438 Seats)	Inspected
Condition	3 - Fair
Deficiency	METAL: DETERIORATED DOOR
Deficiency Location/Instance	Main Entrance
Deficiency Quantity	1
Quantity Uom	EACH
Potential Action	MAINTENANCE
Urgency of Action	PRIORITY 3
Purpose of Action	LEVEL 2
Deficiency Photo1

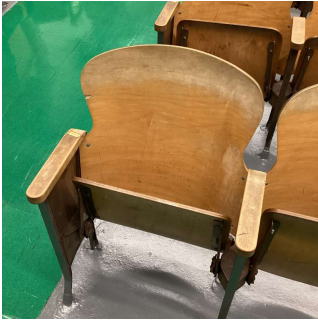
Sear A/101

Instance on Ground Floor (438 Seats)	Inspected
Condition	2 - Between Good and Fair
Deficiency	DAMAGED/BROKEN/INOPERABLE
Deficiency Location/Instance	Sear A/101, 102, 111, C/111, D101 and others
Deficiency Quantity	11
Quantity Uom	EACH
Potential Action	REPLACE
Urgency of Action	PRIORITY 3
Purpose of Action	LEVEL 2
Deficiency Photo1
